GPR investigation on the Chemours terrain in Dordrecht

Ground Penetrating Radar investigation for utility and obstacle detection on the Chemours terrain in Dordrecht, The Netherlands

1520-182933 | 01-02-2021

Draft report

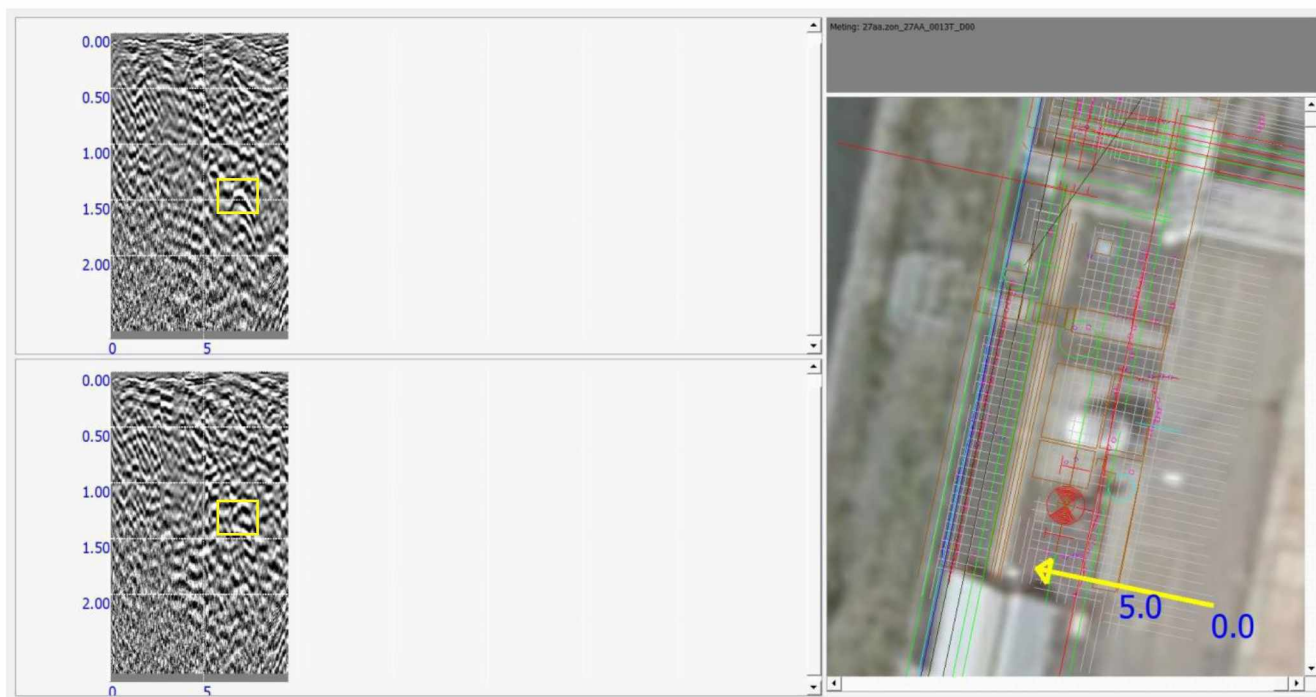
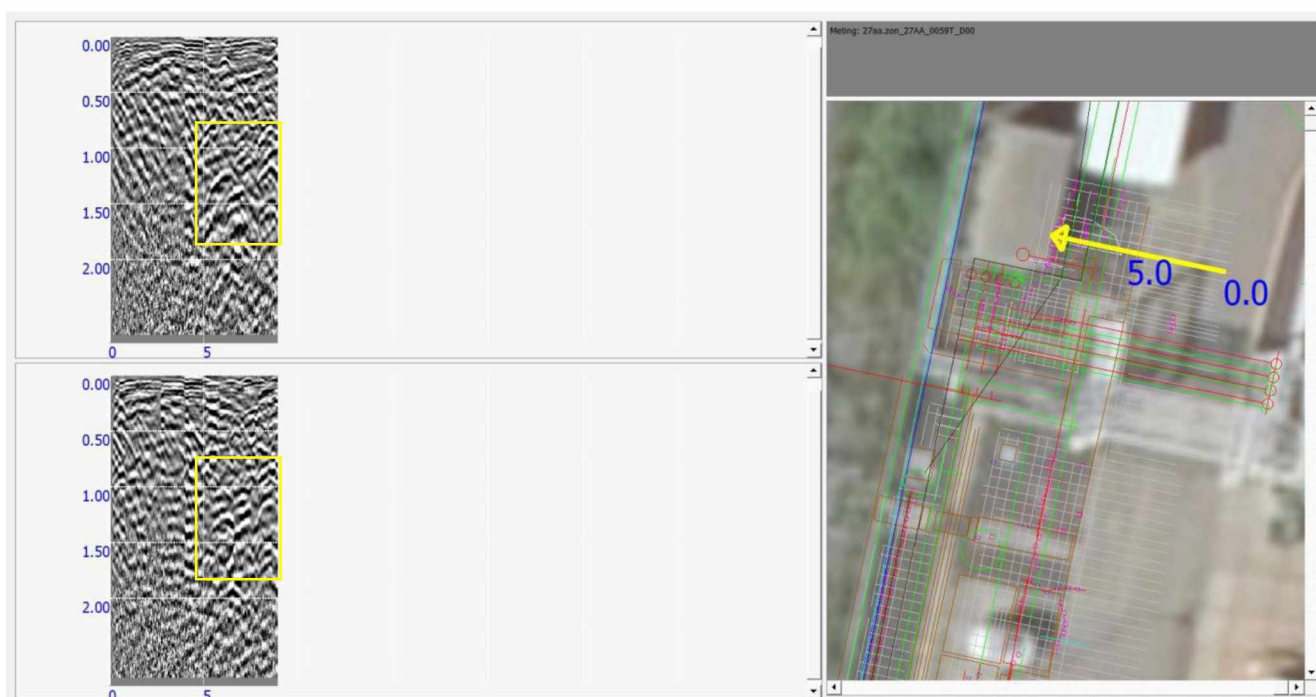
There is a small area in the northern part of the study area, indicated by a hatched polygon which contains so many local anomalies that they are not individually mapped, also see Figure 3b.

Figure 3: Ground radar profile in the study area. 3a (Top): Anomaly interpreted as utility has been highlighted with a yellow box, in this case a possible fire protection line. **3b (Bottom):** large area with many utilities has been highlighted with a large yellow box, and on the CAD map this area is indicated with a hatched polygon.

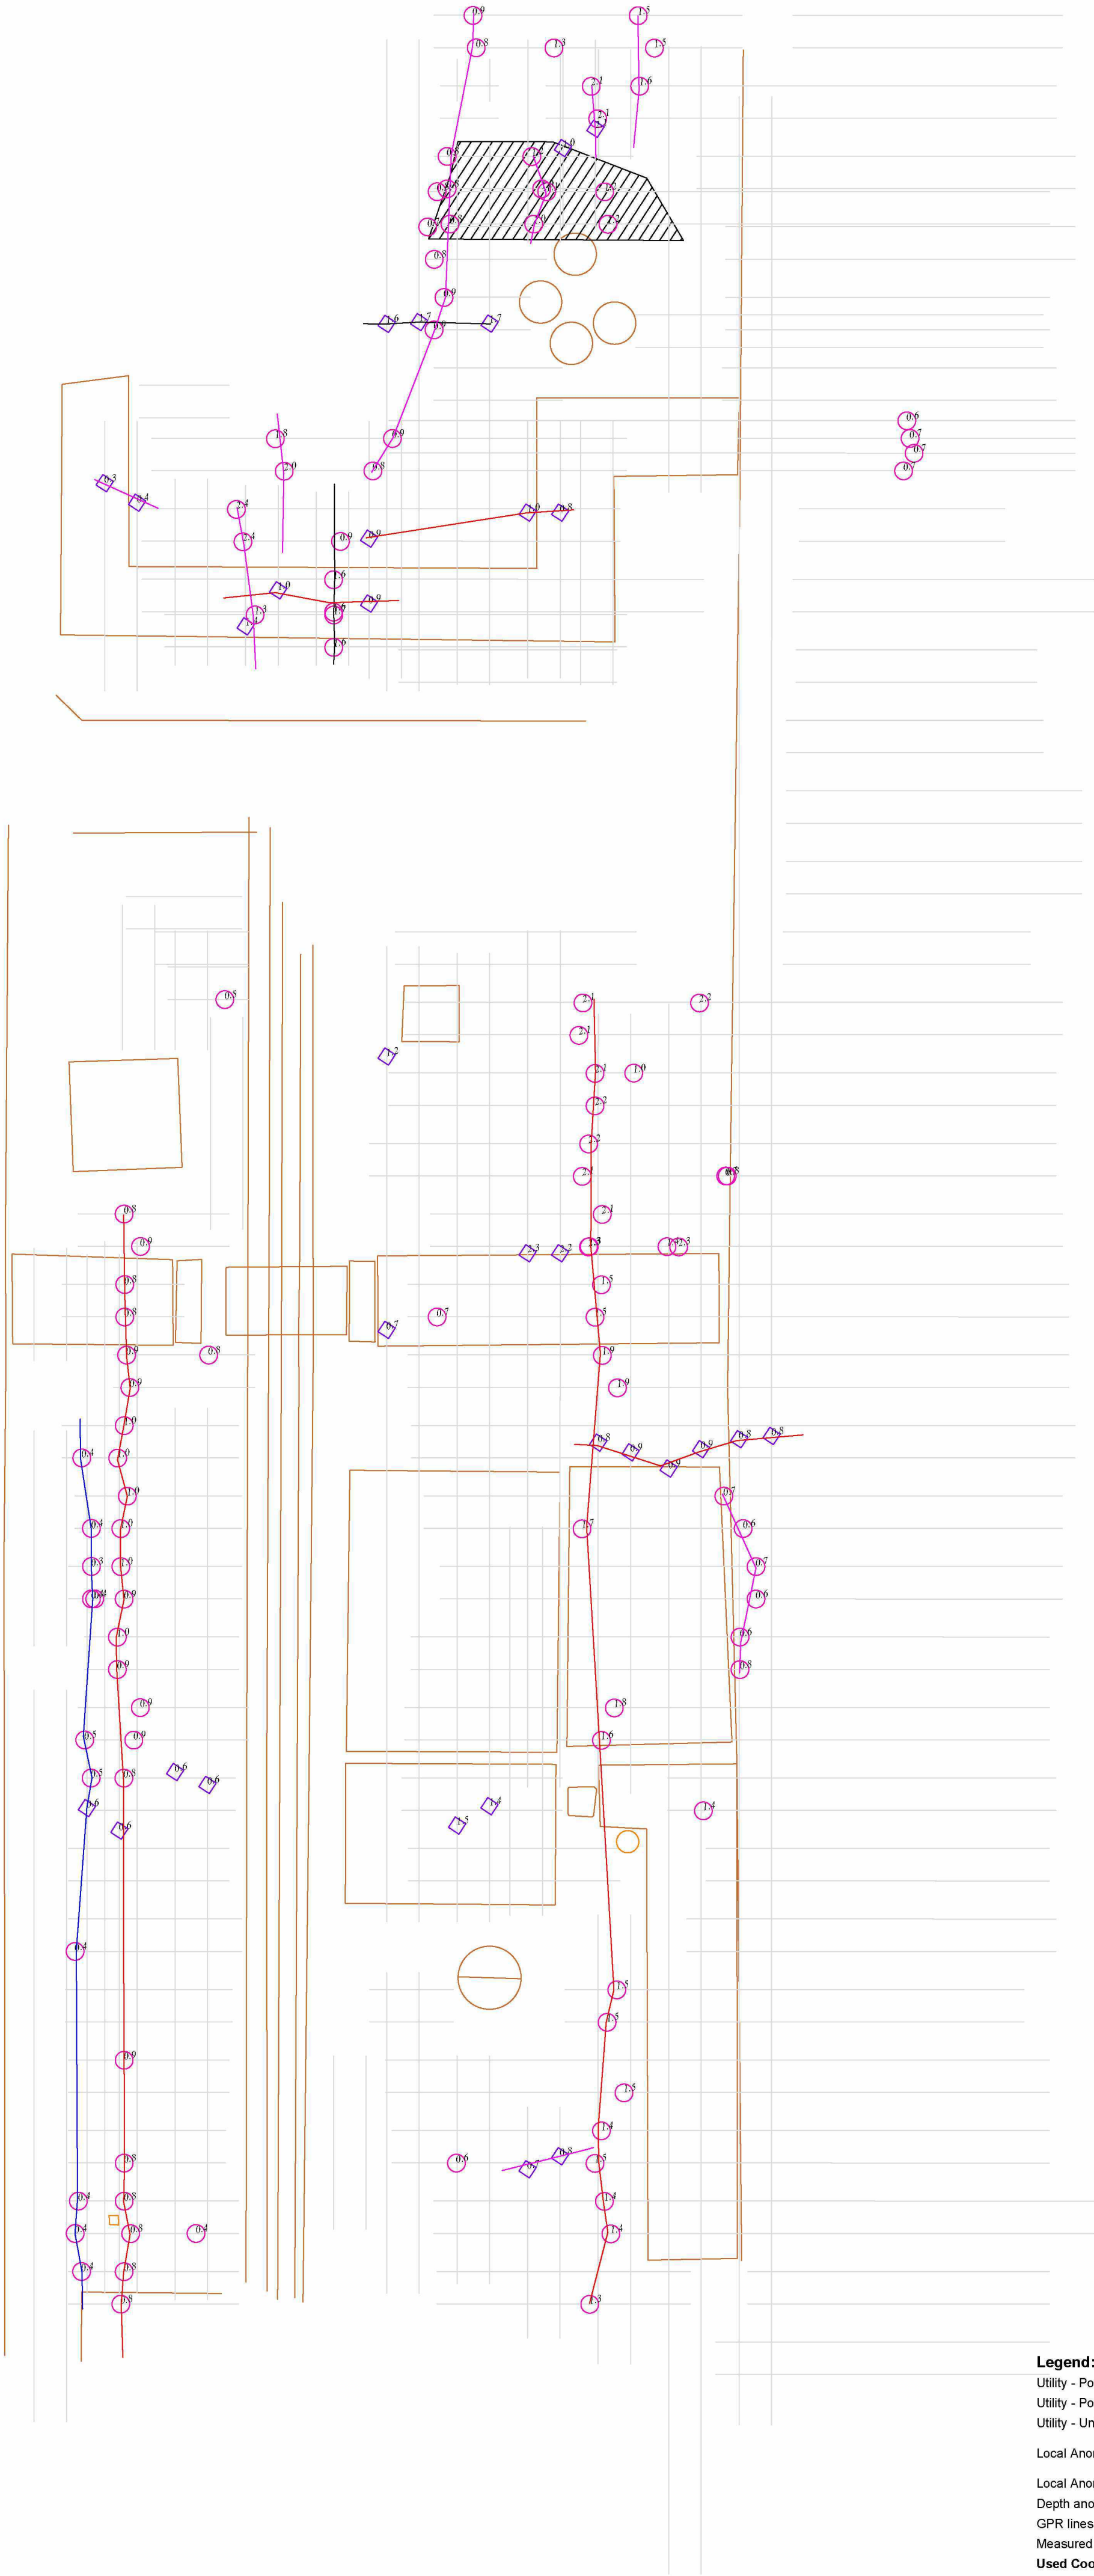
OVERVIEW

Most of the mapped utilities coincide with underground utilities indicated on the underground utility map provided by the client. The following types of Utilities were mapped:

Utility - Possible Underground city water – Line feature which coincides with Underground city water pipeline indicated on the utility map of the client.

Utility - Possible Fire Protection Line – Line feature which coincides with Fire Protection Line pipeline indicated on the utility map of the client.

Utility – Unknown – Line feature which does not coincide with a utility indicated on the utility map of the client.
