Aandachtspunten voor nader onderzoek per thema

West507 – transformatie Oceaanhuis

**Kleurhistorisch onderzoek en bouwhistorische verdieping**  
Plan van Onderzoek

14 juli 2017

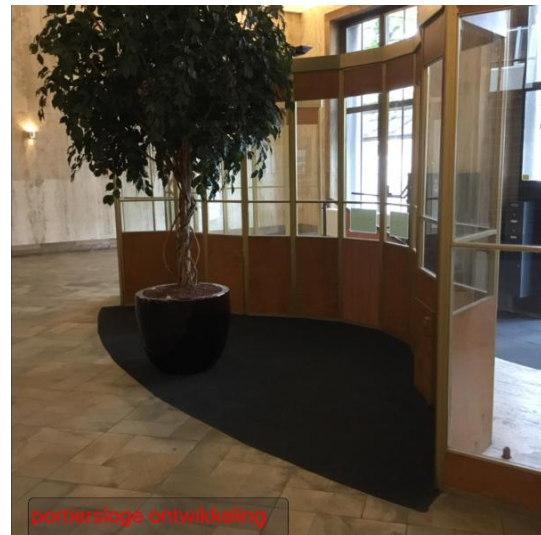
Component 0.001 Entree HD portierloge  
Description Portierloge documenteren en kleuronderzoek stratigrafie op glazen wand. Wordt behouden.

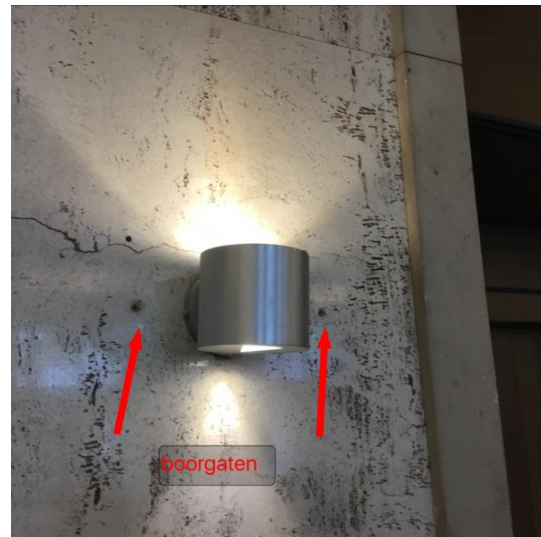
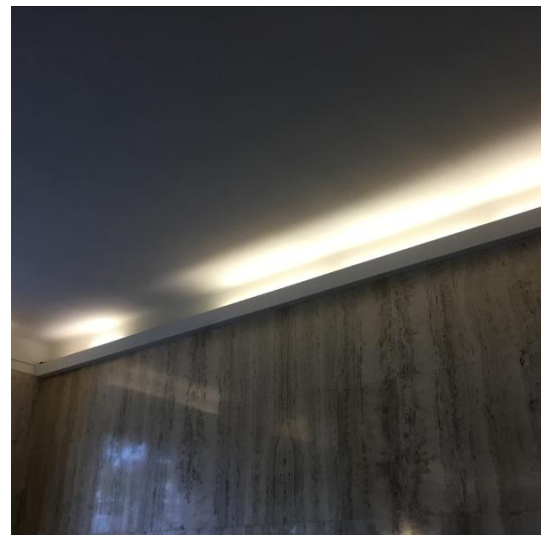
Component 0.001 Entree HD verlichting  
Description Verlichting koof en wandverlichting. Koof had eerder andere uitmonstering.

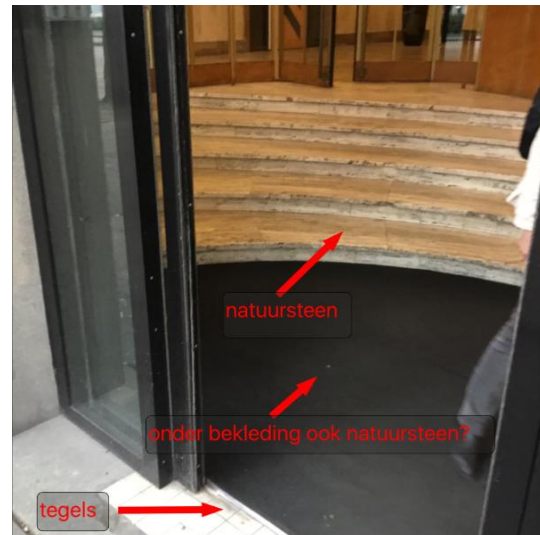
Component 0.001 Entree HD vloer deur  
Description Vloer delen tegels als kelder? Zegt iets over ontwikkeling entree. reparaties? Onder vloerbedekking?

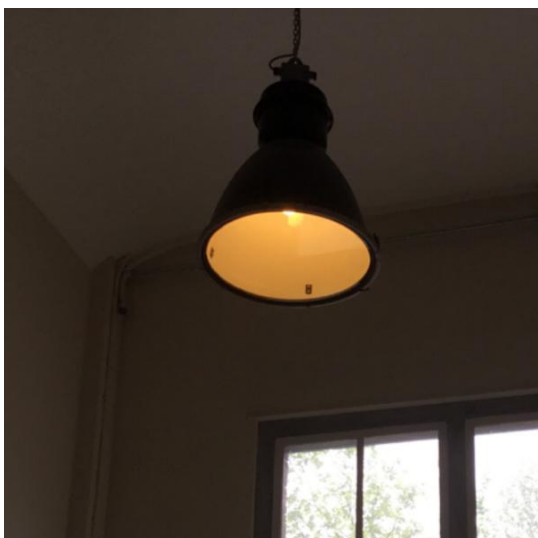
Component 0.091 Entree WZ armaturen  
Description armaturen dateren

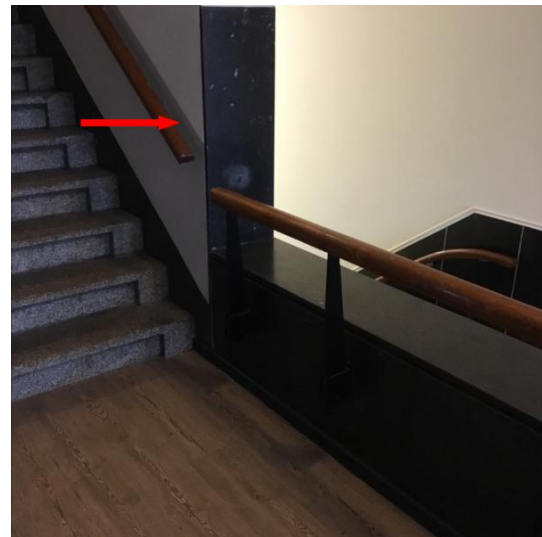
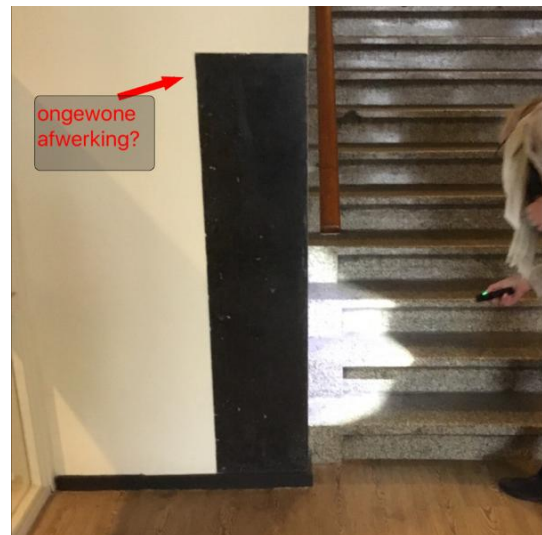
Component 0.091 Entree WZ marmer  
Description Marmer eerder dan overige afwerkingen? Geen afwerking op muur? Restauratieadvies.

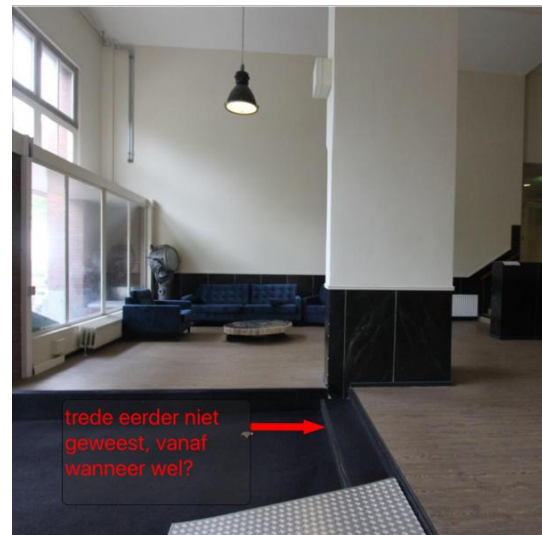
Component 0.091 Entree WZ ontwikkeling muren, trap  
Description muur dichtgezet, trap verlengd

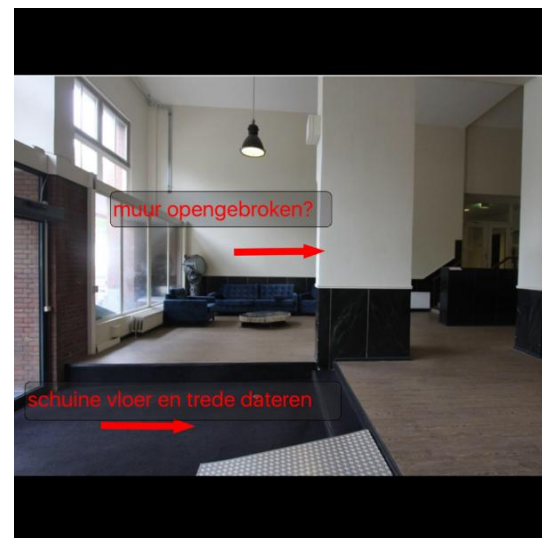
Component 0.091 Entree WZ ramen en entree deuren  
Description Stratigrafie? Vergelijk ingang welke tijdlagen?  
Pui rokersruimte? Ook buitenzijde meenemen

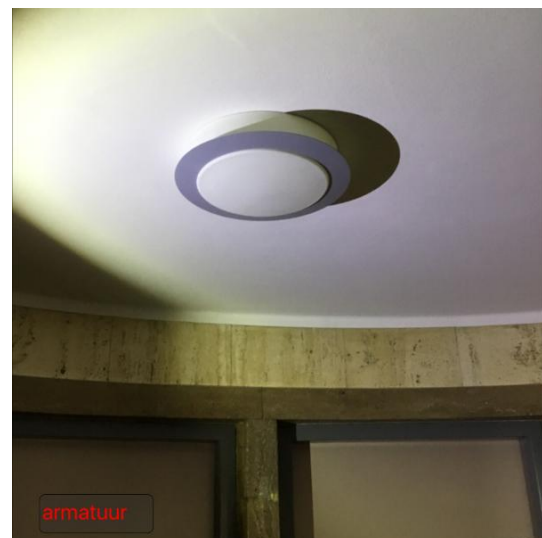
Component 0.132 Entree HD bij 0.130  
Description Documentatie op basis van foto's. Wordt dichtgezet. Witte houten kozijnen dateren. Armatuur meenemen. Onder vloertje.

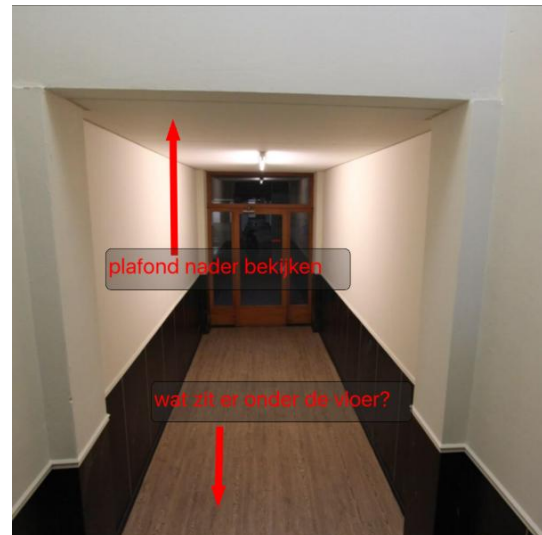
Component -1.14 WZ trappenhuis bekleding  
Description zie ook dossier entreegebied voor marmering etc.

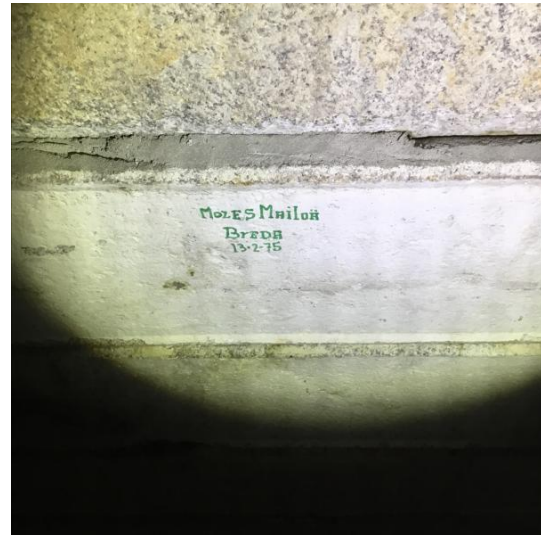
Component -1.15 WZ trappenhuis kelder  
Description Trap onderzijde, documenteren,  
restauratieadvies. sporen van herplaatsing?

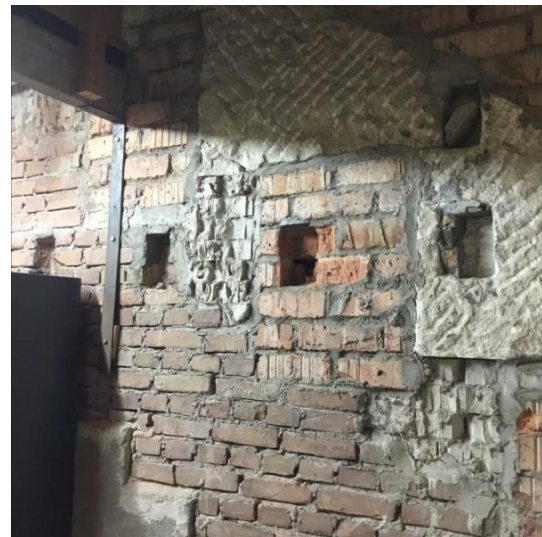
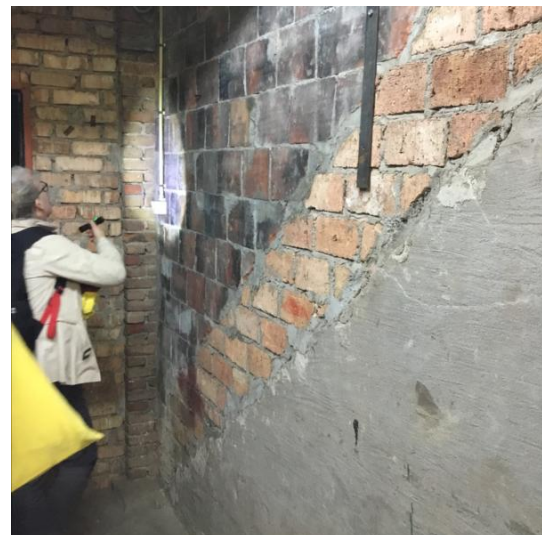
Component -1.16 WZ trappenhuis kelder  
Description Oude details trappen, documenteren, restauratieadvies

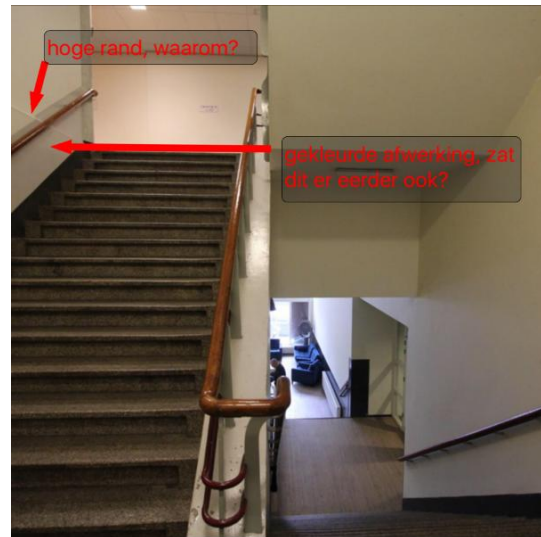
Component 0.93 WZ trappenhuis bg  
Description bekleding trappenhuis
