Combined Phase I & Phase II soil and groundwater investigation at Plantweg 1, Biddinghuizen

February 9, 2026

Our reference R001-1304595MMN-V01-evm-NL

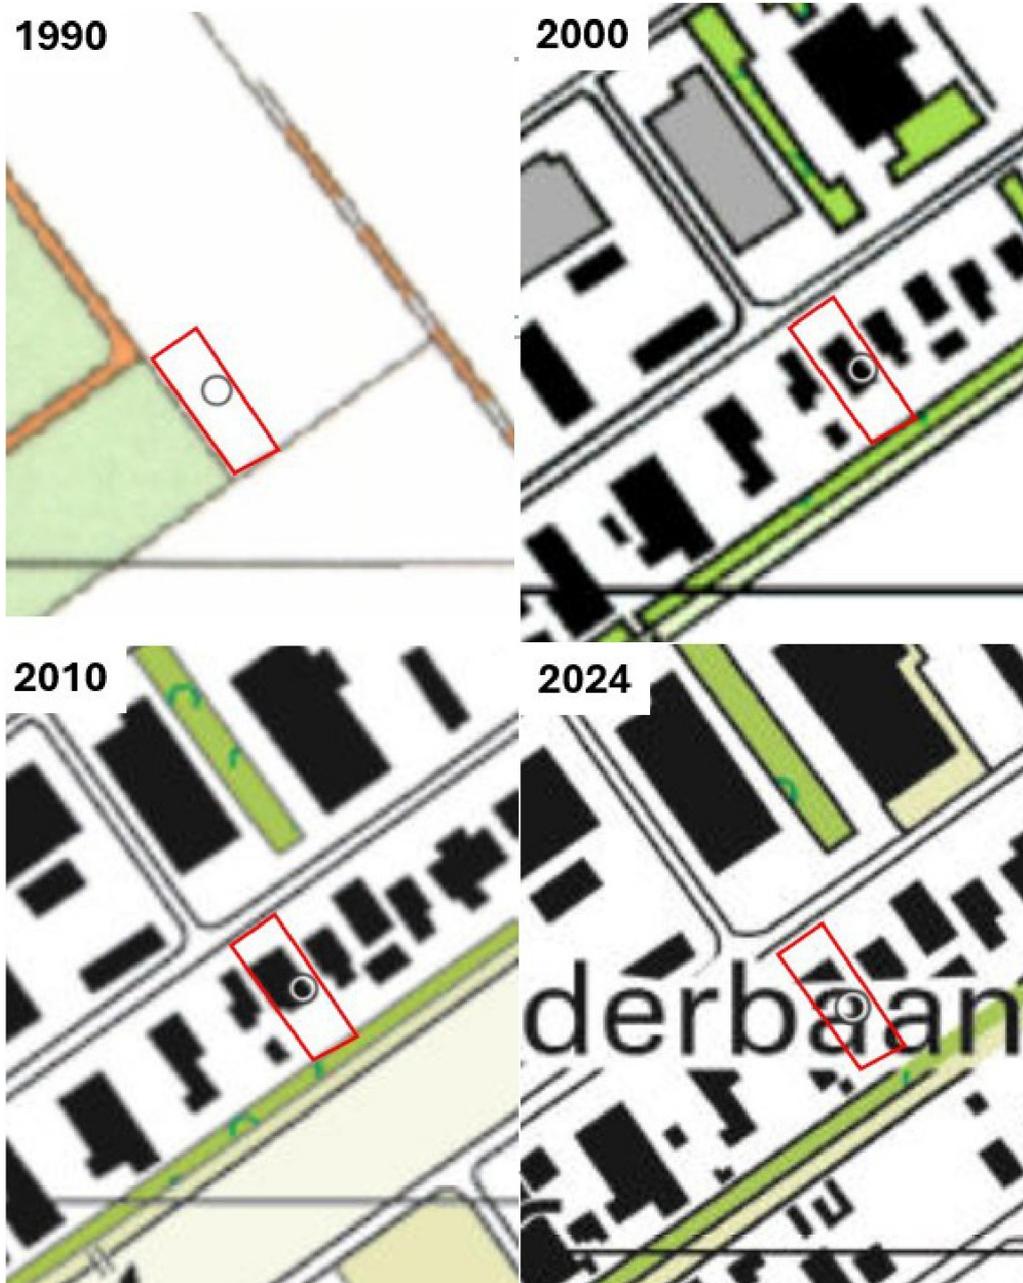
Figure 3.2 Historical maps of the site location from 1990, 2000, 2010 and 2024 delineated by red line (source: topotijdreis.nl)

From historical maps and satellite images (see Figure 3.2 and 3.3) it appears that:

- The site was part of the former 'Zuiderzee' sea until the site and the wider area became reclaimed land in the 1960s. The village of Biddinghuizen was founded in 1963

- Prior to the development of the business area in the 1990s, the site area was used as agricultural land/grassland
- Site building appears the first time on a historical maps in 2000. However, based on information from the Kadaster (Bagviewer), the site building was constructed in 1994

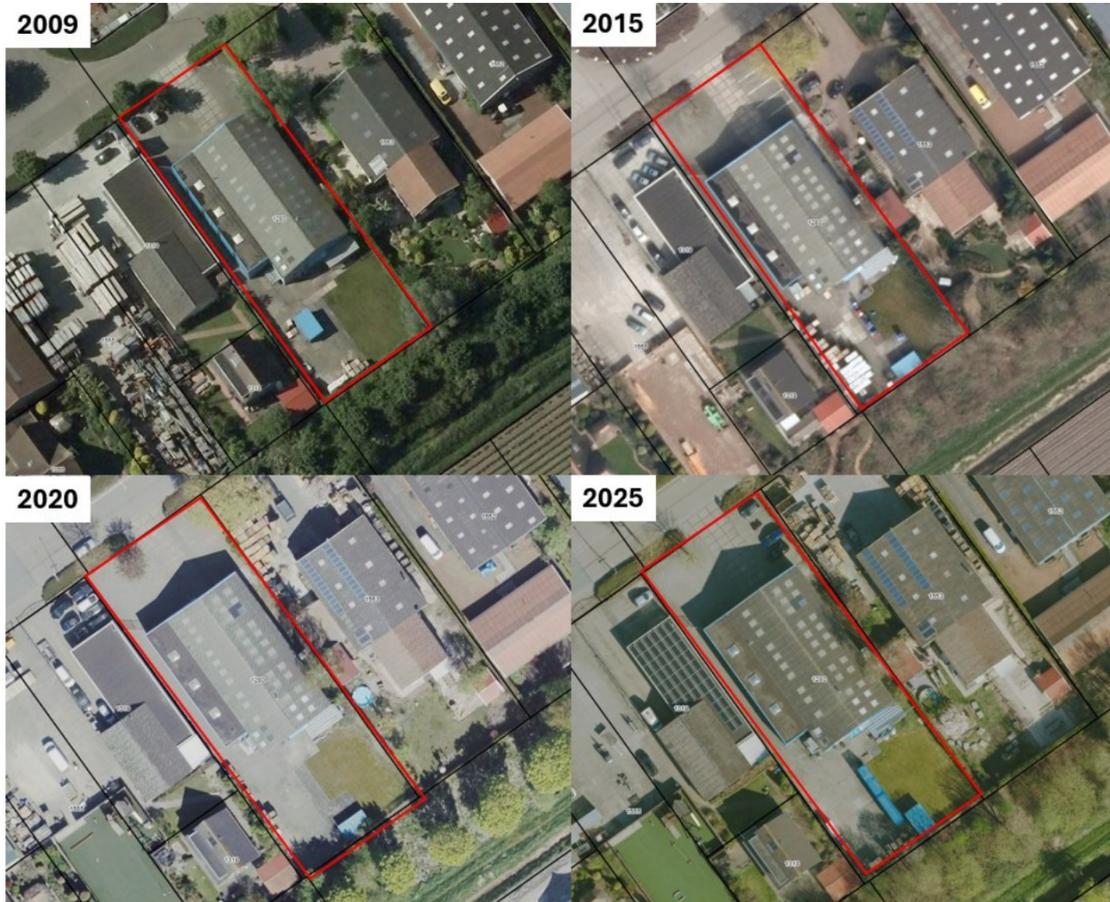
Figure 3.3 Aerial photos of 2009, 2015, 2020 and 2025, site boundaries indicated by the red contour (source: Streetsmart Cyclomedia)

- The site building expanded towards the west in 1998, based on information from the site representative
- From the satellite images it can be derived that a long shaped additional container was installed at the southern part of the site between 2021/2022

- Two above ground storage tanks appear in 2022/2023 at the southern part of the site building below the roofing structure. Reportedly, these are former (above ground indoor) tanks that are empty and no longer in use

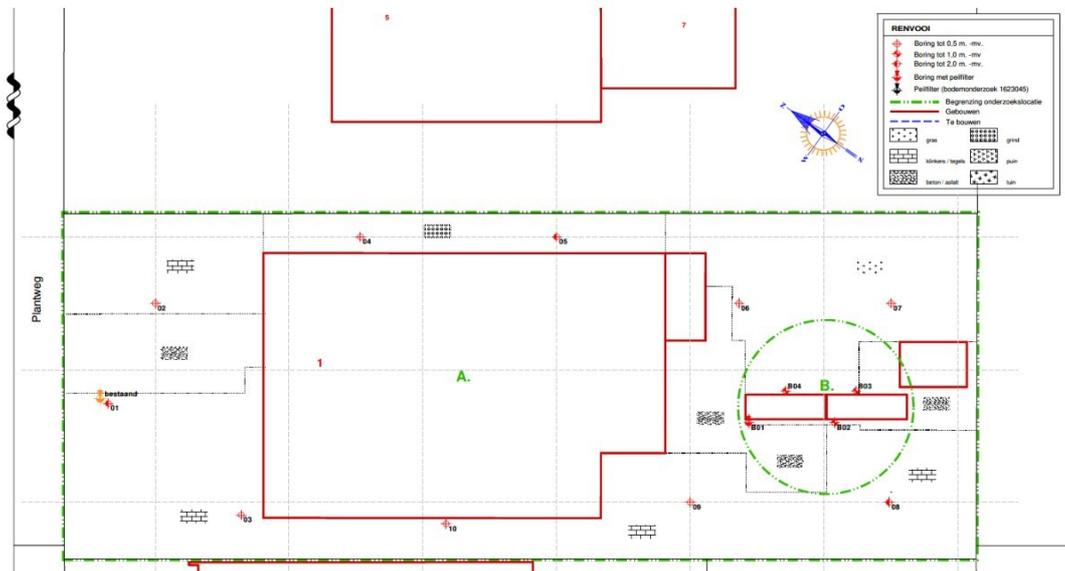
Figure 3.2 Site Layout with location of drillings of the July 2025 investigation

- 7 drillings until 0.5 m bgl, 3 drillings until 1.0 m bgl (at the aboveground storage containers), 3 drillings until 2.0 m bgl and 1 monitoring well were performed. All drillings/monitoring wells were performed outdoors. Analysis took place on the Dutch standard soil and groundwater analytical package

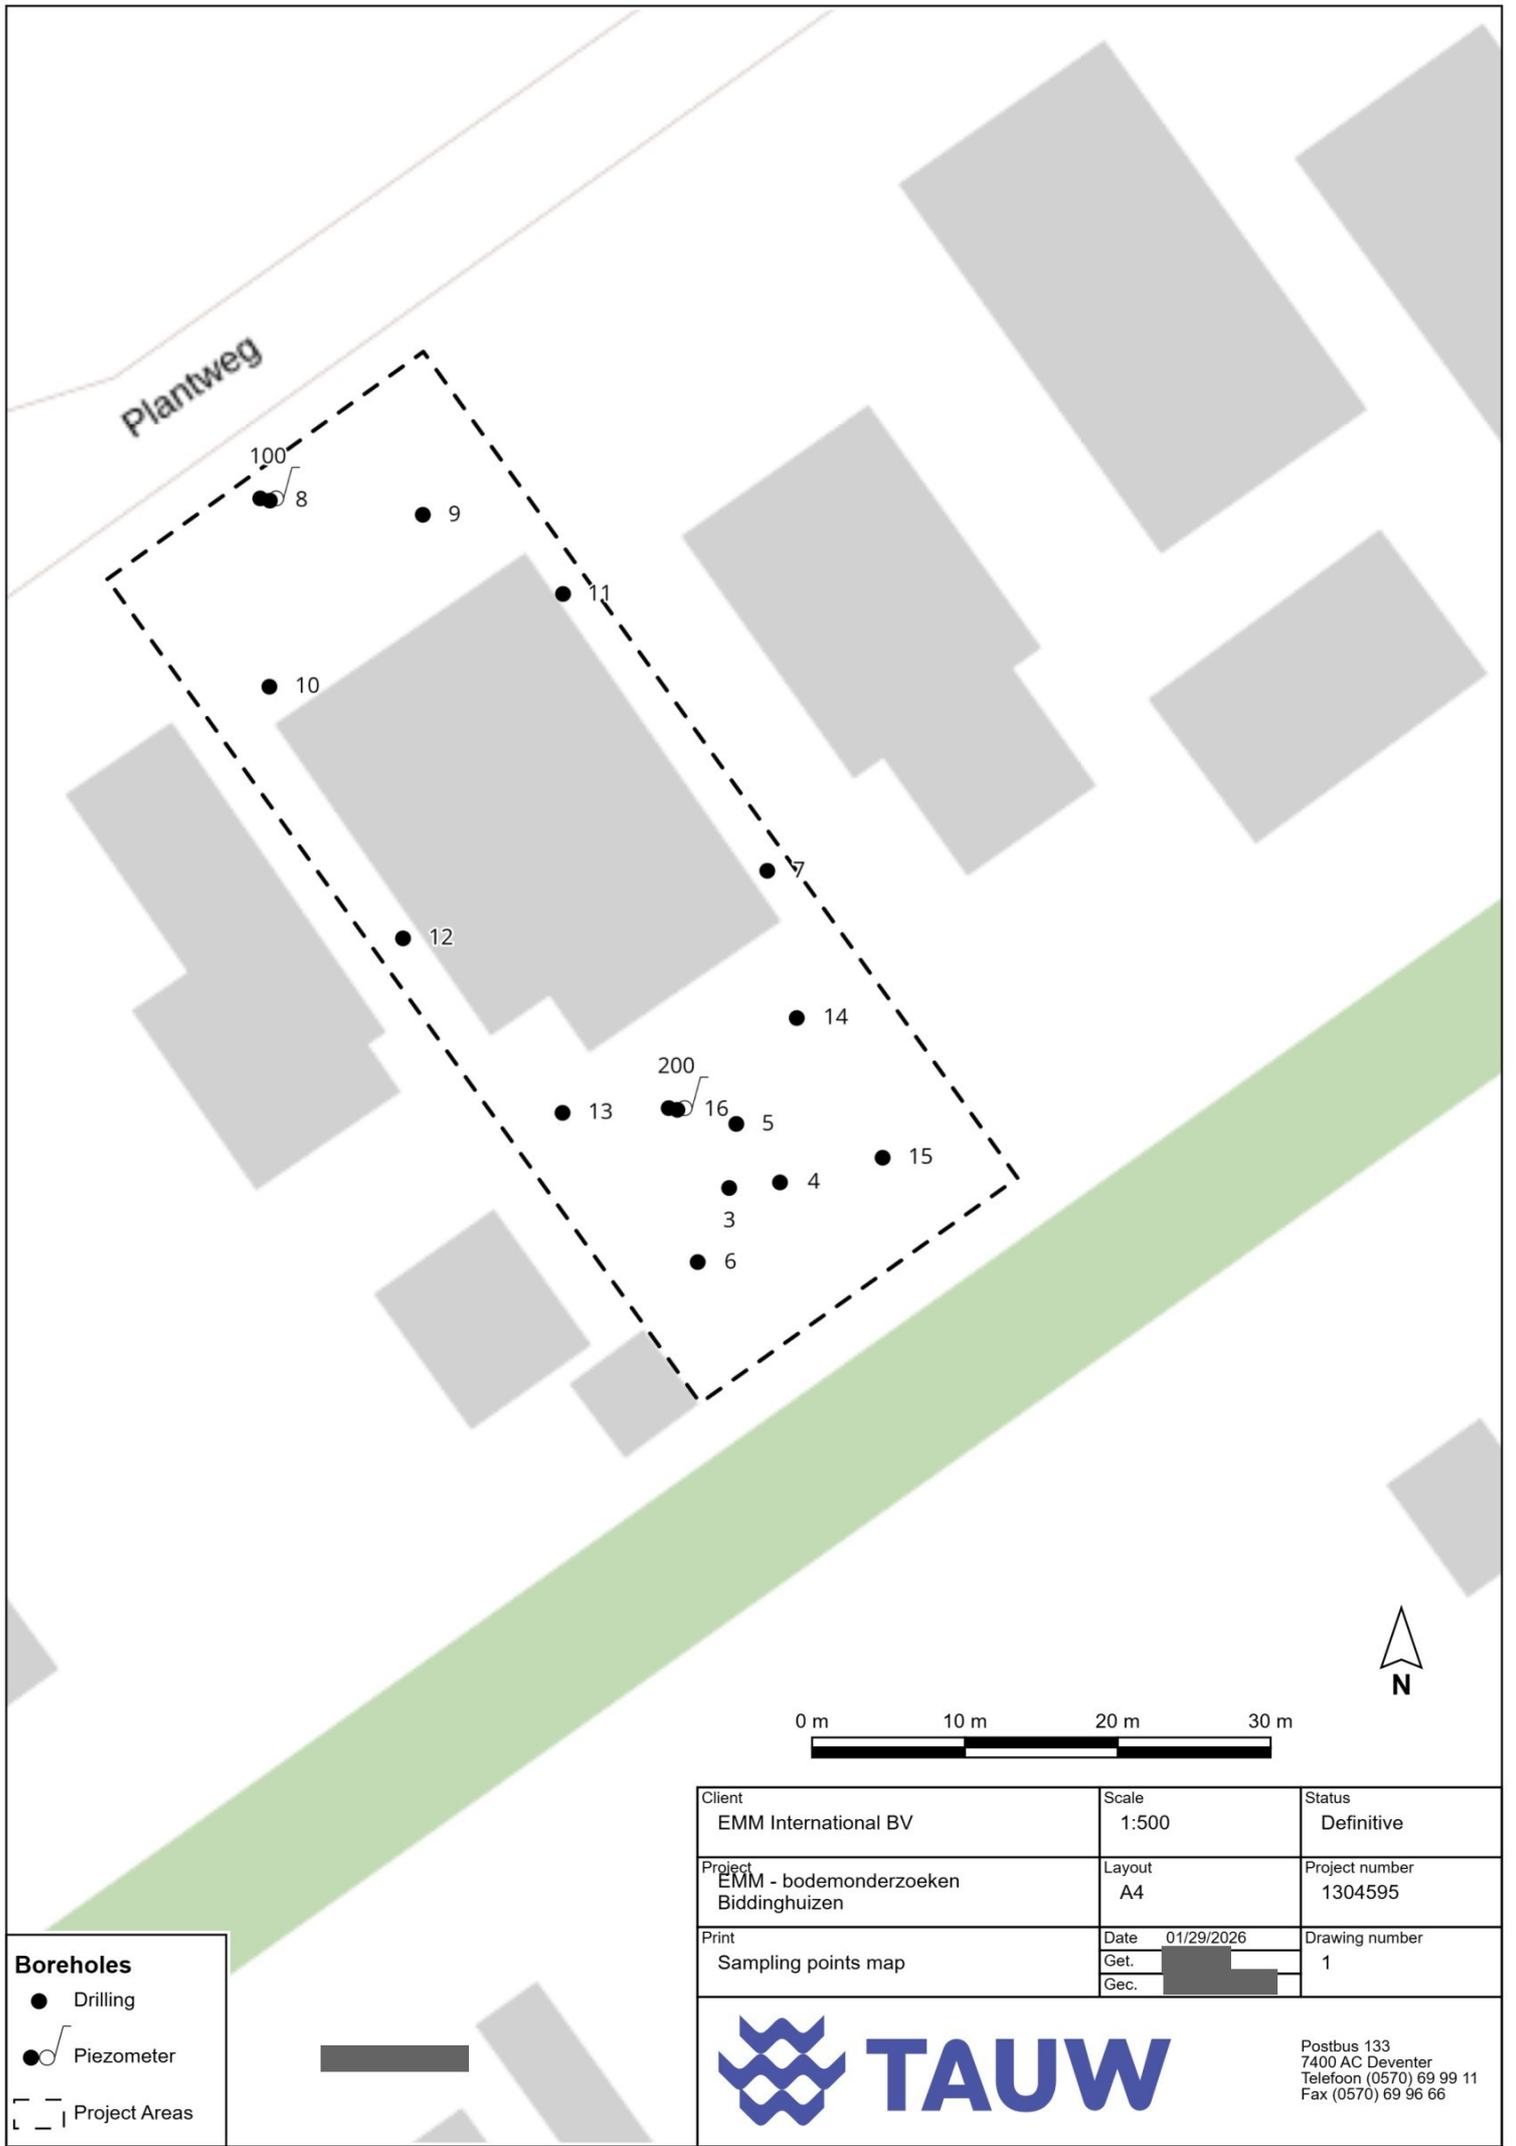
Appendix 2 Sampling points map

Boreholes

- Drilling
- Piezometer
- - - Project Areas

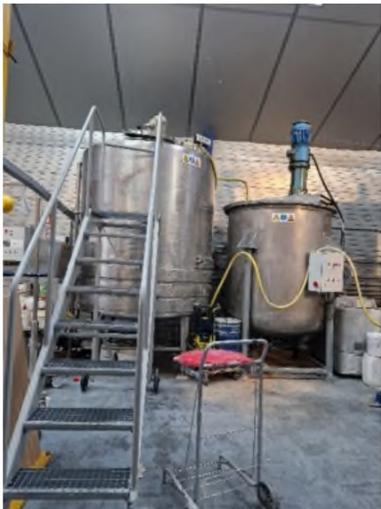
Photo 4. Two mixing tanks and filling lines

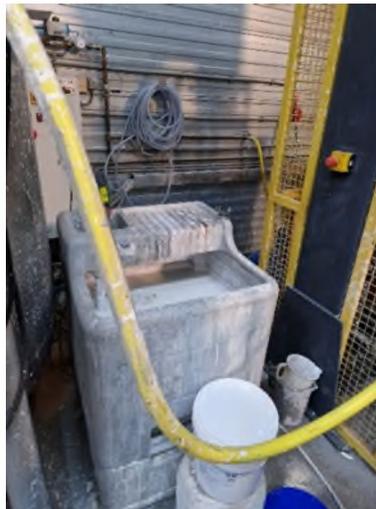
Photo 5. Flocculation tank

At the site a flocculation tank is present near the filling machines. In case of wastewater of hazardous substances related to the production process, this will pass through the flocculation tank. Since all products are water-soluble, the chemicals will flocculate in the tank and after flocculation, the reminder of the wastewater will go into the sewage system. The flocculated parts is collected by Remondis (certified processor).

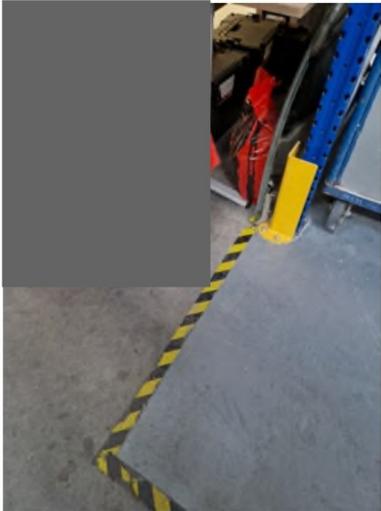
Photo 7. Spill kit

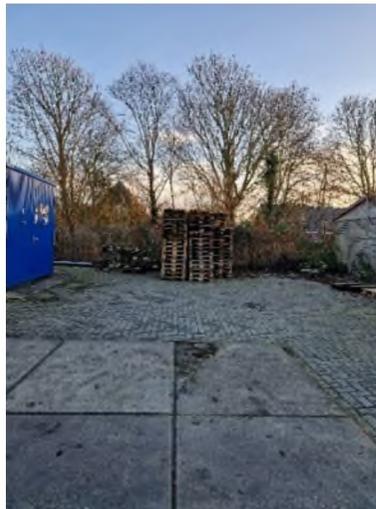
Photo 11. Outdoor overview stelcon plates and clinkers

Outside, south of the building two PGS15 containers are present. These containers appeared in very good condition (with dripping trays in them). The outside area is covered with clinkers, stelcon plates, gravel and grass.

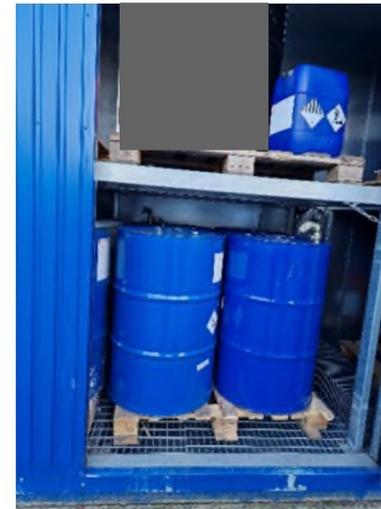
Photo 12. PGS15 storage

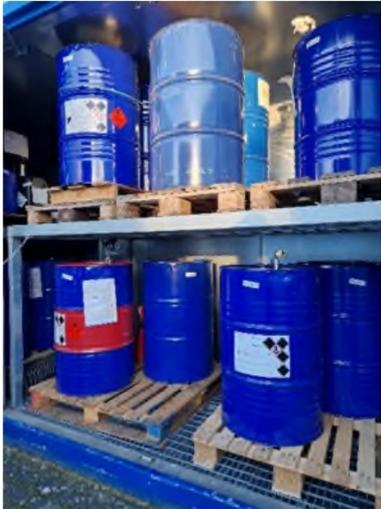
Photo 13. PGS15 storage
