Aandachtspunten voor nader onderzoek per thema

West507 – transformatie Oceaanhuis

**Kleurhistorisch onderzoek en bouwhistorische verdieping**  
Plan van Onderzoek

14 juli 2017

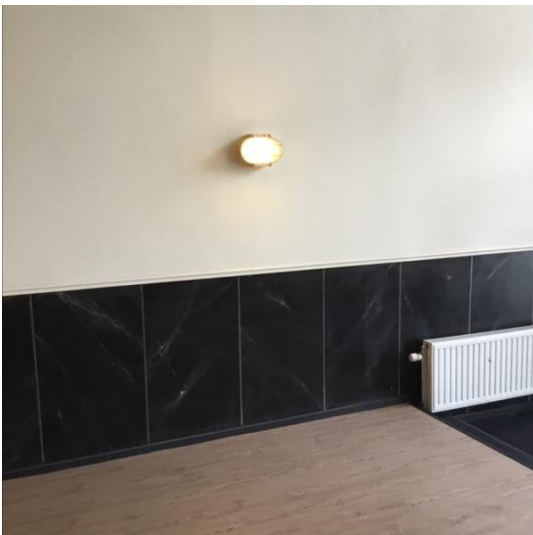
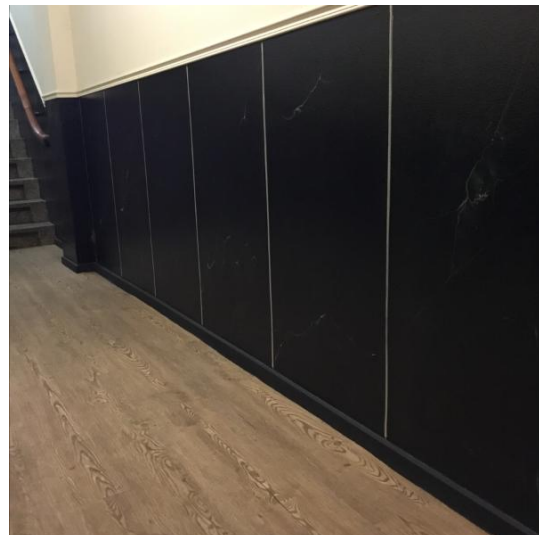
ID number 12.10  
Location  
Priority  None  
Date Time 2017-07-02 09:08:11  
Decision

Component -1.14 Entree WZ marmerimitatie  
Description Dateren kleuronderzoek, mogelijk factuur schilder op te vragen bij de huismeester? Gelijk met houting personenliften?

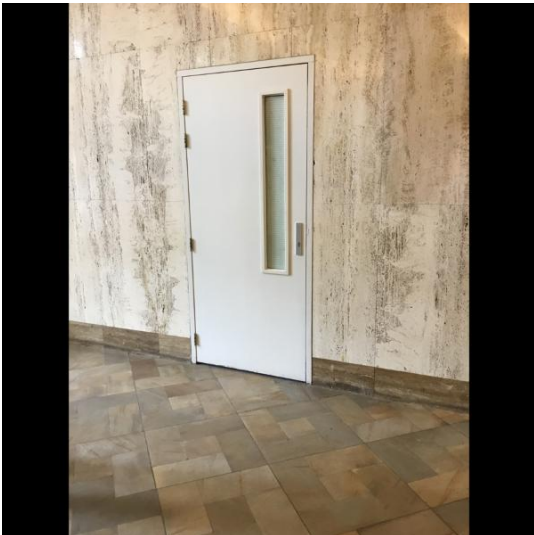
ID number 12.9  
Location  
Priority  None  
Date Time 2017-07-02 09:08:11  
Decision

Component 0.001 Entree HD deur richting 0.09  
Description Deur servicepunt. Restauratieadvies, ontwikkeling, wanneer is de deur erin gezet? Huismeester: waar zijn overige platen?

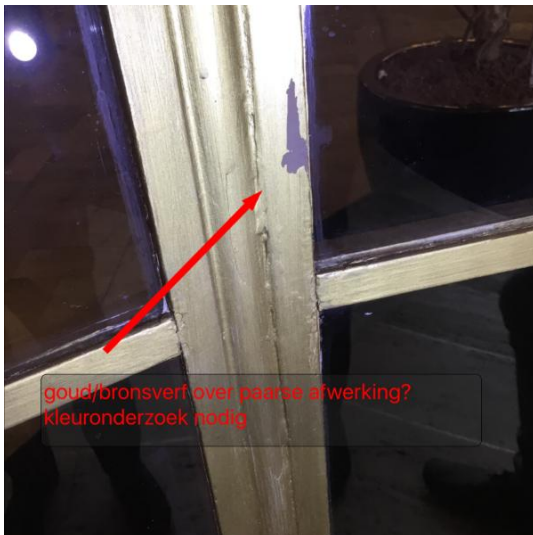
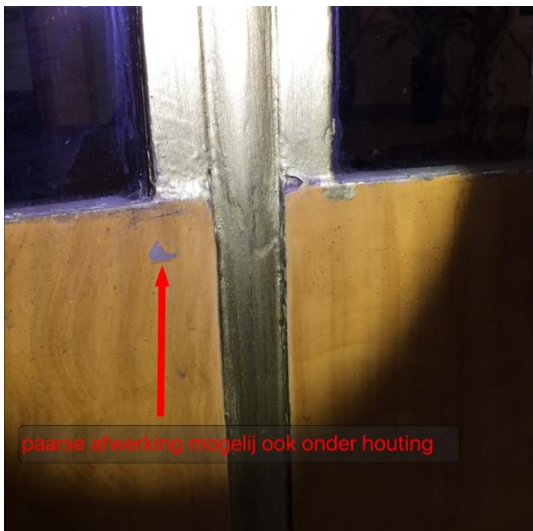
ID number 12.7  
Location  
Priority  None  
Date Time 2017-07-02 09:08:12  
Decision

Component 0.001 Entree HD portierloge  
Description Portierloge documenteren en kleuronderzoek stratigrafie op glazen wand. Wordt behouden.

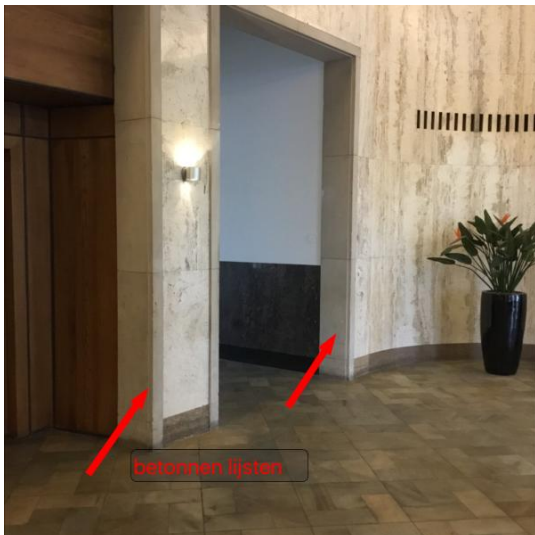
ID number 12.6  
Location  
Priority  None  
Date Time 2017-07-02 09:08:12  
Decision

Component 0.001 Entree HD richting trappenhuis  
Description Betonnen lijsten geen natuursteen.  
Authenticiteit, hoe elders?

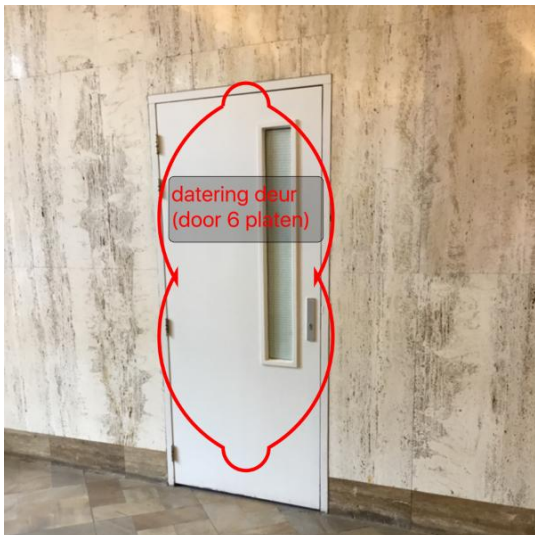
ID number 12.15  
Location  
Priority  None  
Date Time 2017-07-04 09:45:46  
Decision

Component 0.001 Entree HD travertin muurbekleding  
Description Datering travertin, beschrijving en restauratieadvies.

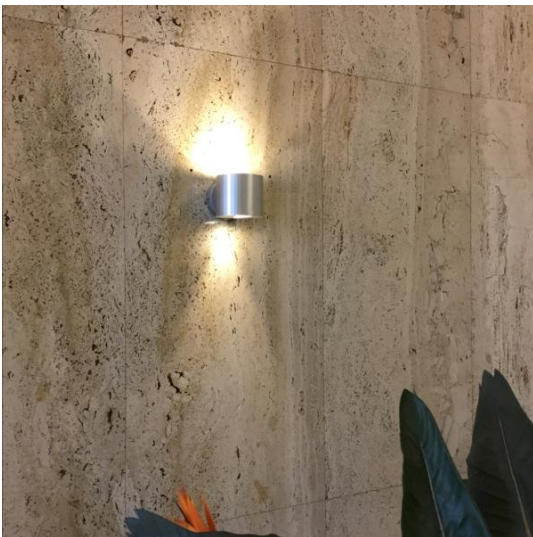
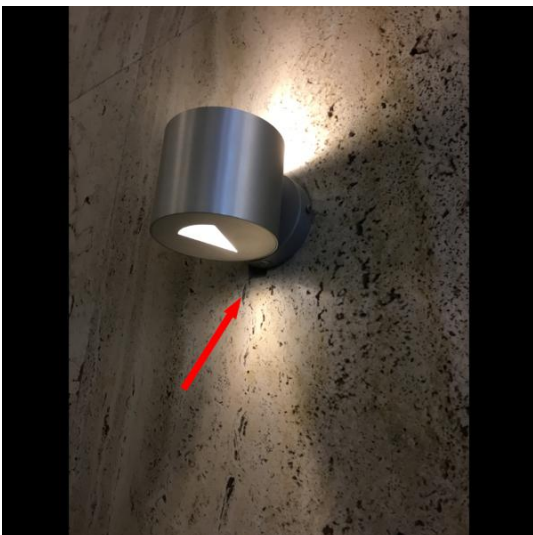
ID number 12.5  
Location  
Priority  None  
Date Time 2017-07-02 09:08:12  
Decision

Component 0.001 Entree HD verlichting  
Description Verlichting koof en wandverlichting. Koof had eerder andere uitmonstering.

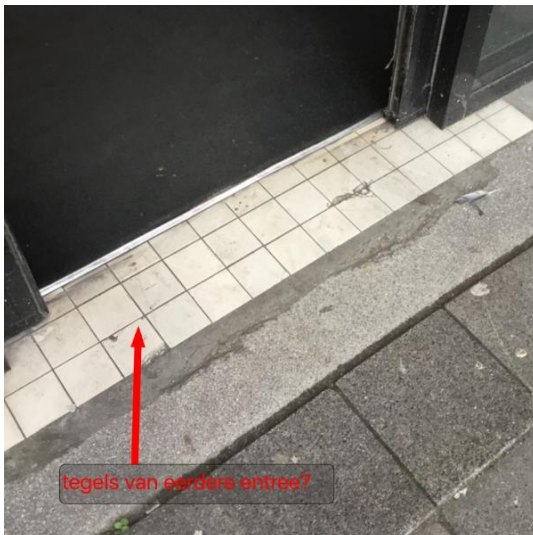
ID number 12.8  
Location  
Priority  None  
Date Time 2017-07-02 09:08:11  
Decision

Component 0.001 Entree HD vloer deur  
Description Vloer delen tegels als kelder? Zegt iets over ontwikkeling entree. reparaties? Onder vloerbedekking?

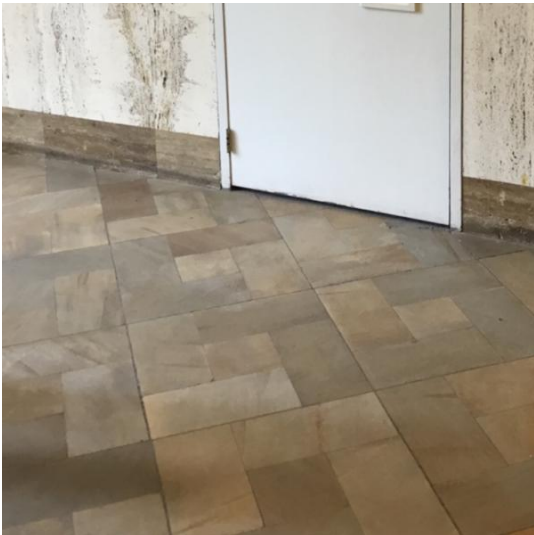
ID number 12.14  
Location  
Priority  None  
Date Time 2017-07-04 09:44:07  
Decision

Component 0.01 Entree HD vloer natuursteen  
Description Datering, schadeinventarisatie, restauratieadvies

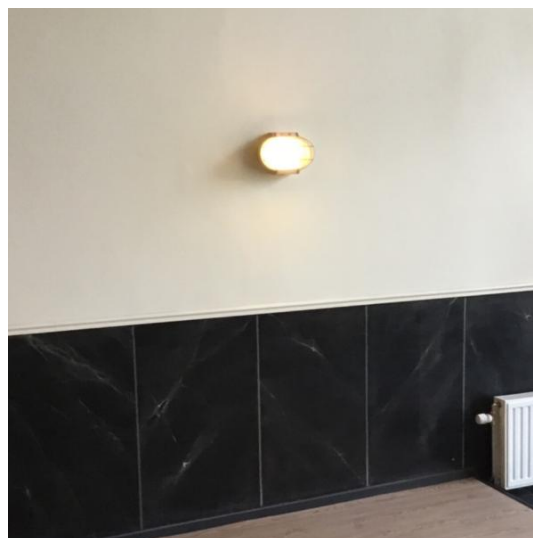
ID number 12.11  
Location  
Priority  None  
Date Time 2017-07-04 09:05:36  
Decision

Component 0.091 Entree WZ armaturen  
Description armaturen dateren

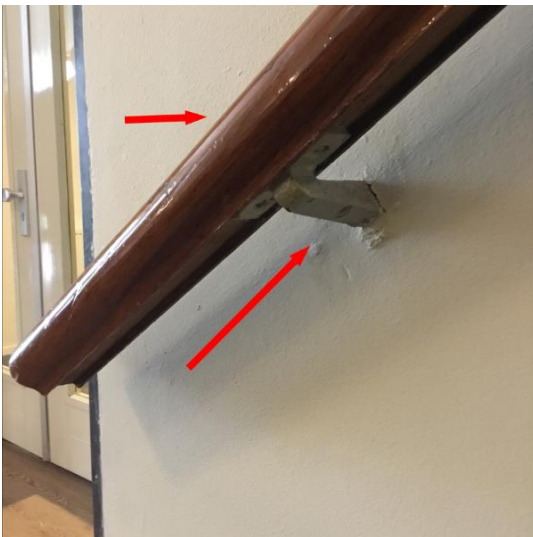
ID number 12.3  
Location  
Priority  None  
Date Time 2017-07-02 09:08:14  
Decision

Component 0.091 Entree WZ leuningen  
Description Trapleuningen in deze ruimte met elkaar vergelijken. Tijdslagen benoemen. Zie ook trappenhuizen.

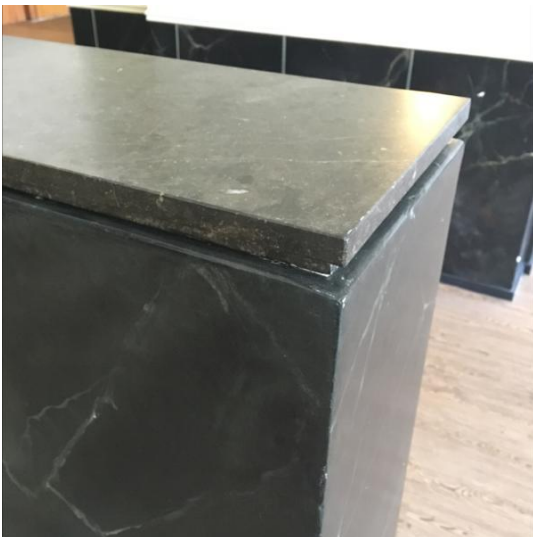
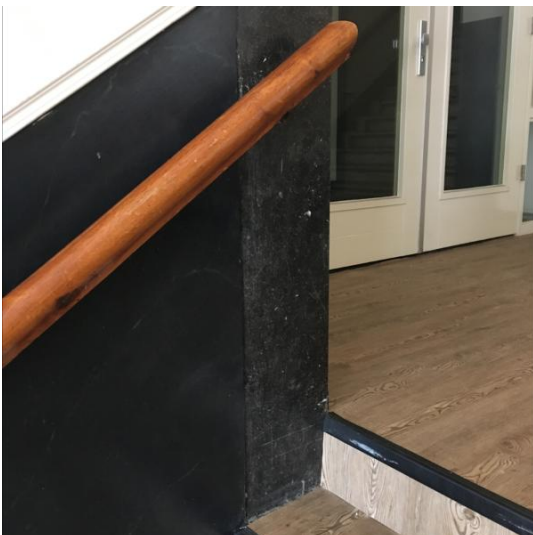
ID number 12.2  
Location  
Priority  None  
Date Time 2017-07-02 09:08:14  
Decision

Component 0.091 Entree WZ marmer  
Description Marmer eerder dan overige afwerkingen? Geen afwerking op muur? Restauratieadvies.

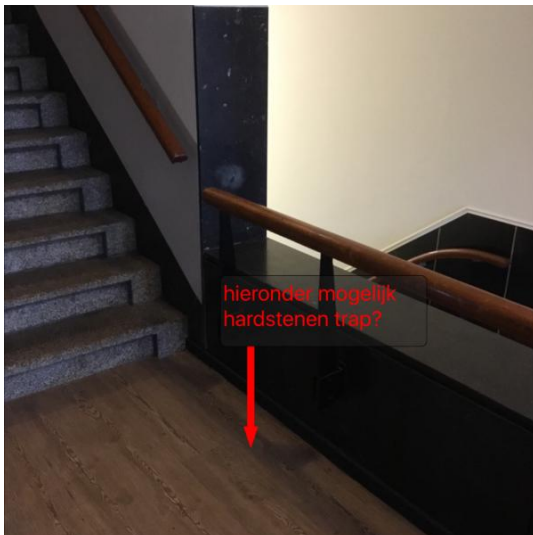
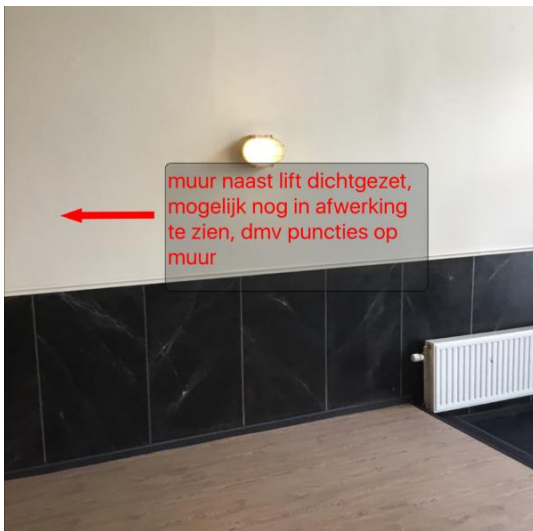
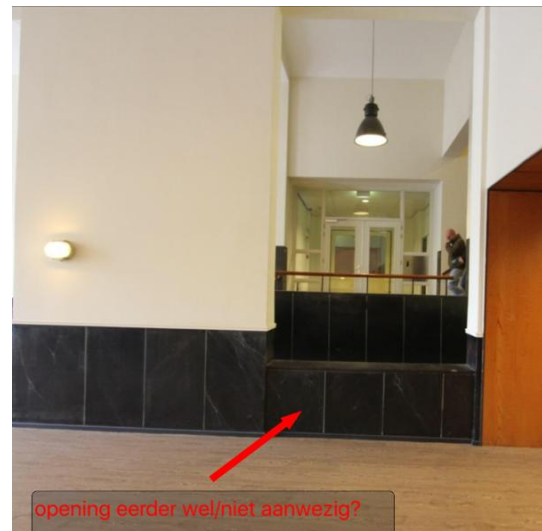
ID number 12.12  
Location  
Priority  None  
Date Time 2017-07-04 09:22:12  
Decision

Component 0.091 Entree WZ ontwikkeling muren, trap  
Description muur dichtgezet, trap verlengd

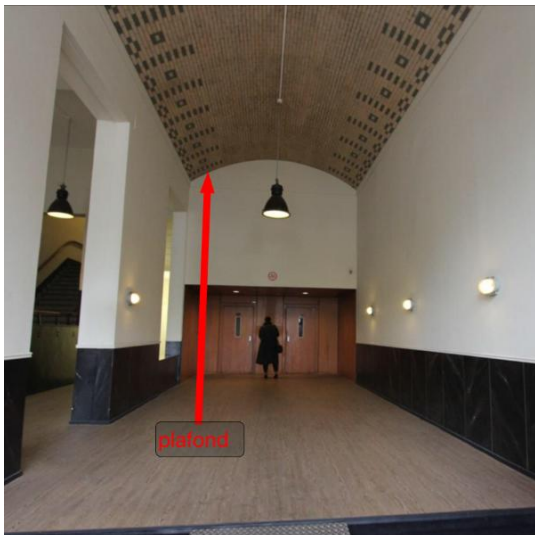
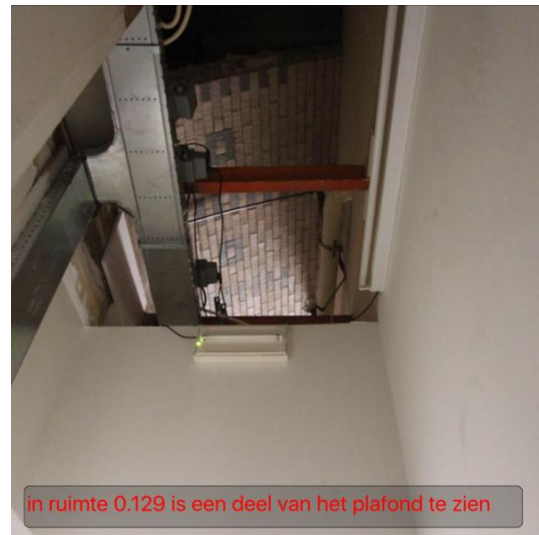
ID number 12.13  
Location  
Priority  None  
Date Time 2017-07-04 09:32:03  
Decision

Component 0.091 Entree WZ plafond  
Description Plafond beschrijven en hoe liep het verder?  
overgang lichthof, nu liftschacht.  
Restauratieadvies.

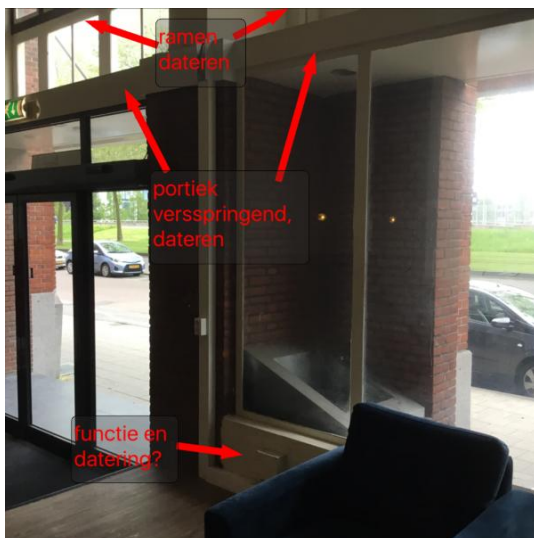
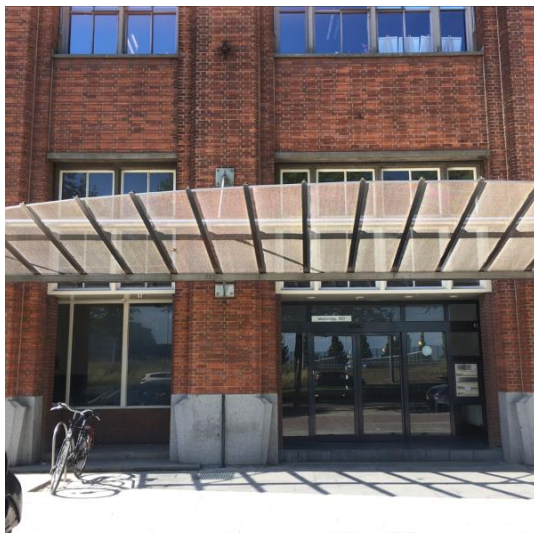
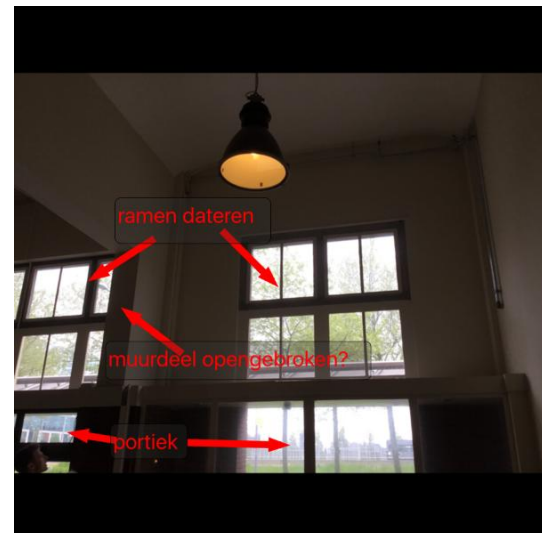
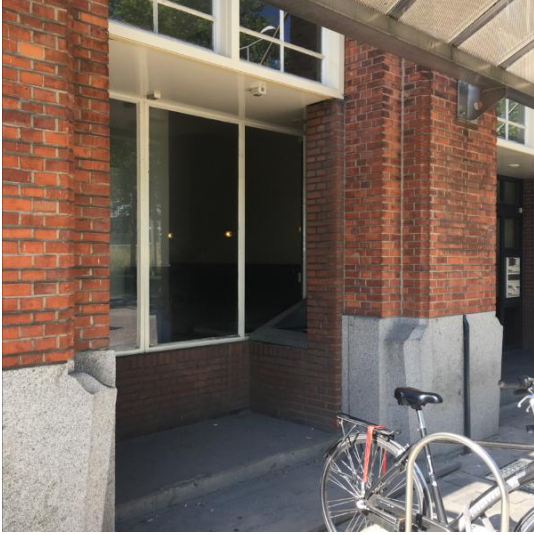
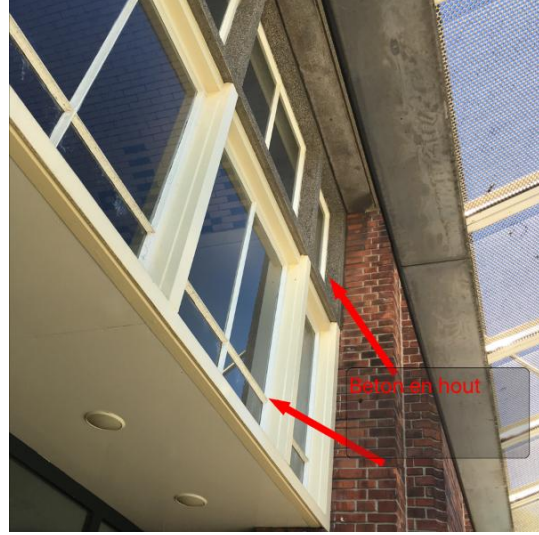
ID number 12.4  
Location  
Priority  None  
Date Time 2017-07-02 09:08:13  
Decision

Component 0.091 Entree WZ ramen en entree deuren  
Description Stratigrafie? Vergelijk ingang welke tijdlagen?  
Pui rokersruimte? Ook buitenzijde meenemen

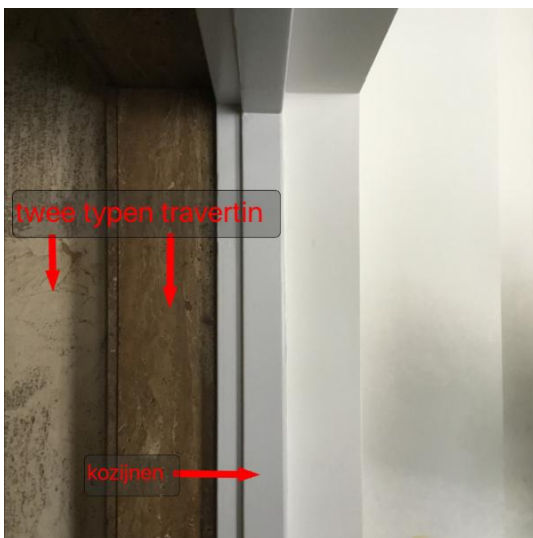
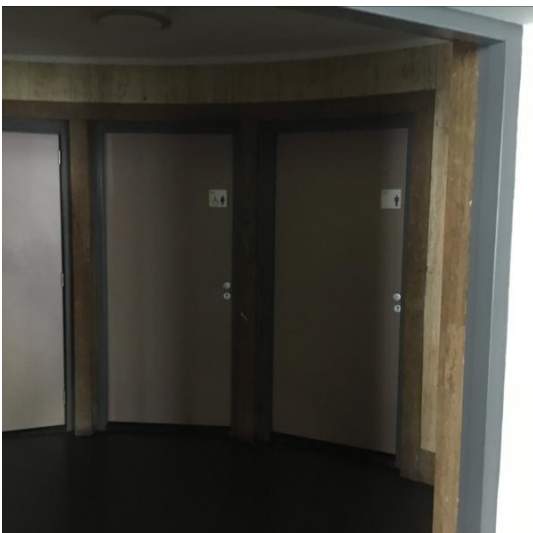
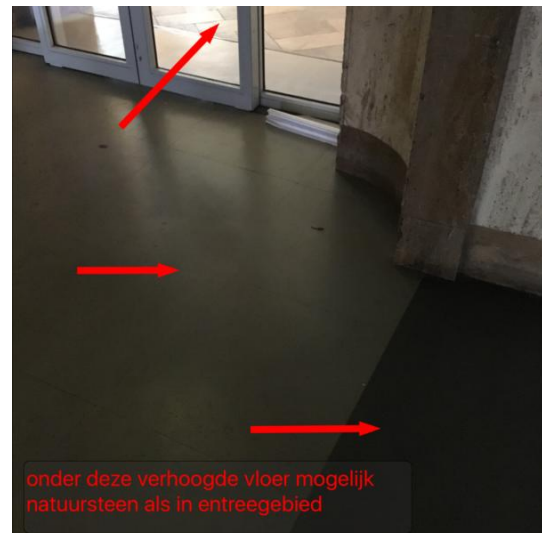
ID number 12.1  
Location  
Priority  None  
Date Time 2017-07-02 09:08:14  
Decision

Component 0.132 Entree HD bij 0.130  
Description Documentatie op basis van foto's. Wordt dichtgezet. Witte houten kozijnen dateren. Armatuur meenemen. Onder vloertje.

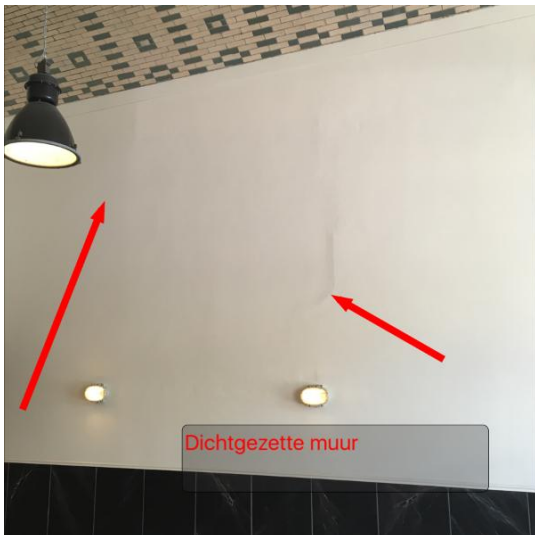
ID number    12.16  
Location  
Priority        ■ None  
Date Time     2017-07-05 14:55:08  
Decision

Component    Entree WZ dichtgezette muur  
Description

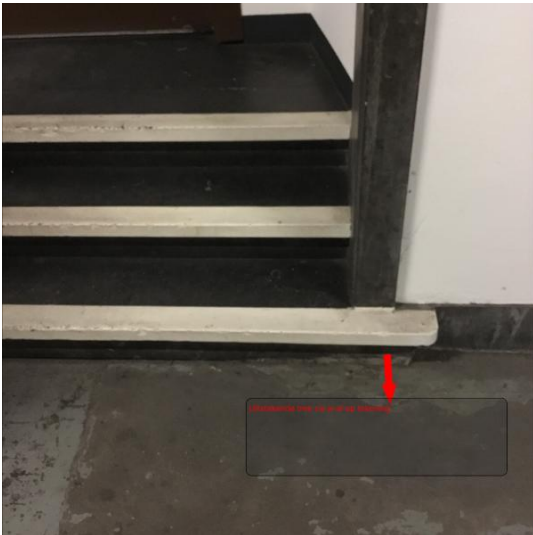
ID number 10.1  
Location  
Priority  None  
Date Time 2017-07-02 08:59:57  
Decision

Component -1.01 Trap liftdeuren  
Description Uit 51 of 73? tekeningen en vergelijk steen

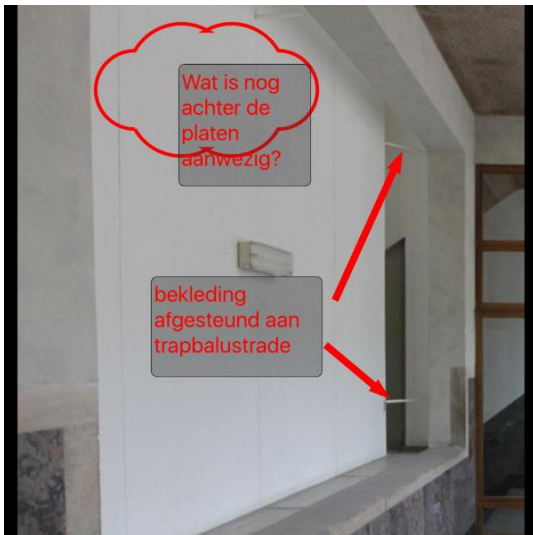
ID number 10.2  
Location  
Priority **None**  
Date Time 2017-07-02 13:43:23  
Decision

Component 0.003 Liftschacht buitenkant en opbouw  
Description Puncties nemen liftschacht buitenkant.  
Destructief onderzoek

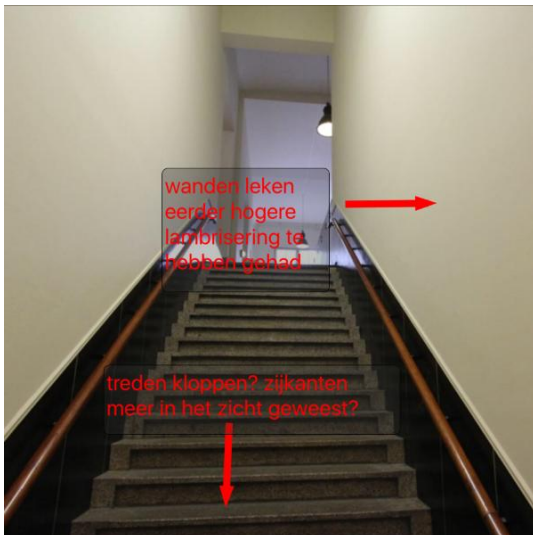
Component -1.14 WZ trappenhuis bekleding  
Description zie ook dossier entreegebied voor marmering etc.

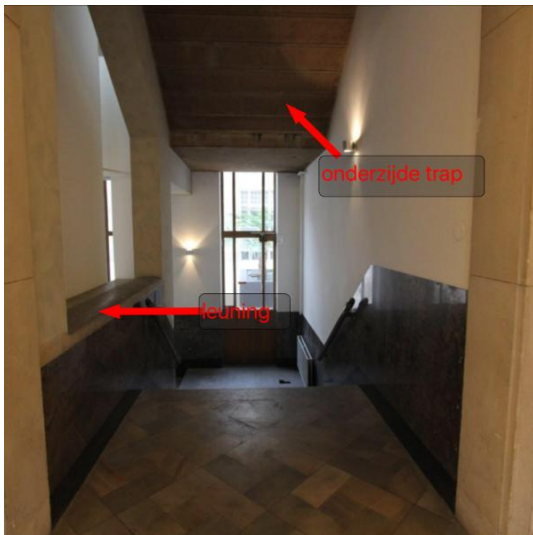
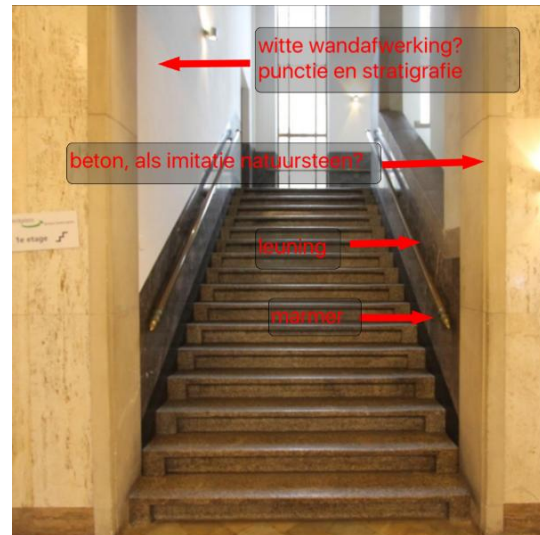
ID number 13.9  
Location  
Priority  None  
Date Time 2017-07-02 15:18:18  
Decision

Component 0.003 HD trappenhuis bg en entresol  
Description trapbekleding

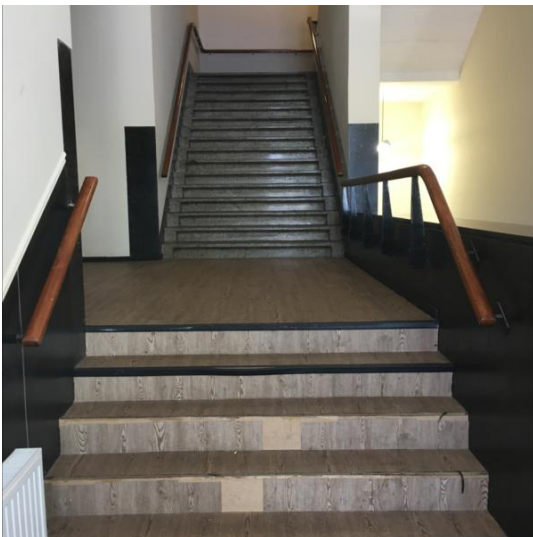
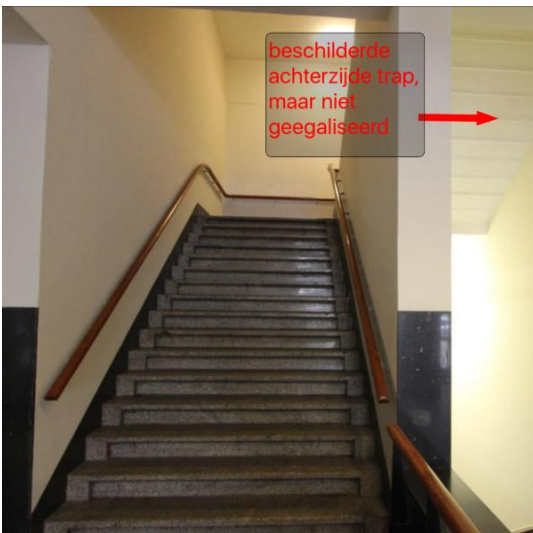
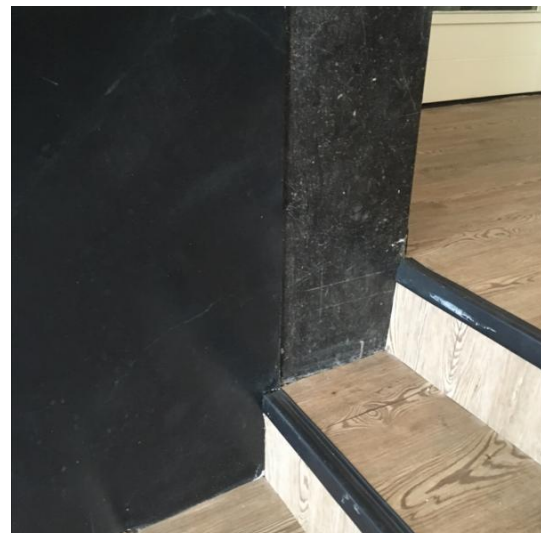
ID number 13.5  
Location  
Priority  None  
Date Time 2017-07-02 15:04:33  
Decision

Component 0.93 WZ trappenhuis bg  
Description bekleding trappenhuis

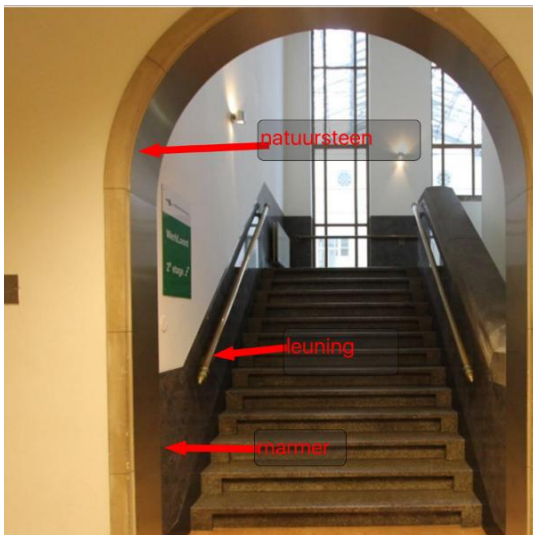
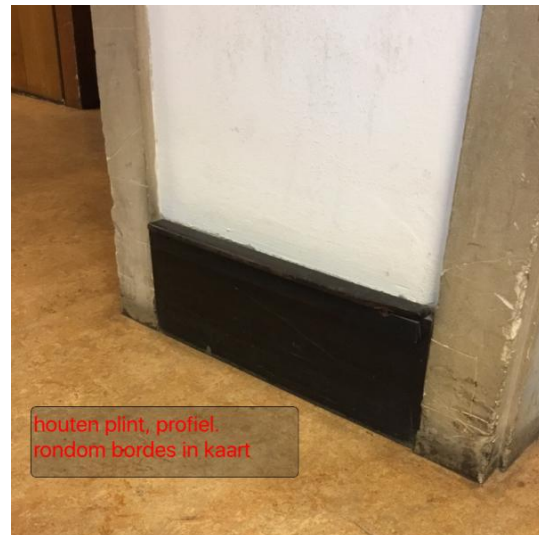
ID number 13.6  
Location  
Priority  None  
Date Time 2017-07-02 15:06:15  
Decision

Component 1.04 HD trappenhuis 1e etage  
Description Trapbekleding, vergelijk met begane grond

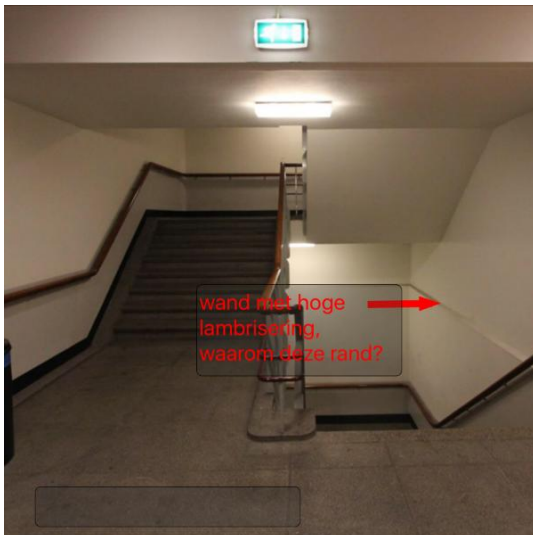
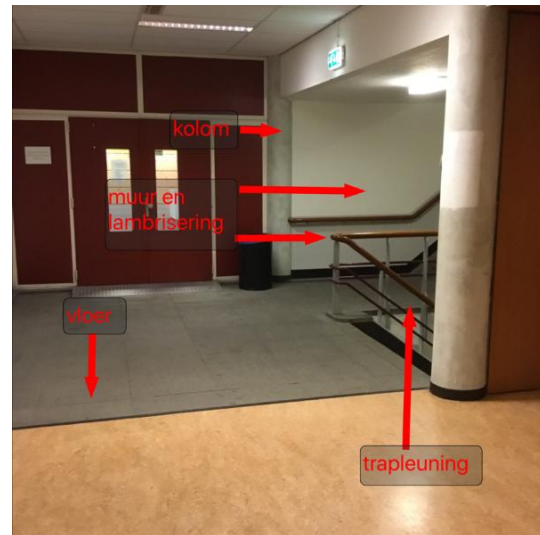
ID number 13.7  
Location  
Priority  None  
Date Time 2017-07-02 15:07:25  
Decision

Component 1.41 WZ trappenhuis 1e etage  
Description trapbekleding, zie ook tweede etage

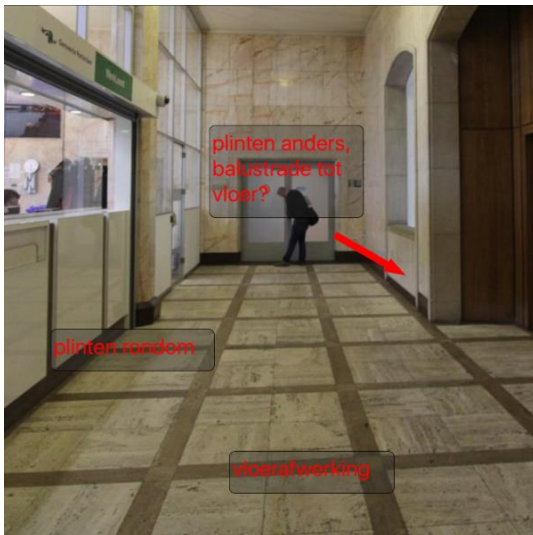
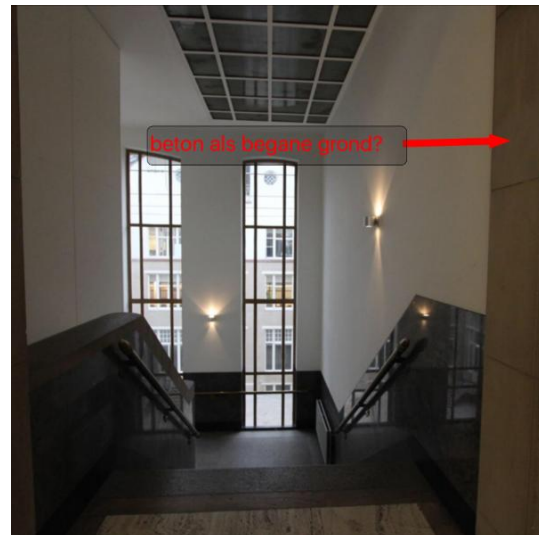
ID number 13.12  
Location  
Priority  None  
Date Time 2017-07-04 12:46:16  
Decision

Component 2.02 HD trappenhuis bekleding (bordes)  
Description bekleding trappenhuis, marmer in gang tevens bij juliana zaal betrekken

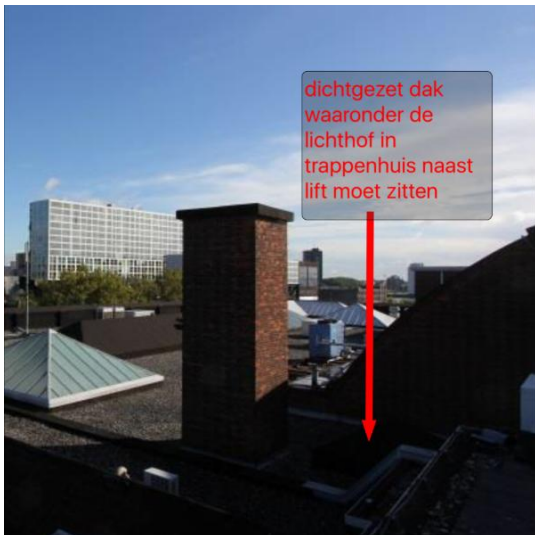
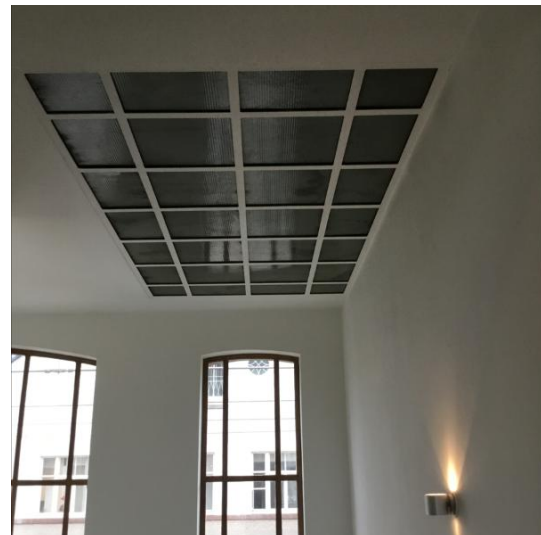
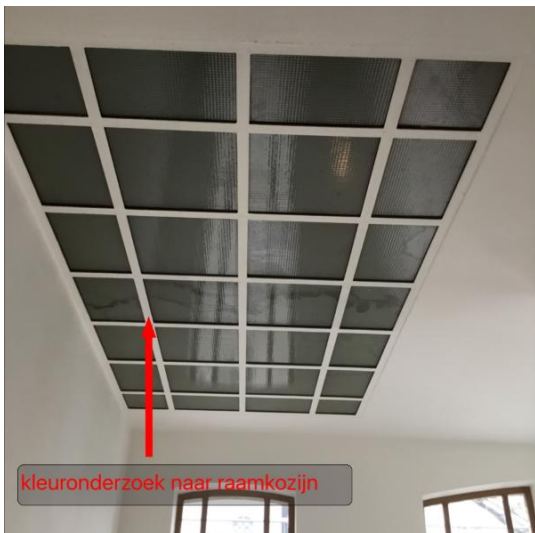
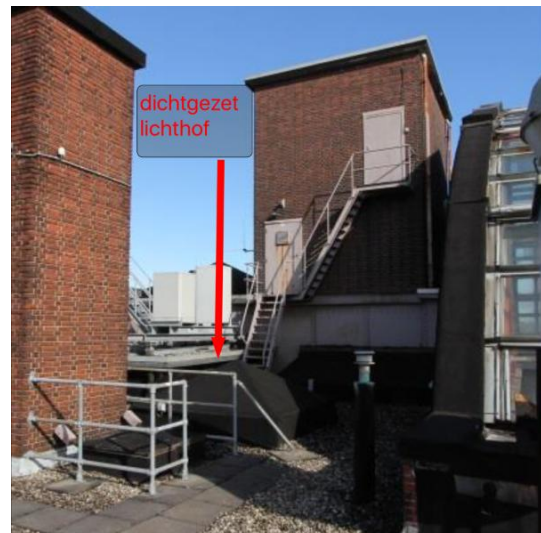
ID number 13.1  
Location  
Priority  None  
Date Time 2017-07-02 09:12:16  
Decision

Component 2.04 HD trappenhuis 2e etage lichtraam  
Description Bredere stijlen dan ramen, verduisterd vanaf bovenzijde

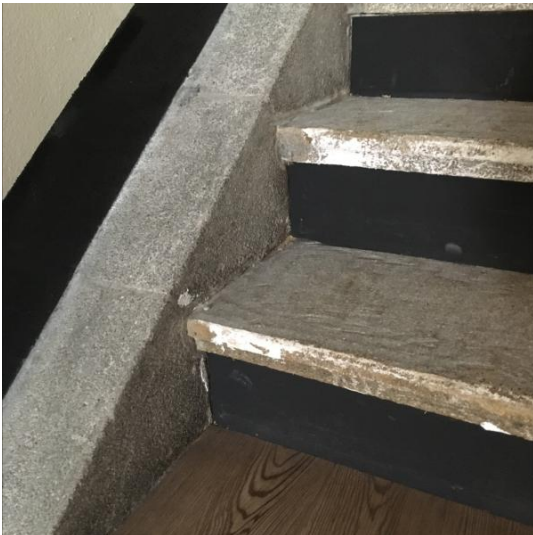
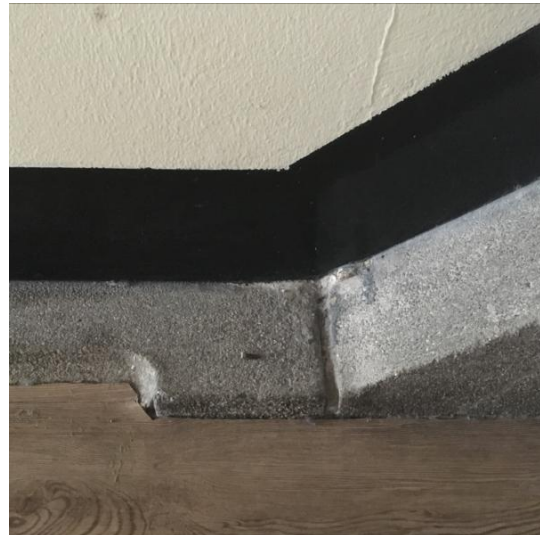
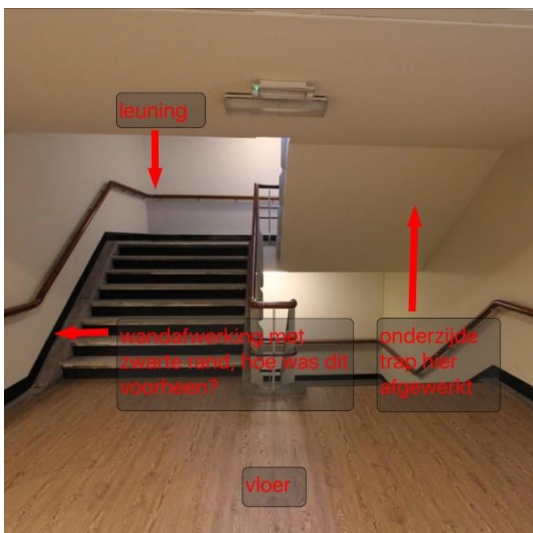
ID number 13.8  
Location  
Priority  None  
Date Time 2017-07-02 15:10:03  
Decision

Component 2.57 WZ trappenhuis 2e etage  
Description bekleding en afwerking trappenhuis

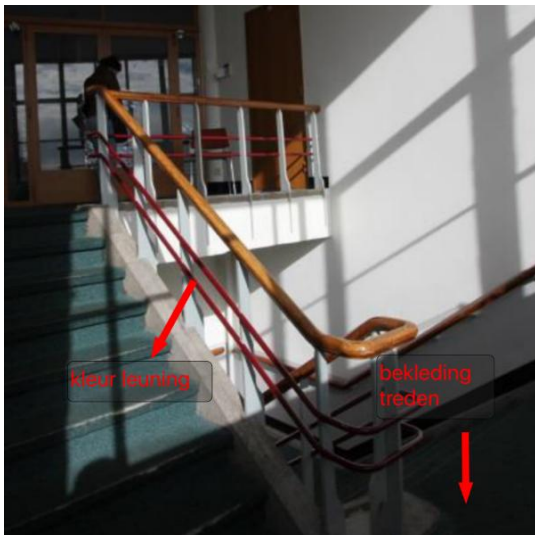
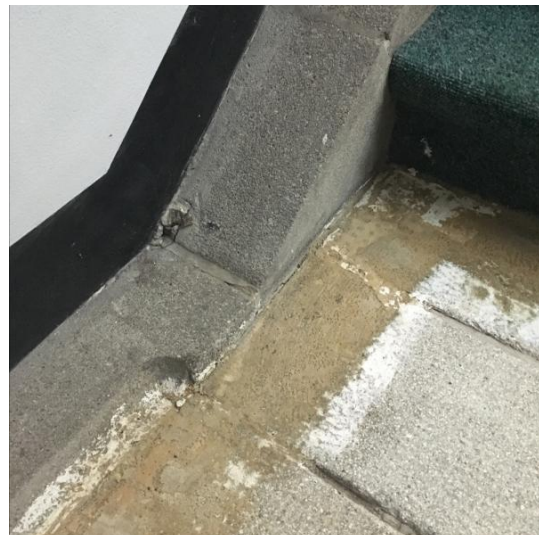
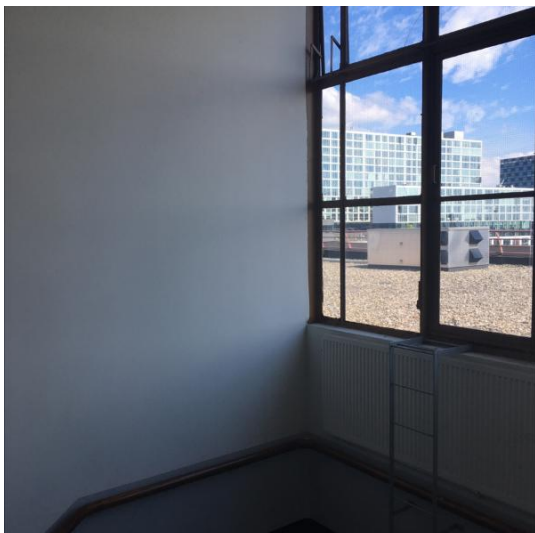
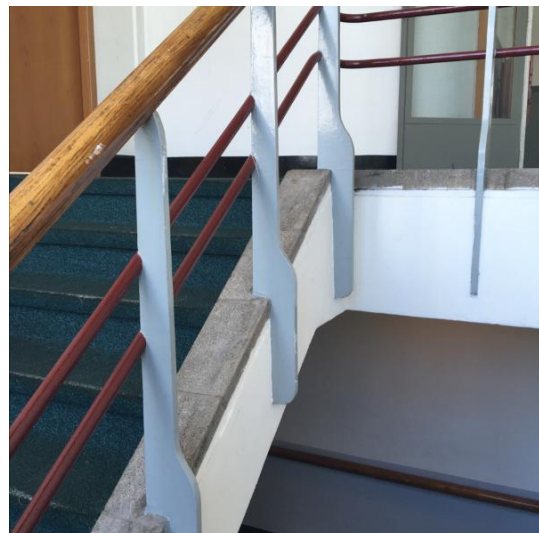
ID number 13.10  
Location  
Priority  None  
Date Time 2017-07-04 12:15:30  
Decision

Component 3.03 WZ trappenhuis 3e etage  
Description Trapbekleding

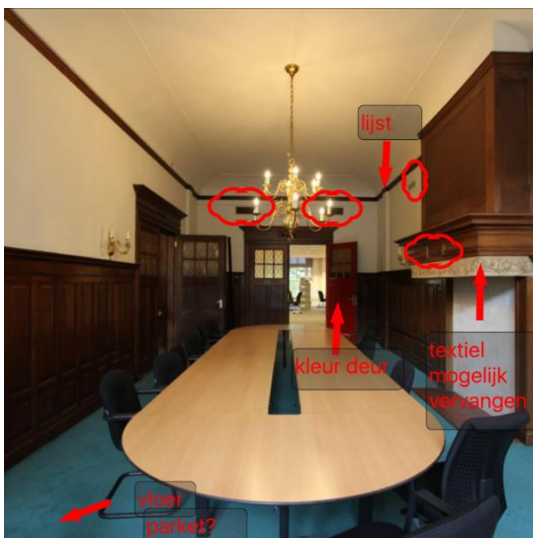
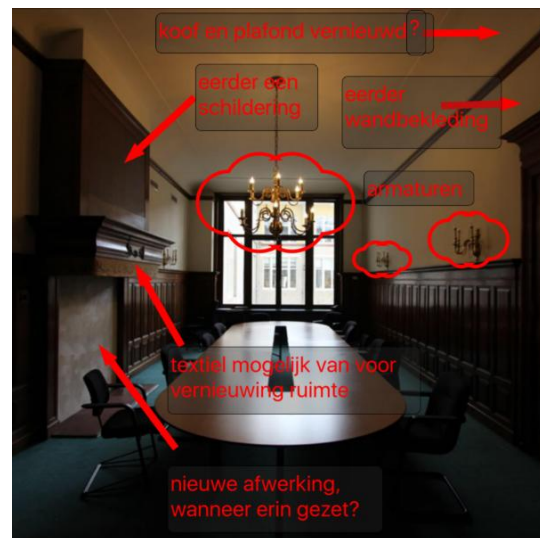
ID number 21.1  
Location  
Priority  None  
Date Time 2017-07-11 12:10:05  
Decision

Component 1.21 Tudorzaal  
Description Onderzoek en datering plafond, wanden, lambrisering, vloer, schouw, armaturen, ramen. Restauratieadvies.

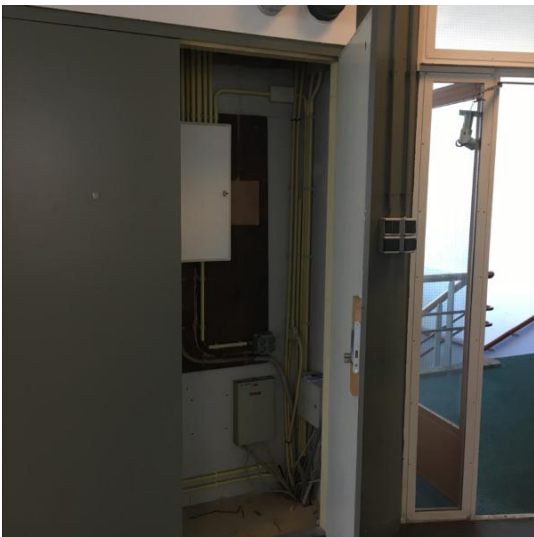
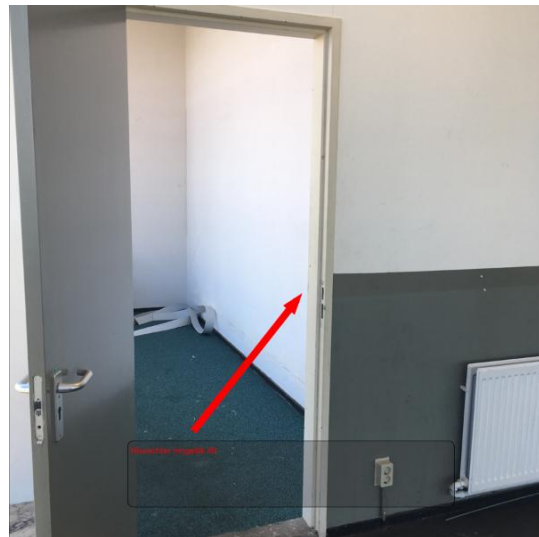
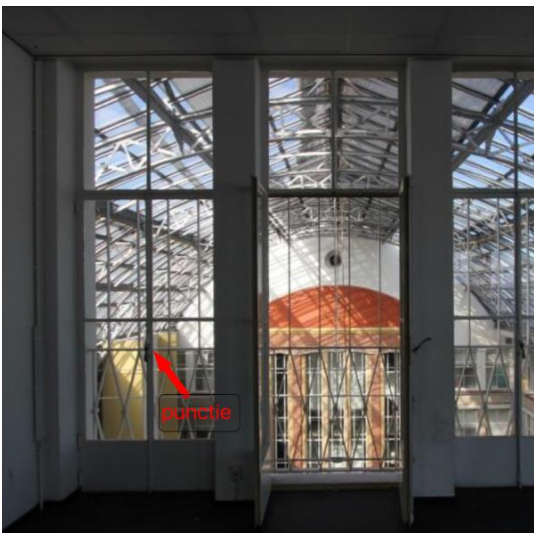
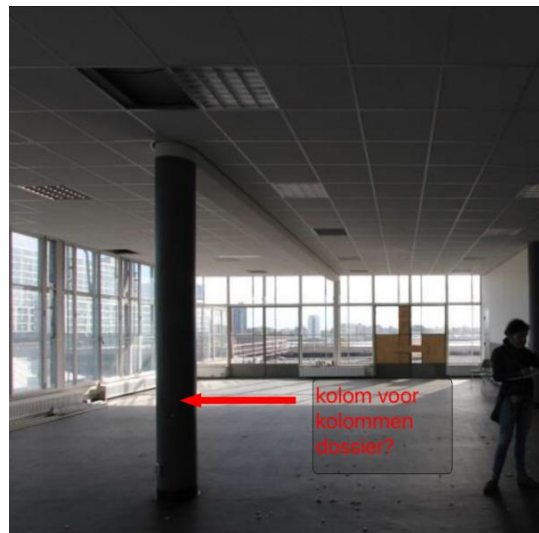
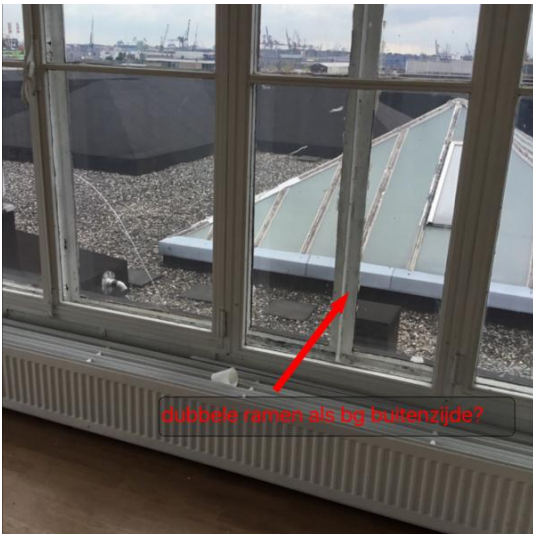
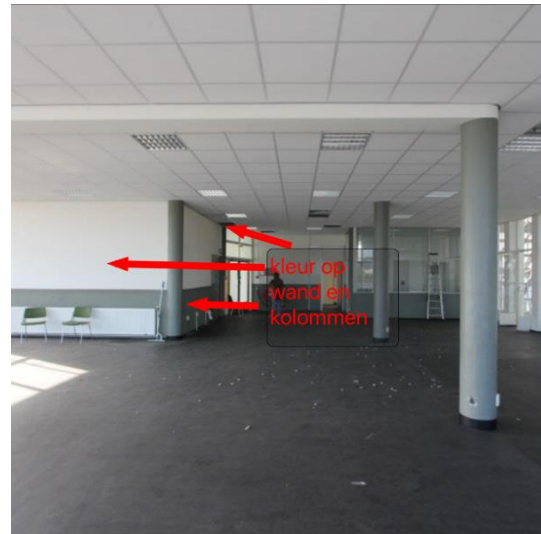
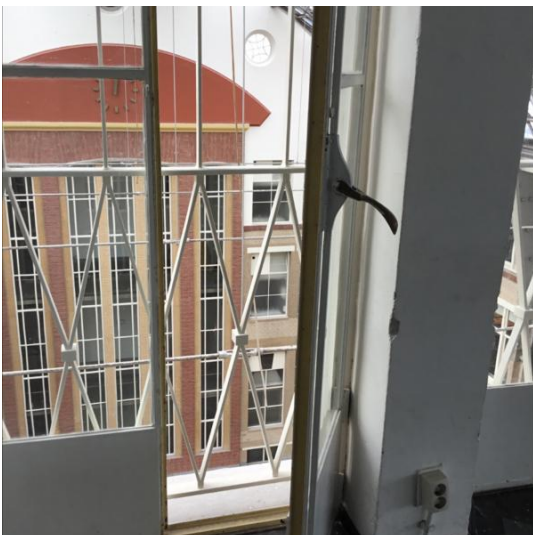
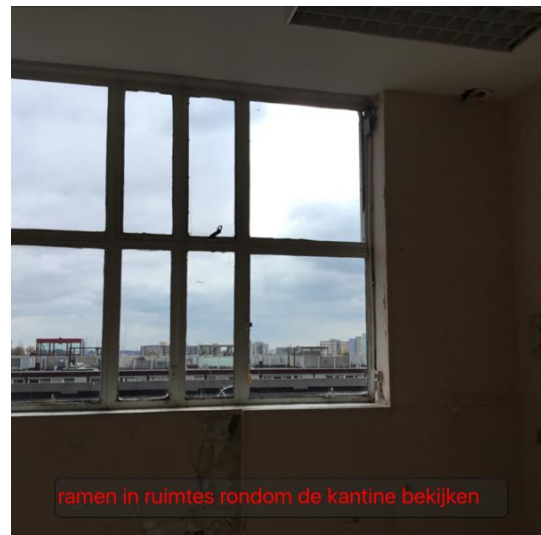
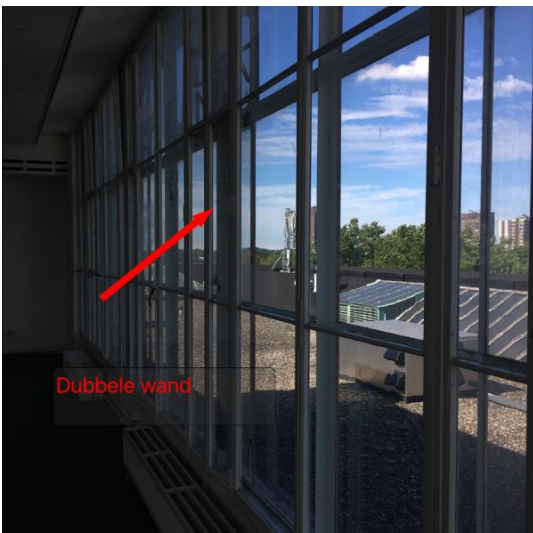
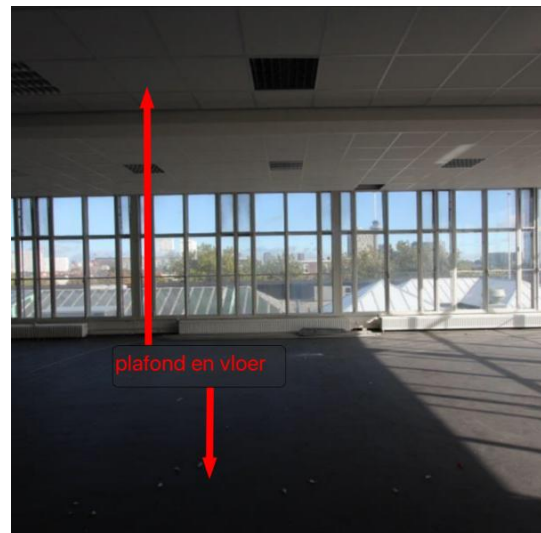
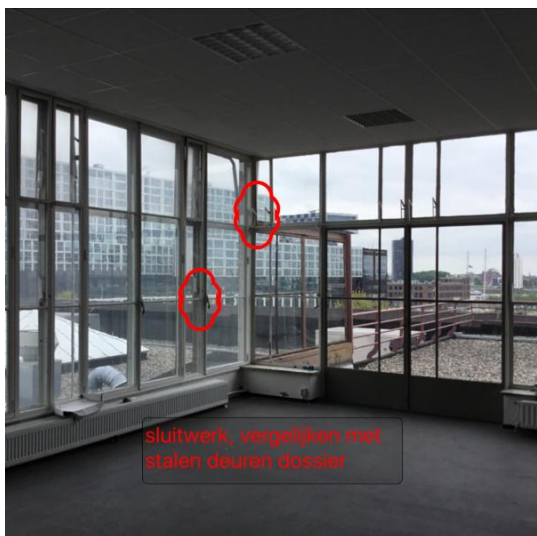
Component 3.03 Kantine interieur  
Description Kleurontwikkeling ramen, deuren en wanden.  
Systeemplafond?

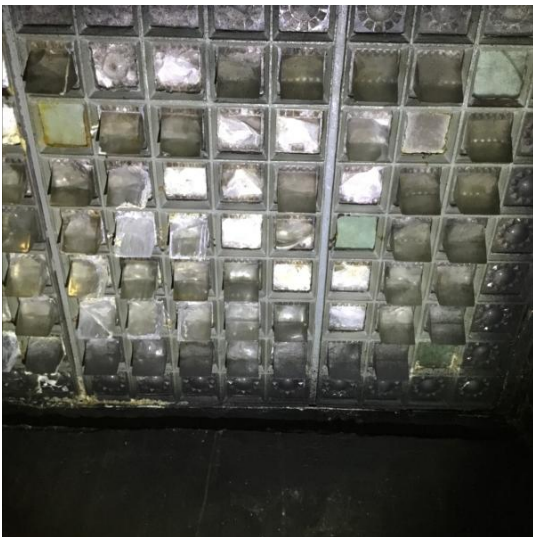
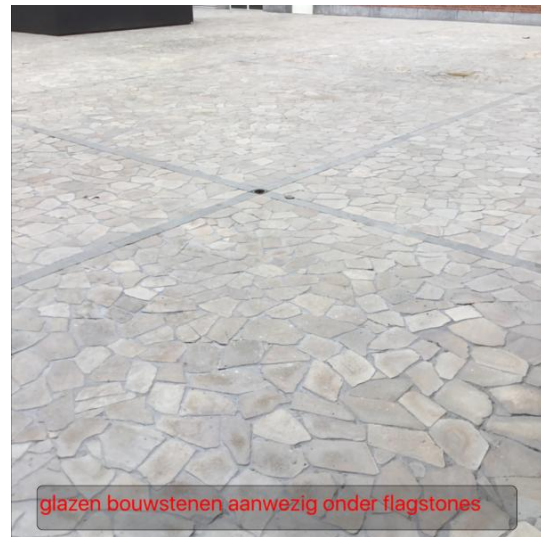
Component -1.01 Glazen bouwstenen  
Description Moet worden gerestaureerd. Advies restauratie in fase 3
