Aandachtspunten voor nader onderzoek per thema

West507 – transformatie Oceaanhuis

**Kleurhistorisch onderzoek en bouwhistorische verdieping**  
Plan van Onderzoek

14 juli 2017

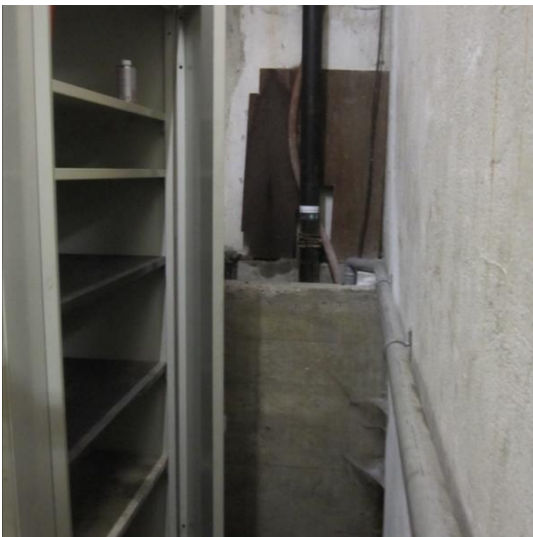
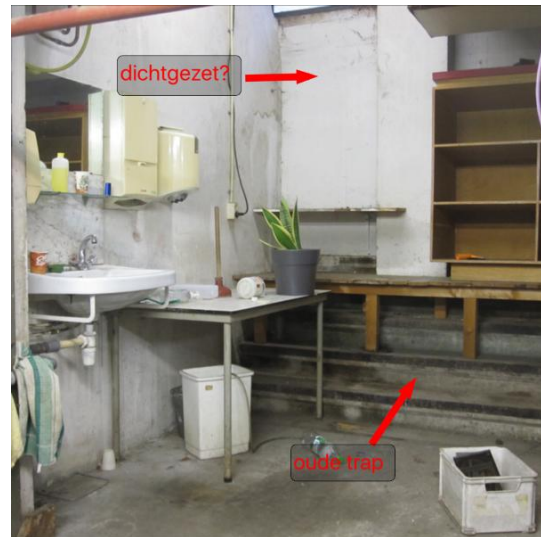
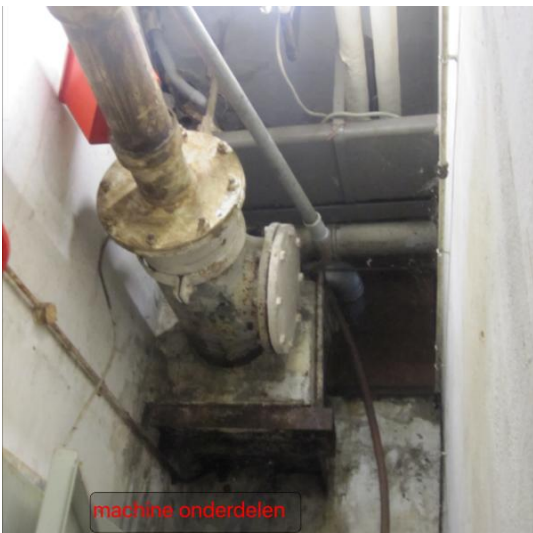
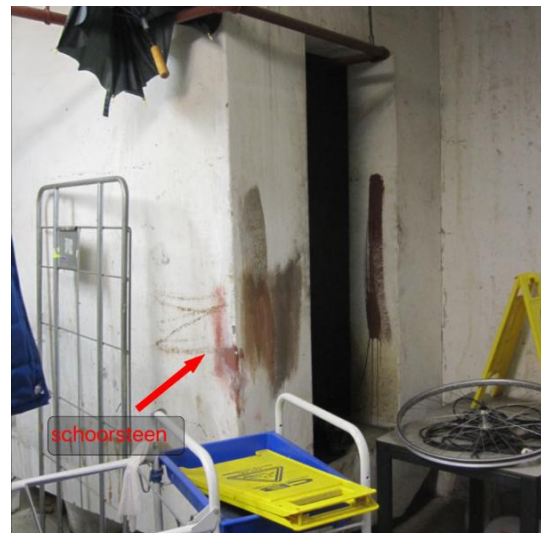
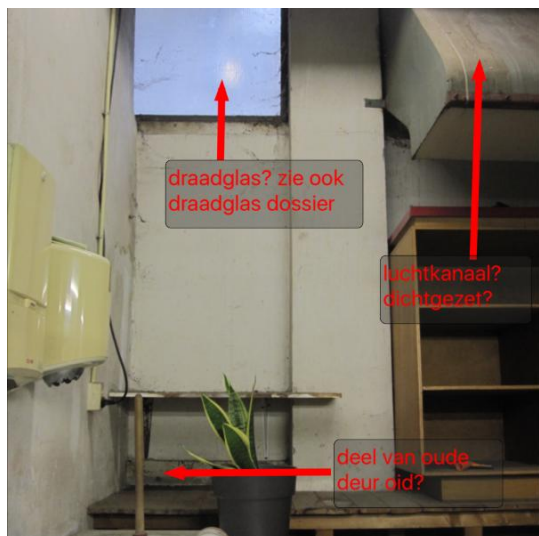
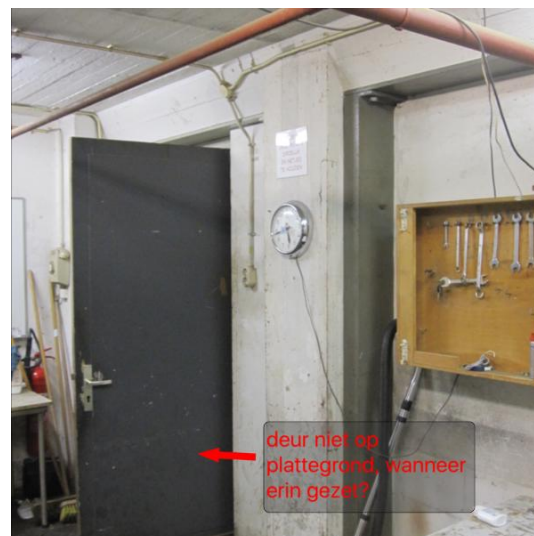
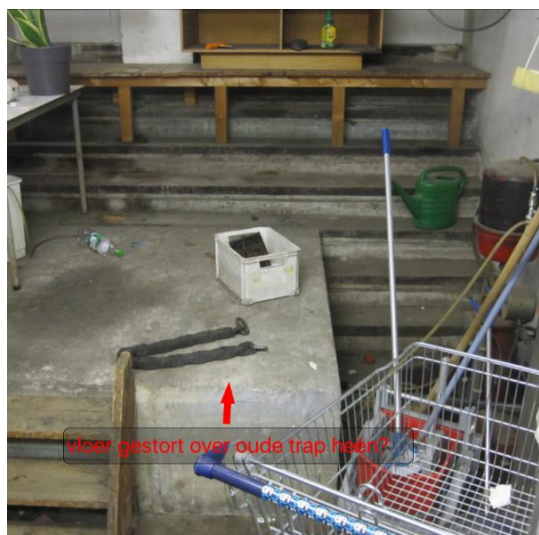
Component -1.29 Ruimte met treden oude trap  
Description ruimte dichtgezet, welke elementen van voor en van na dichtzetten?

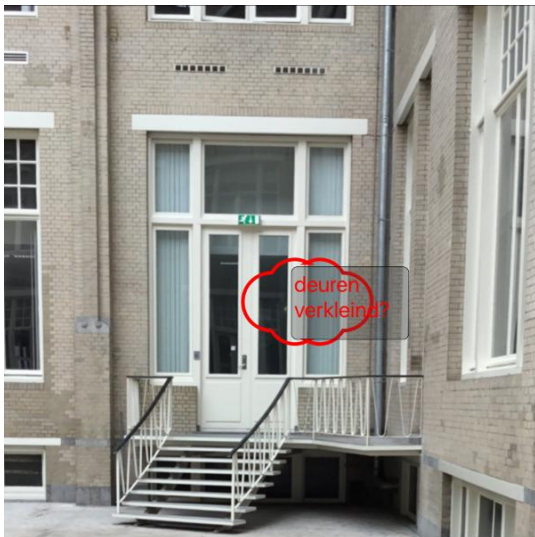
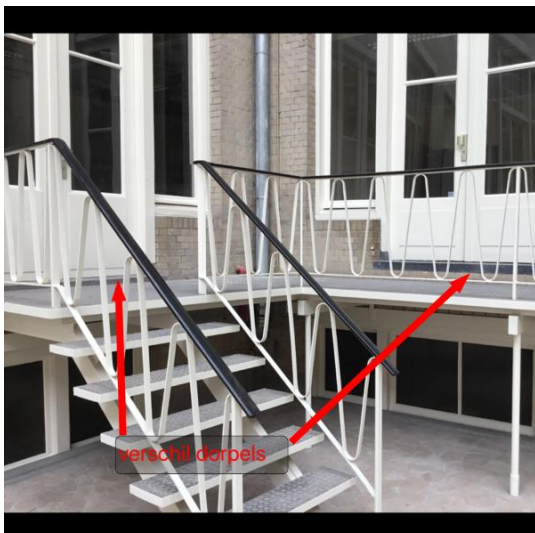
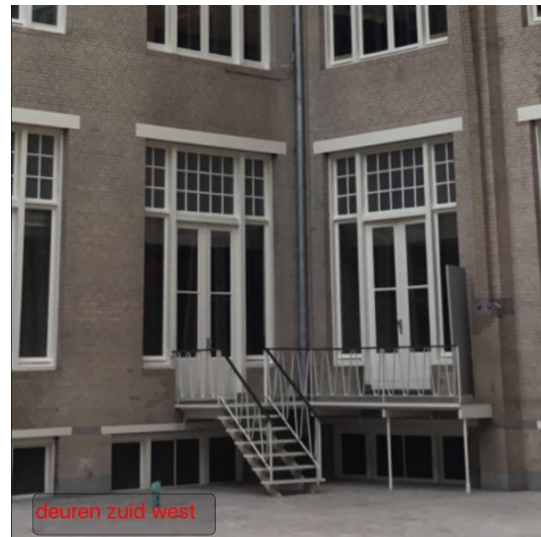
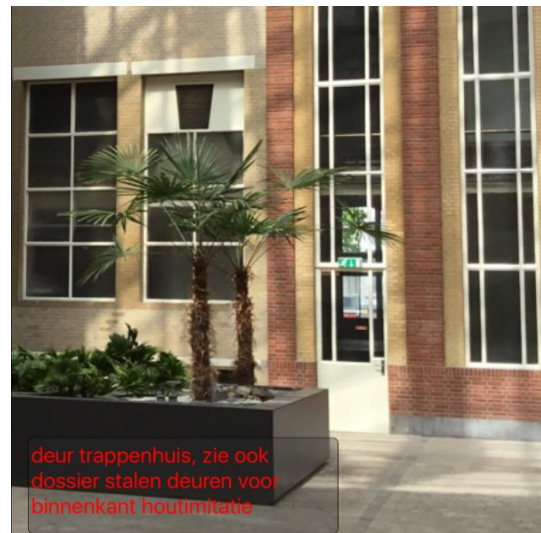
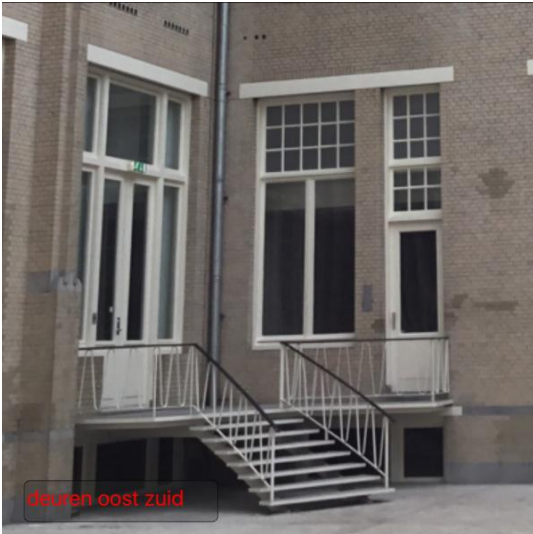
Component 0.135 Deuren atrium  
Description deuren atrium vergelijk stijlen dmv punctie en stratigrafie

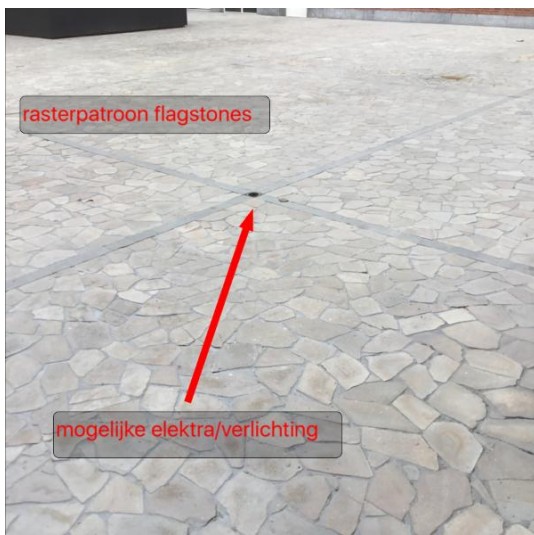
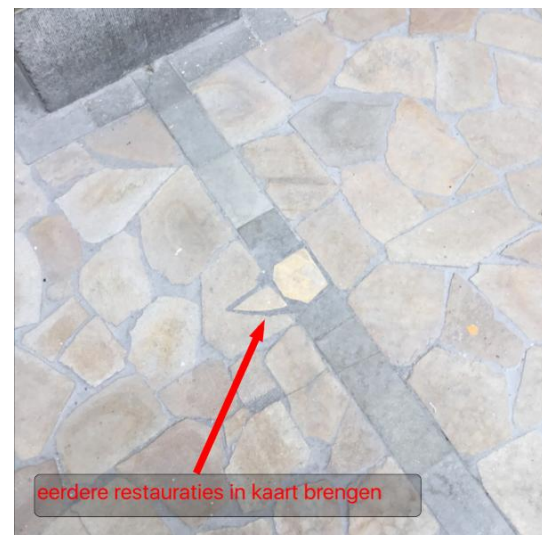
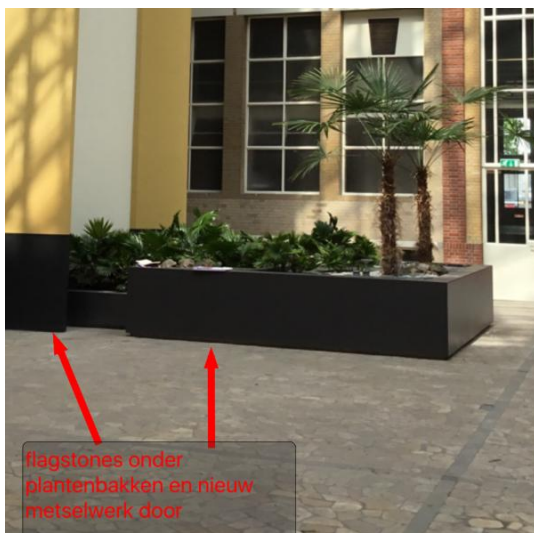
Component 0.135 Flagstones atrium  
Description Vloer flagstones uit 70, over glazen bouwstenen heen en onder plantenbakken en metselwerk liftschacht. Rasterpatroon.

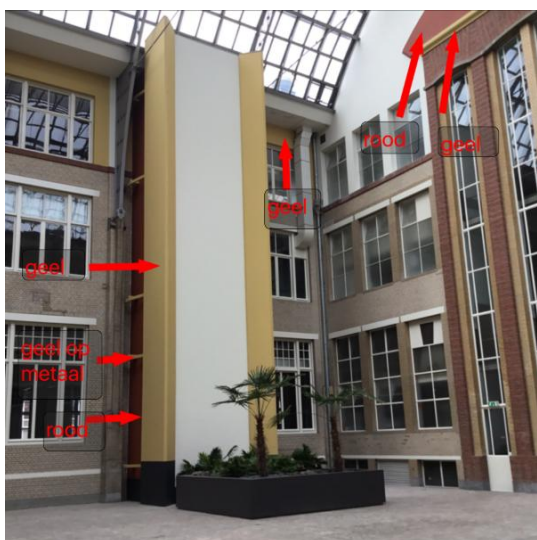
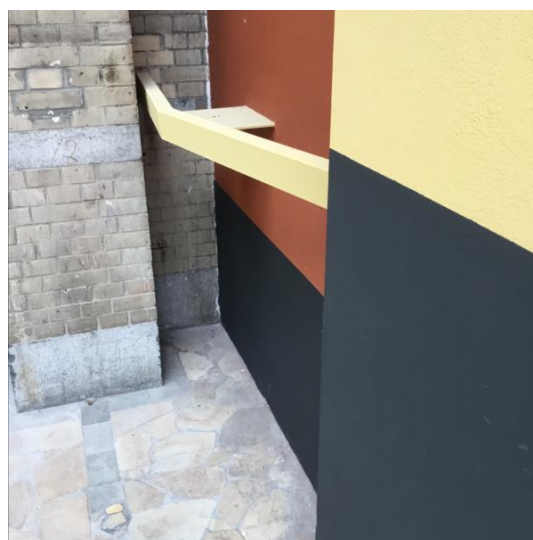
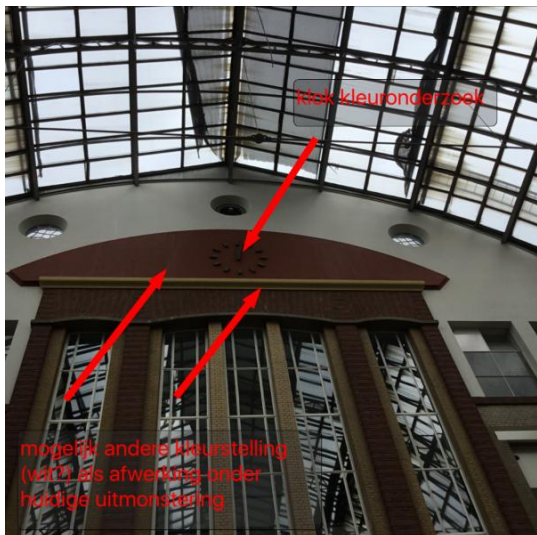
Component 0.135 Gekleurde afwerking op stucwerk  
Description Fase drie kleuronderzoek. Gele en rode afwerking. Geel ook vergelijken met kleur in kelder bij 'oceanhuis'.

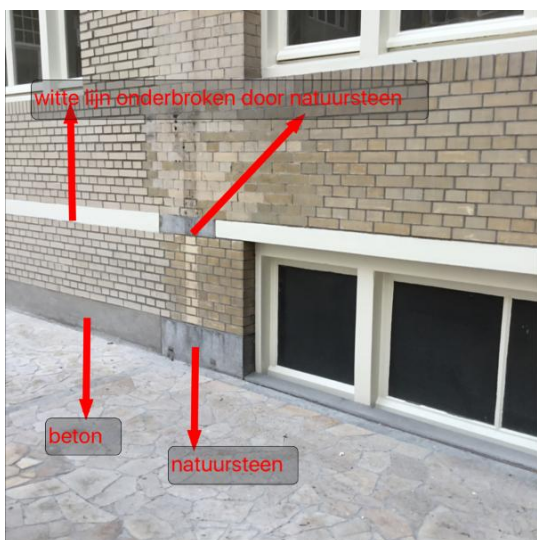
Component 0.135 Metselwerk atrium  
Description Overschilderd baksteen. Retouches van oude boorgaten? Dichtgezette deuren.

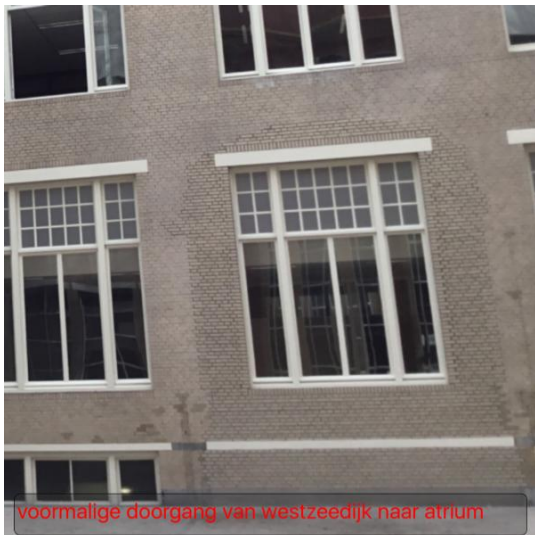
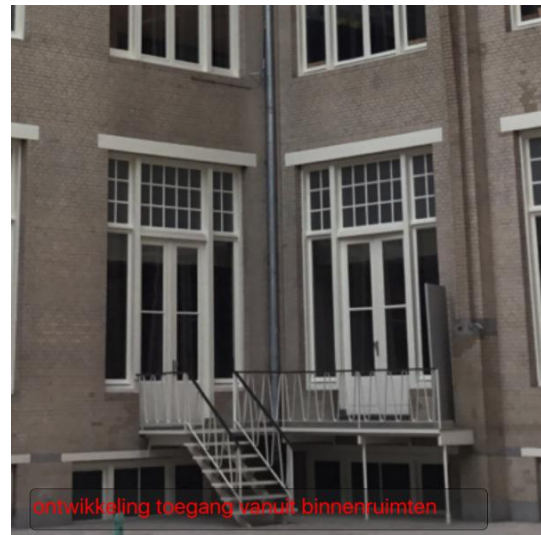
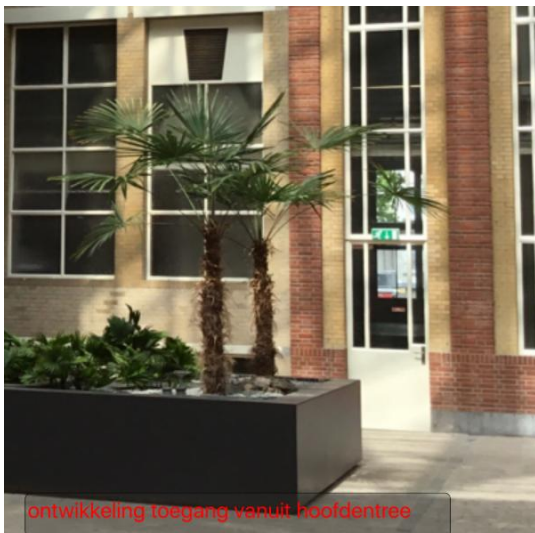
Component 0.135 Ontwikkeling toegang tot atrium  
Description bronnen over deuren en toegangsgebieden, opname maken

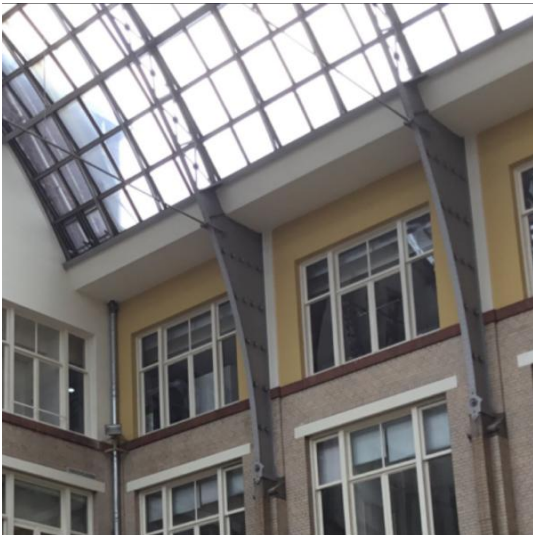
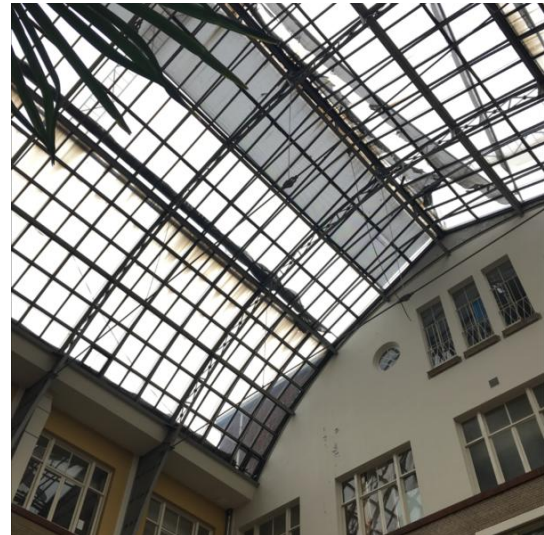
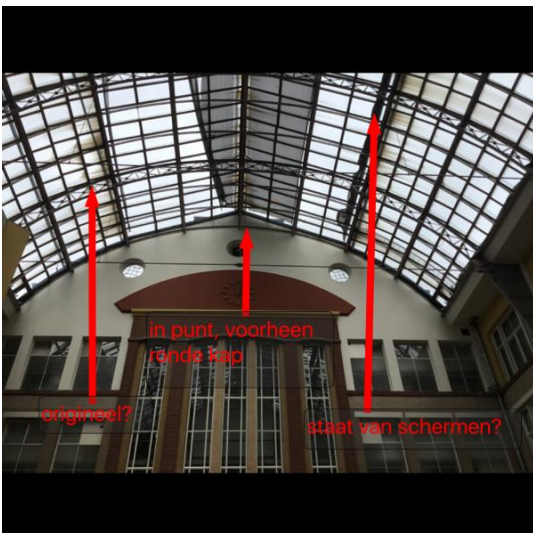
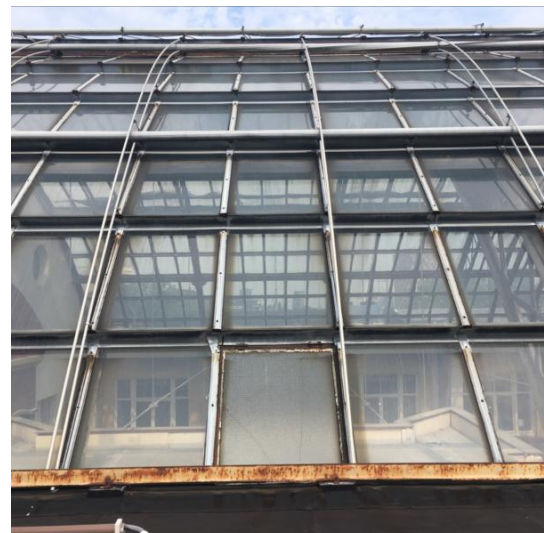
Component 0.135 Overkapping atrium  
Description Glazen overkapping: staat van glaswerk, metaal en ontwikkeling constructie. Zijn er nog originele delen? Ontwikkeling.

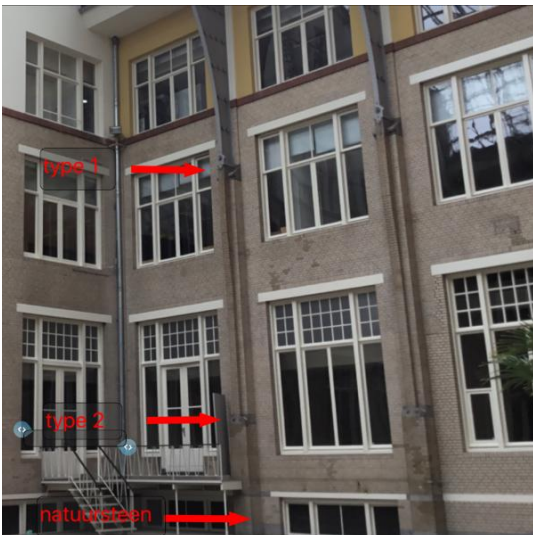
Component 0.135 Pendants muren atrium  
Description Consoles natuursteen beschrijven

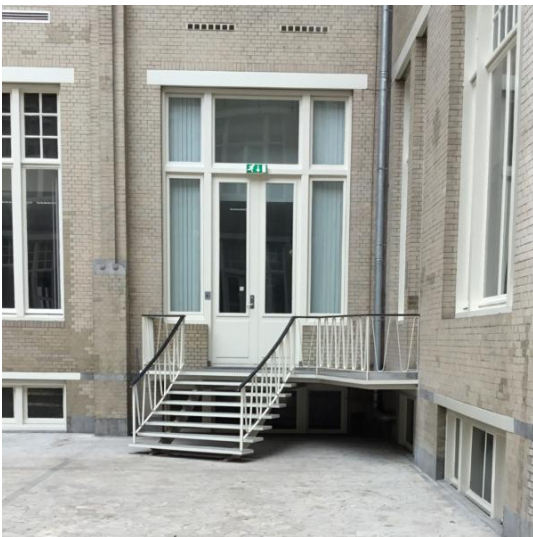
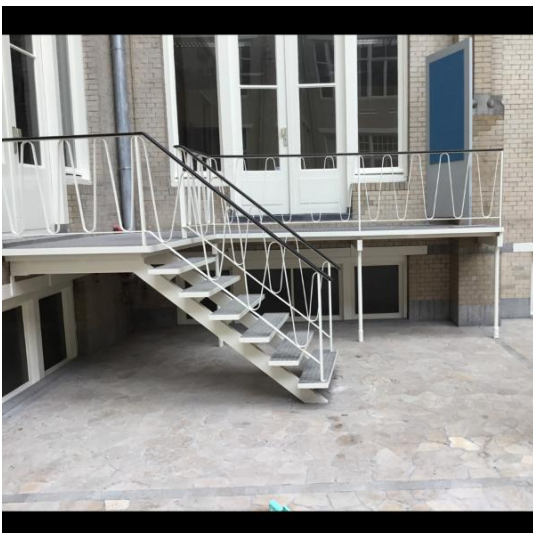
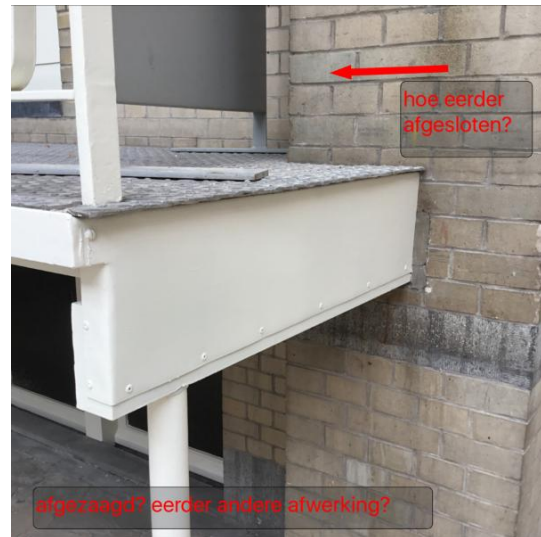
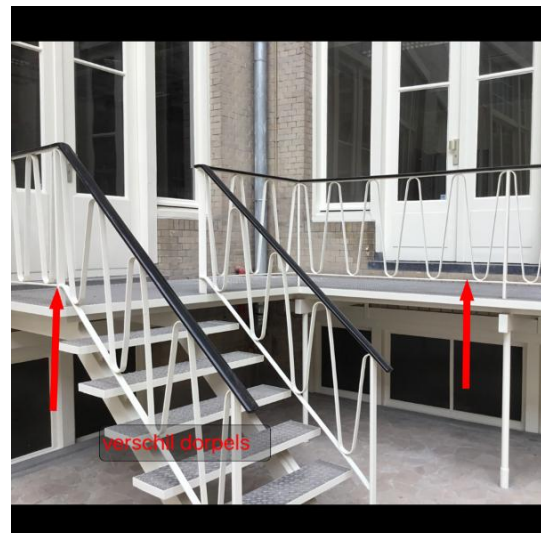
Component 0.135 Platforms atrium  
Description Kleuronderzoek balustrade en constructie. 1 trap onderzoek 2e alleen puncties.

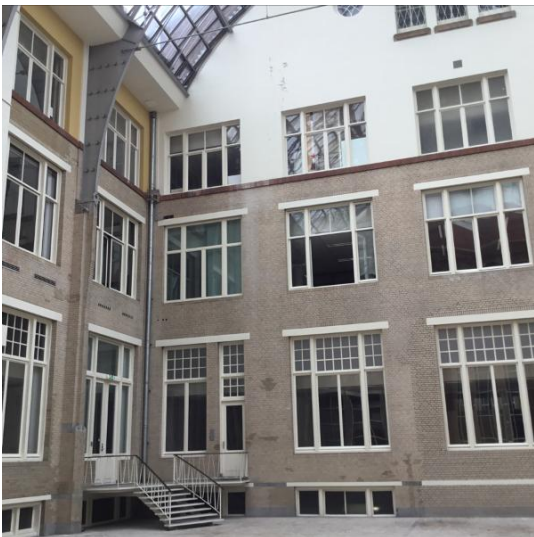
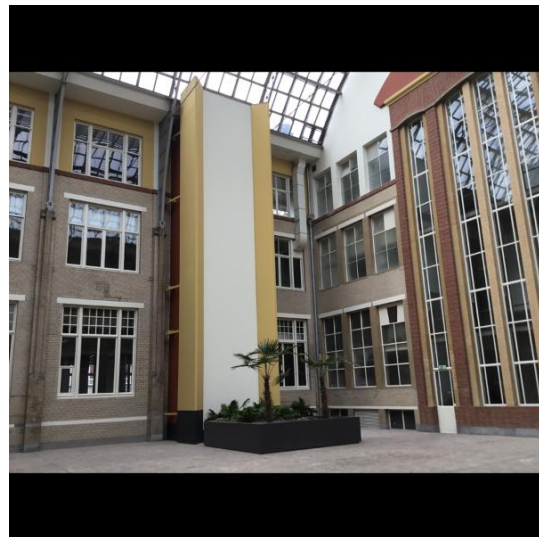
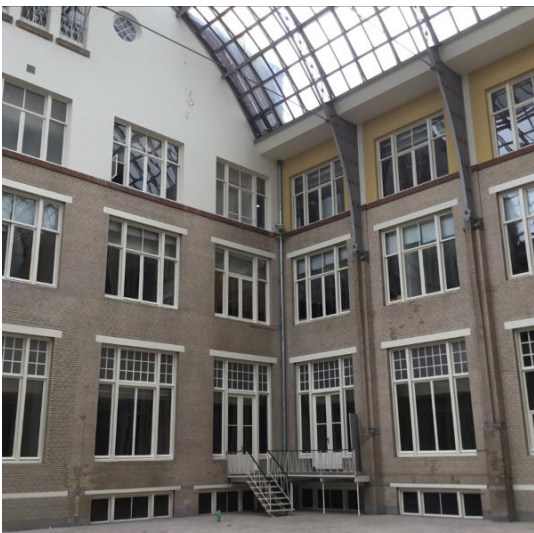
Component 0.135 Raamkozijnen atrium  
Description Buitenkant: typen benoemen, ontwikkeling in afwerking dmv puncties/strati, typen ramen benoemen

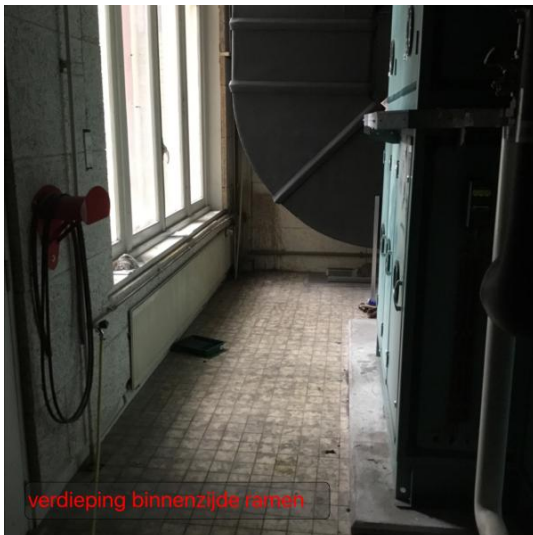
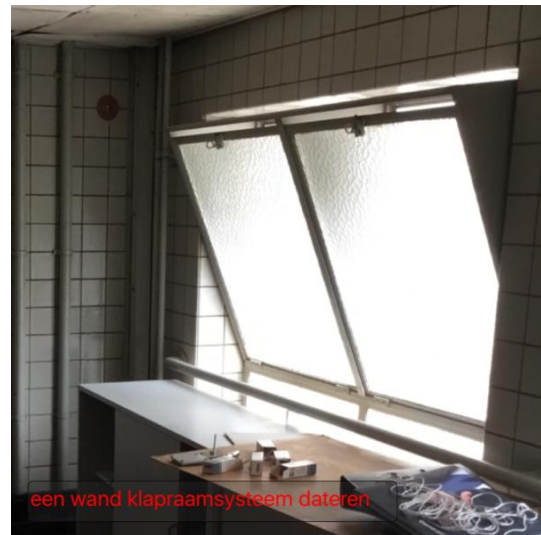
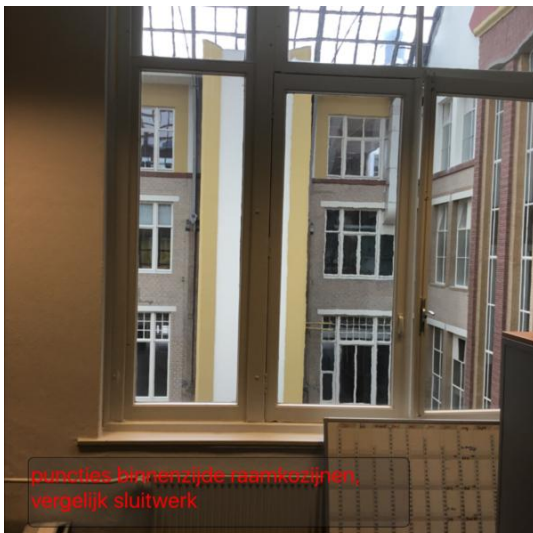
Component 0.135 Raamkozijnen atrium binnenkant  
Description Binnenkant, benoemen typen en datering, ontwikkeling afwerking dmv puncties. Deel voor de oorlog deel erna.

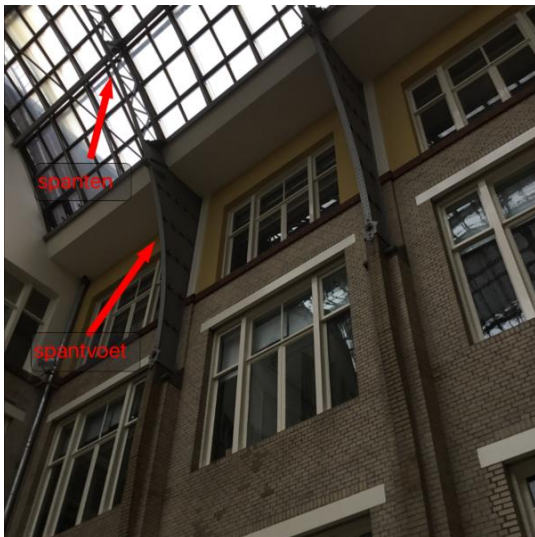
Component 0.135 Spanten glazen kap atrium  
Description Kleuronderzoek spanten en spantvoet,  
bronnenonderzoek en datering

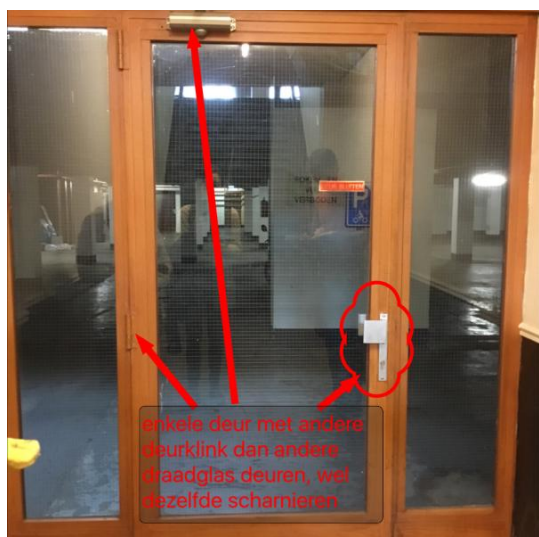
Component -1.14 stalen pui 73  
Description Afwerkingen als derde verdieping draadglas deuren? Stratigrafie

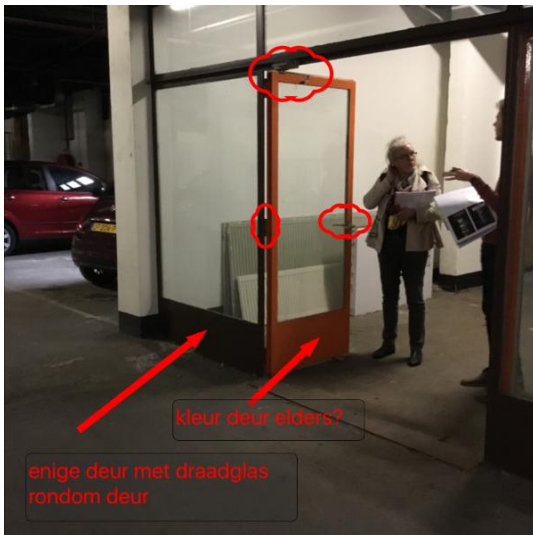
Component -1.24 glazen pui  
Description Kleuronderzoek pas na 51 op tekening,  
vergelijken andere draadglas deuren

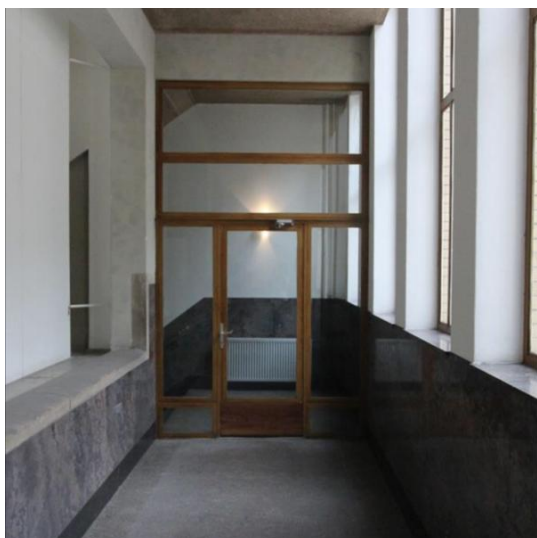
Component 0.003 Stalen deur bordes trappenhuis  
Description houtimitatie, als enkele deur kelder en derde verdieping?

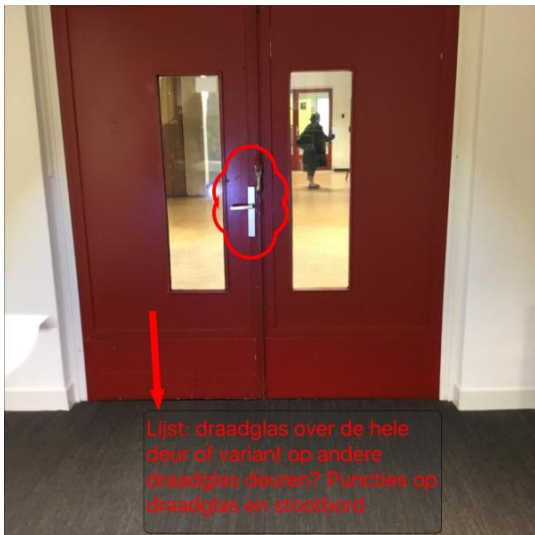
Component 1.11 Buiten deur naar 1.02 (bij 1.05)  
Description deur naar trappenhuis noord. Alleen wat puncties nemen voor vergelijk

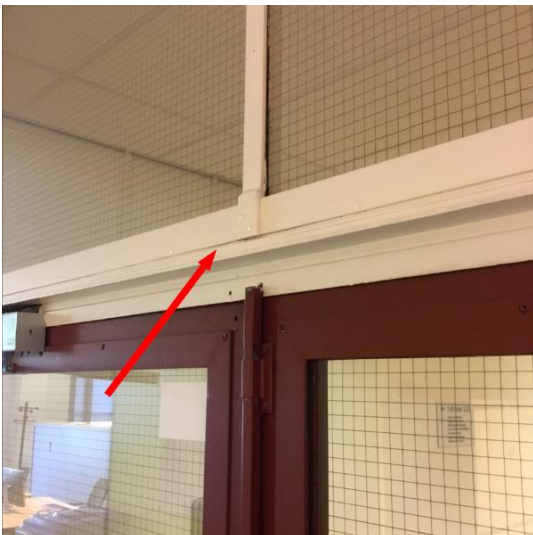
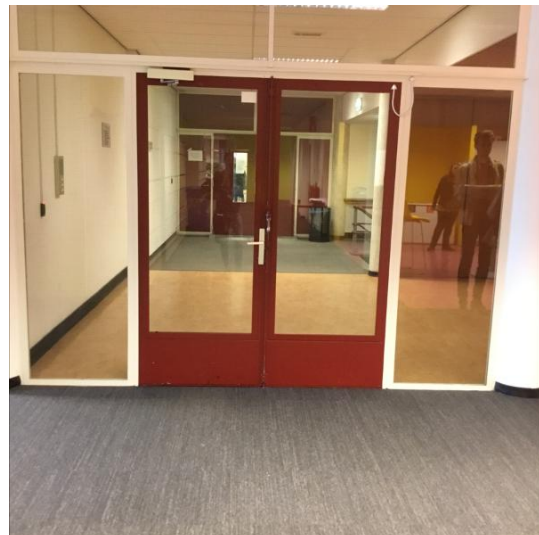
Component 1.41 stalen deur (bij 1.34)  
Description Deuren stratigrafie, deze misschien ouder dan t.o. gelegen deur 1.05

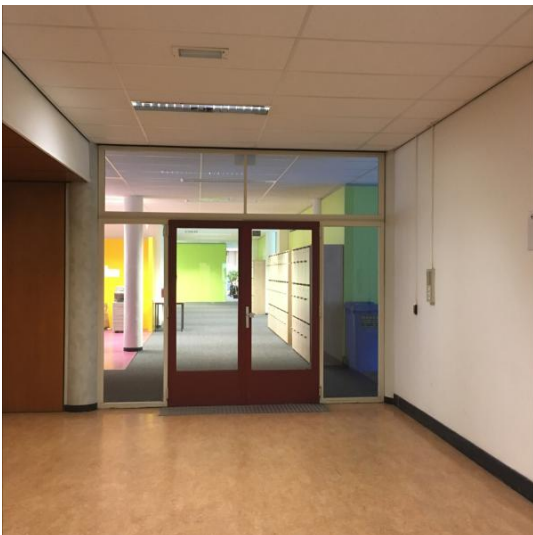
Component 1.44 Stalen deur  
Description Stalen deur bij trappenhuis WZ

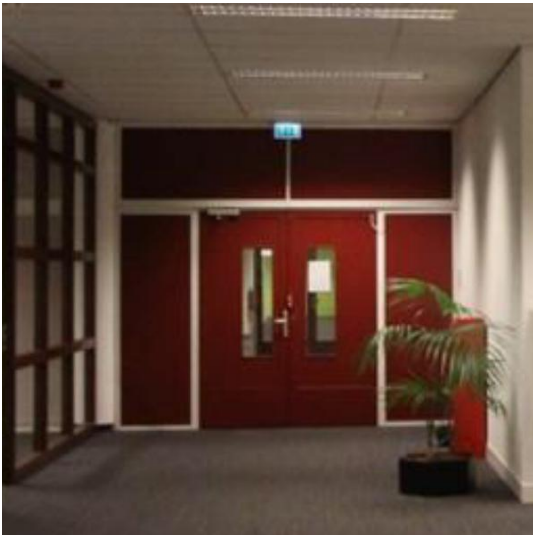
Component 1.44 stalen deur naar 1.41  
Description duer naar trappenhuis zuid

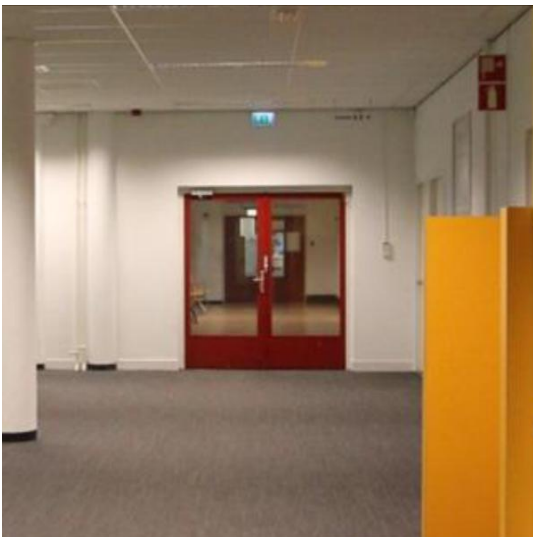
Component 1.71 Stalen deur (naar 1.02 trappenhuis)  
Description Stalen deur punctie, scharnieren, sluitwerk

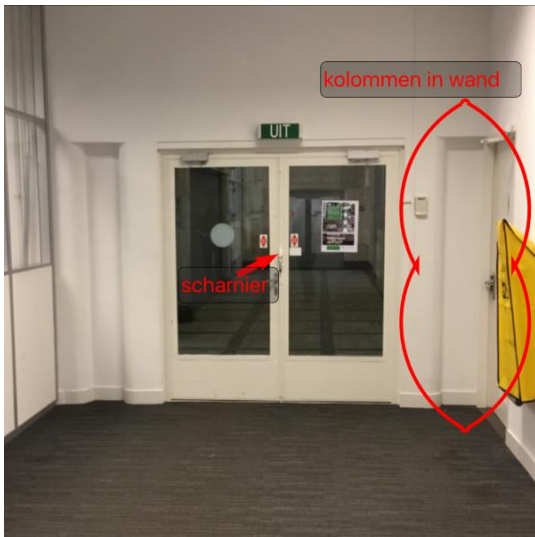
Component 2.02 deur bij 2.89  
Description Deur kleuronderzoek bij stalen puien.

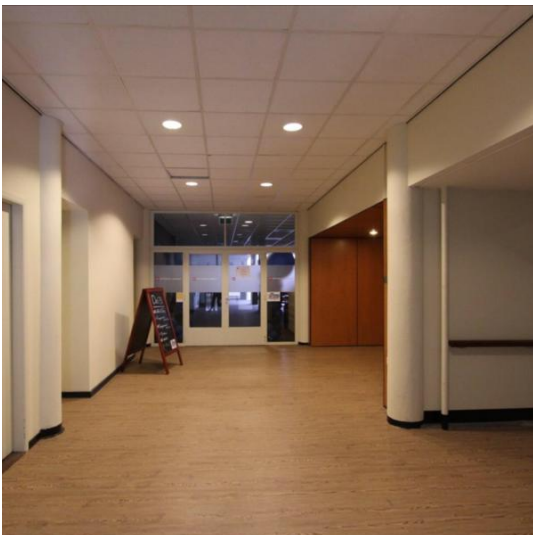
Component 2.57 Stalen deur (naar 2.43)  
Description Scharnieren, punctie, deurklink

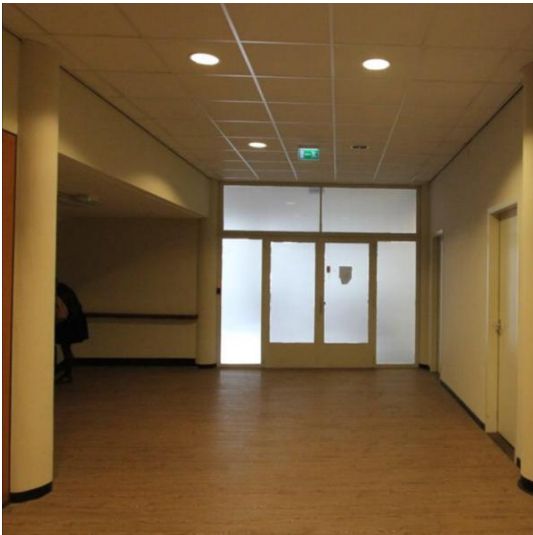
Component 2.57 Stalen deur (naar 2.69)  
Description Punctie, scharnieren, deurklink, maten

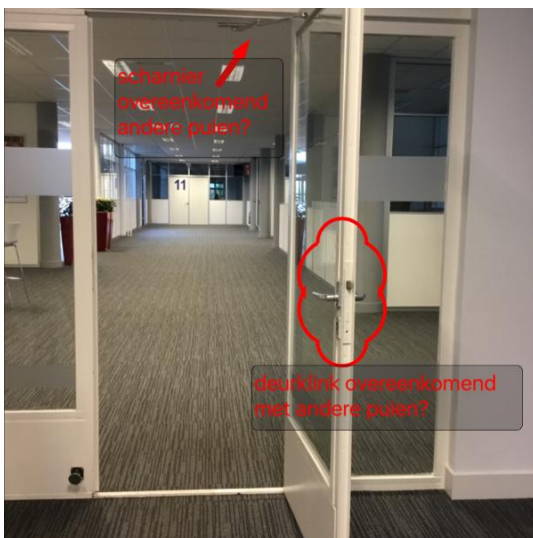
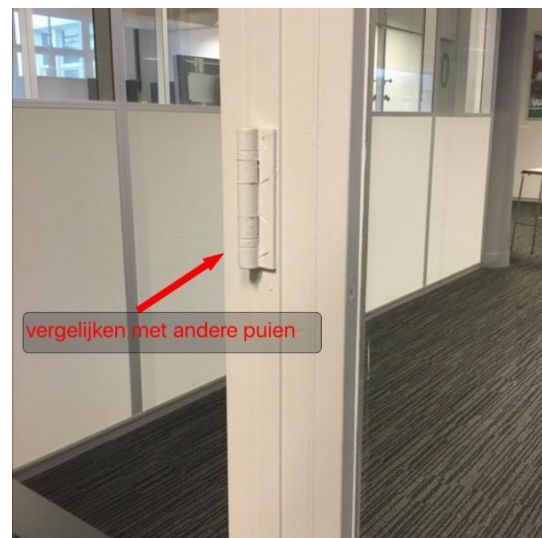
Component 2.78 Stalen pui  
Description Kleuronderzoek op stalen pui, scharnier en plint wand. Deurklinken vergelijken.

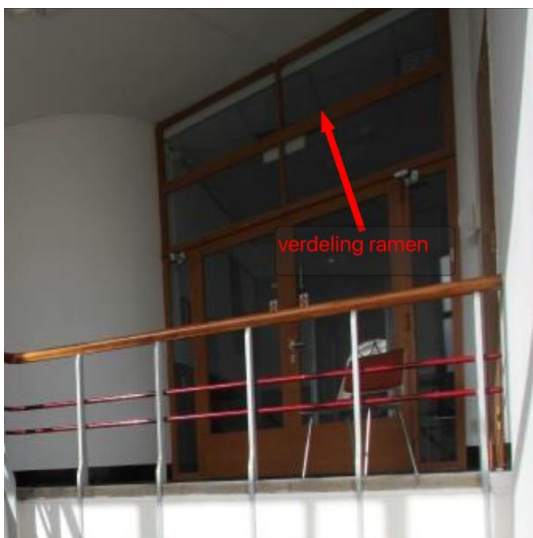
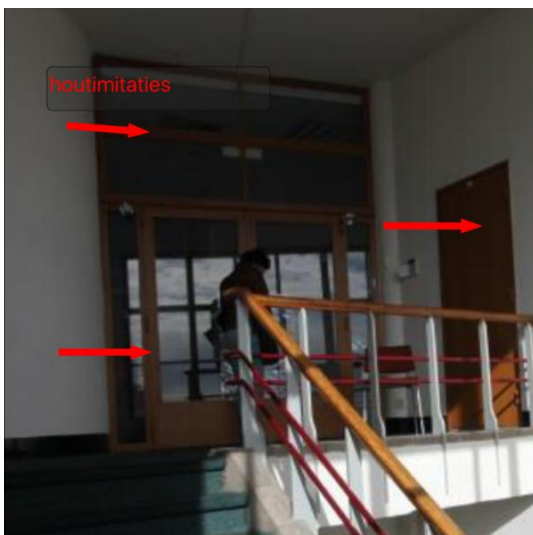
Component 3.03 Deur bij stalen puin  
Description Deur binnen en buitenzijde: houtimitatie dezelfde als stalen deur kelder? Grijsze kleur elders? Klink, scharnier.

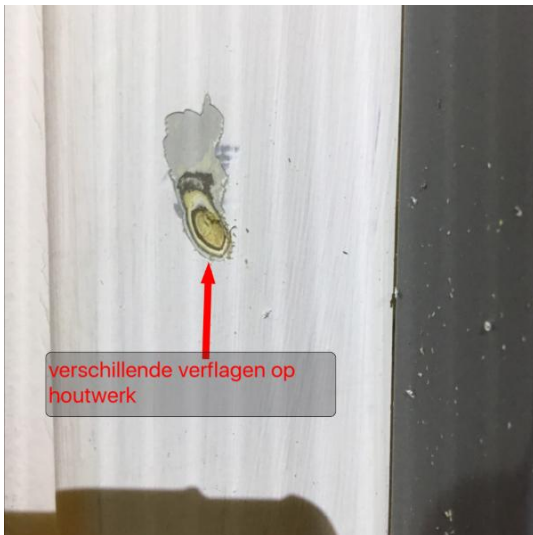
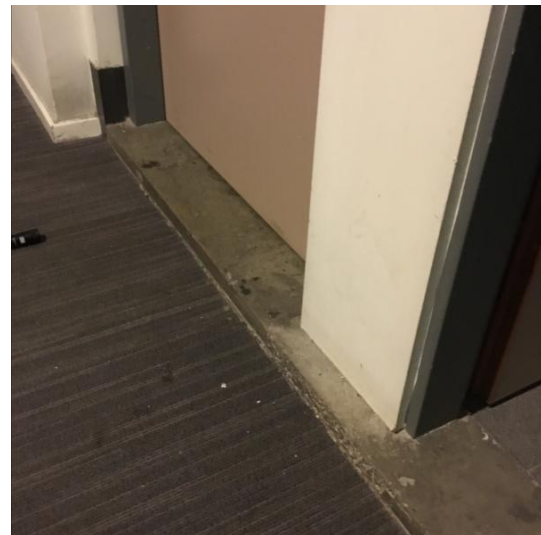
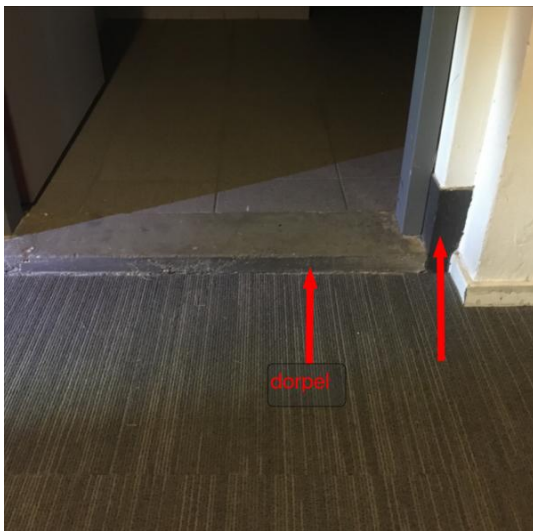
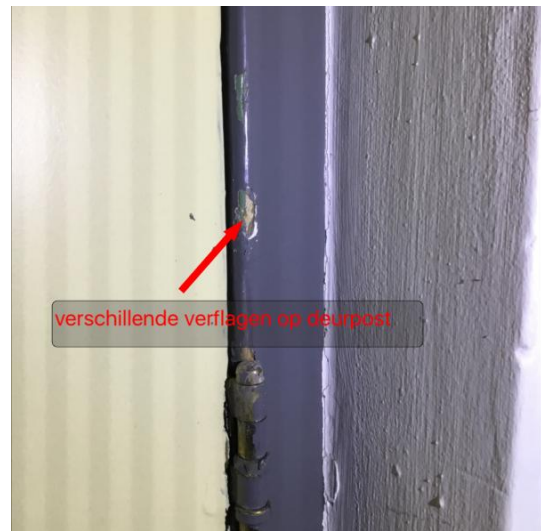
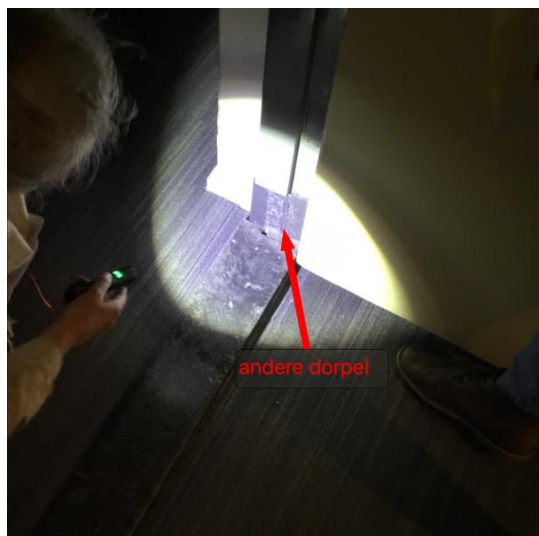
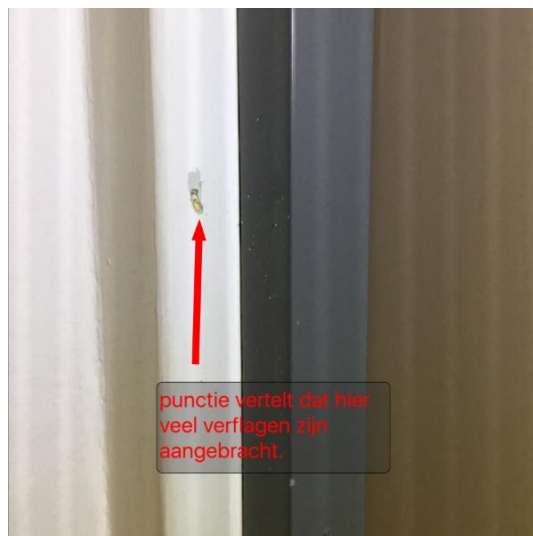
Component 0.095 Toiletruimte  
Description vernieuwde toiletten, maar met restanten van de oude situatie. kleuronderzoek.

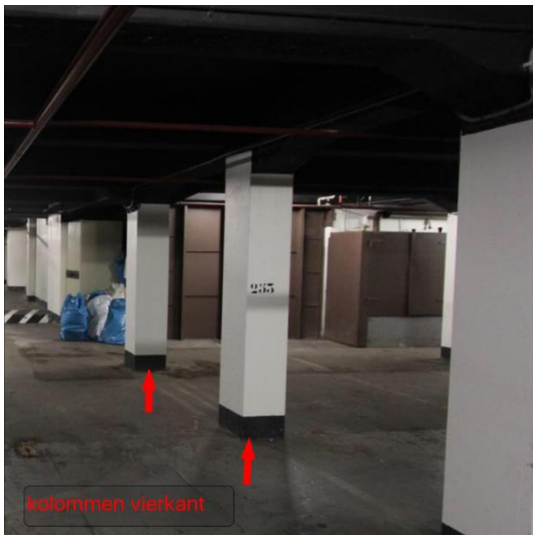
Component K -1.17 Kolommen  
Description Zie foto steenhuismeurs, kolommen kelder  
eerder ook vierkant.

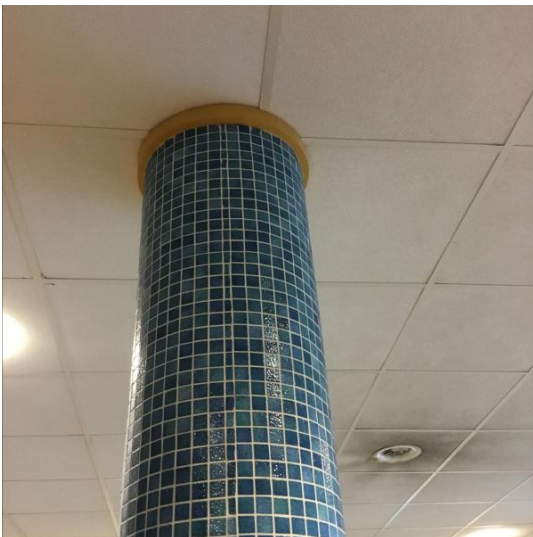
Component K 0.004 Entree politie kolom  
Description Kolom geel van het atrium? Semedx?  
Bronnenonderzoek.

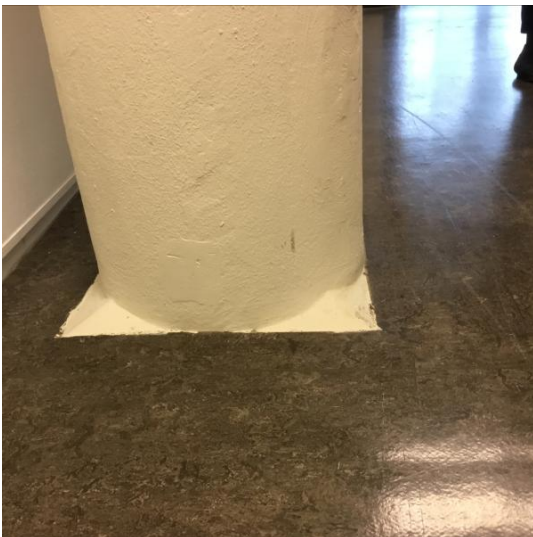
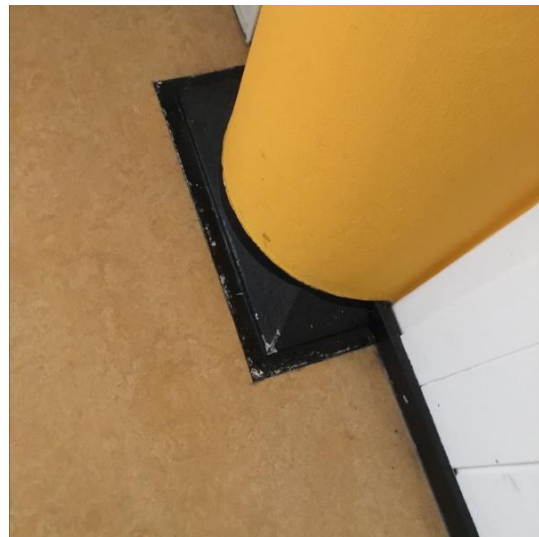
Component K 0.015 en 0.086 Kolommen  
Description Voet kolom stratigrafie, typische voet. Elders onder vloerdelen? typologie van kolommen

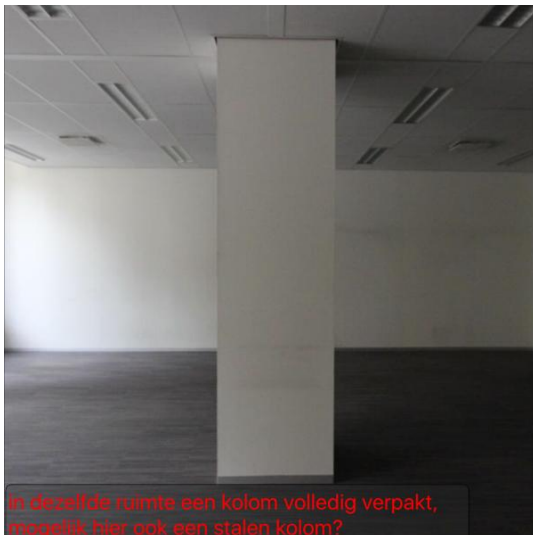
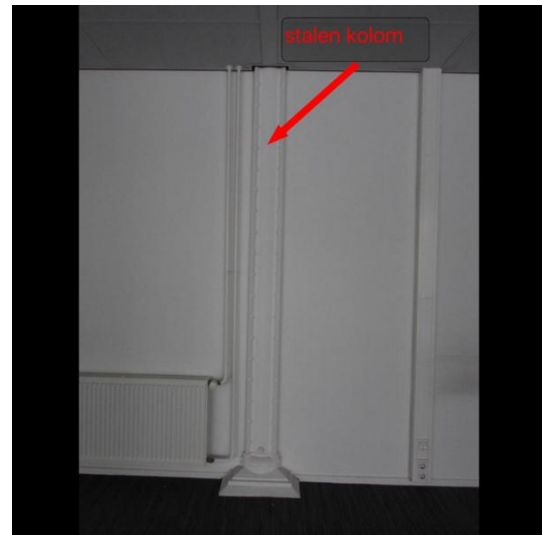
Component K 0.054 stalen kolom  
Description Stalen kolom, niet elders gezien, waarom op deze plek wel? De enige? Kleuronderzoek voor eerdere uitmonstering kolom.

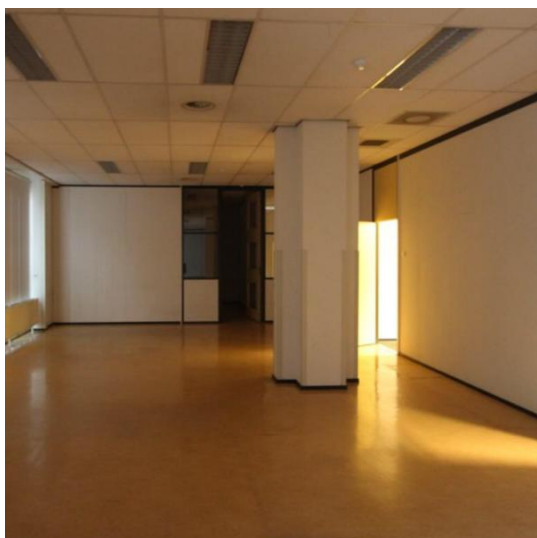
Component K 0.082 Kolom met hoekige ombouw  
Description Ombouw hol, opbouw? past hoe in typologie?

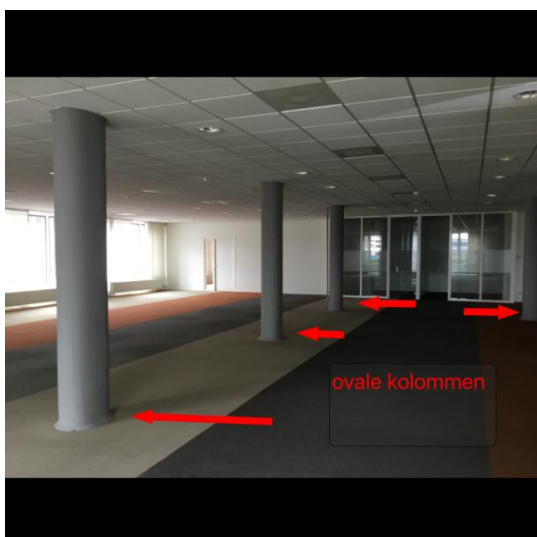
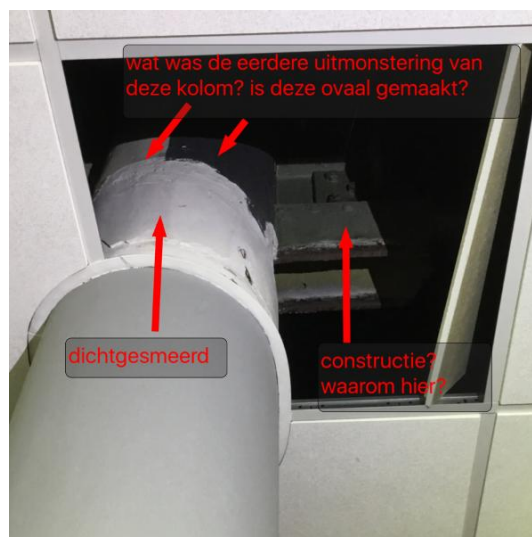
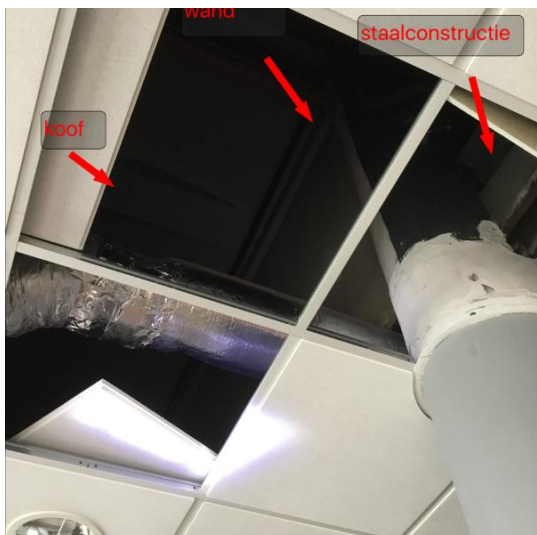
Component K 0.098 Kolommen  
Description Laagopbouw. Kolommen zijn hier ovaal.  
Nergens anders. Boven systeemwand muur en  
staalconstructie, waarom? datering

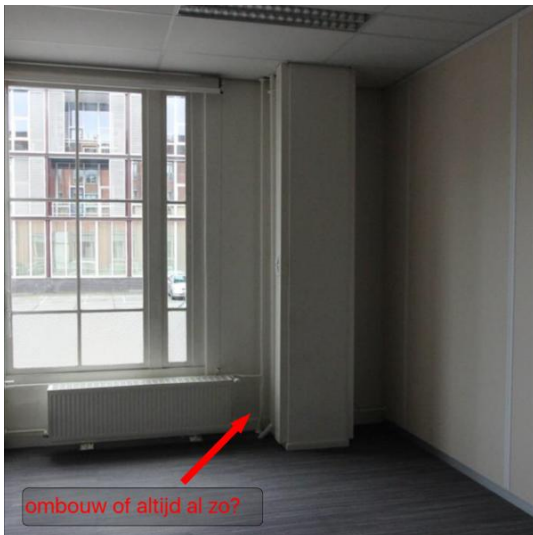
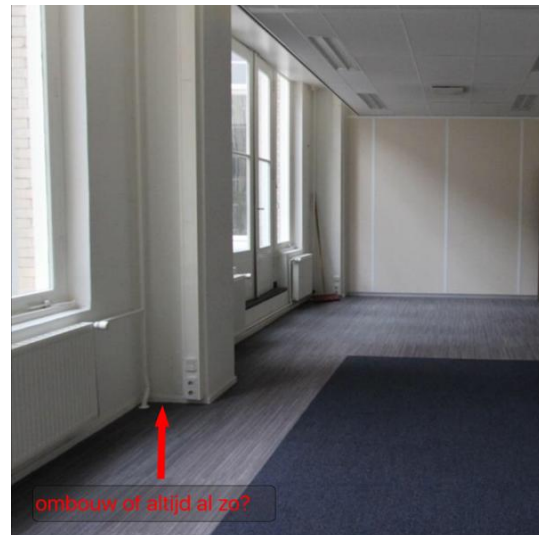
Component K 0.112 en 0.124 Kolommen buitenmuur  
Description Kolommen langs atriummuur, holle ombouw?

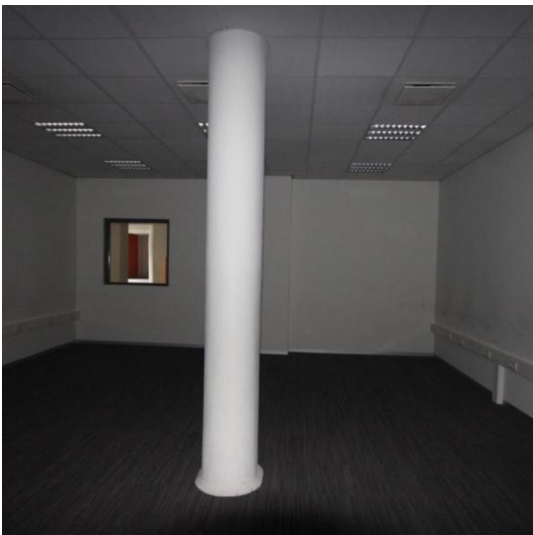
Component K 0.122 Kolom met ronde voet  
Description Ronde voet elders? typologie van kolommen

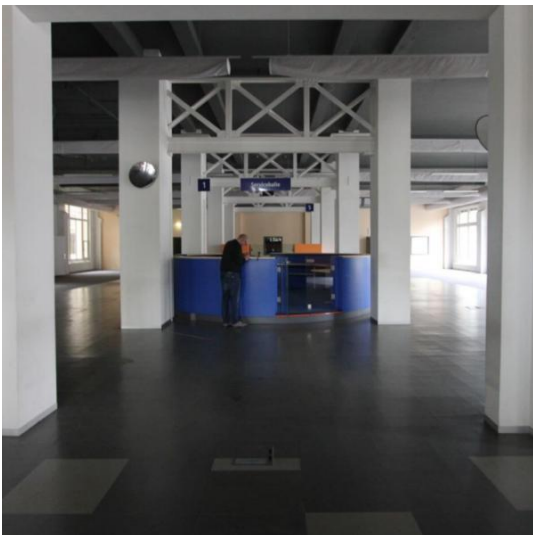
Component K 0.130 Vierkante kolommen  
Description Geheel dragend of deels holle wandjes?

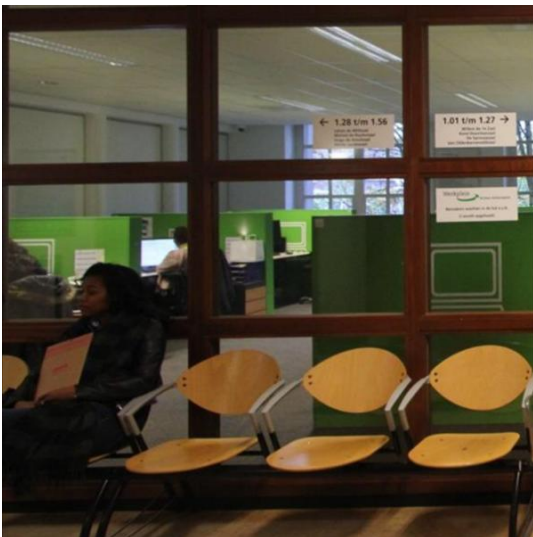
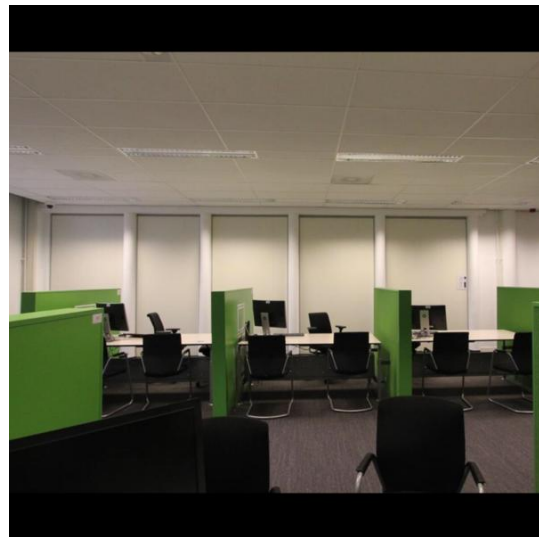
Component K 1.01 kolommen naar 1.71  
Description Stratigrafie. Kolom in het midden eerst niet op tekening. Balie. Constructieve kolommen of sierkolommen?
