Aandachtspunten voor nader onderzoek per thema

West507 – transformatie Oceaanhuis

**Kleurhistorisch onderzoek en bouwhistorische verdieping**  
Plan van Onderzoek

14 juli 2017

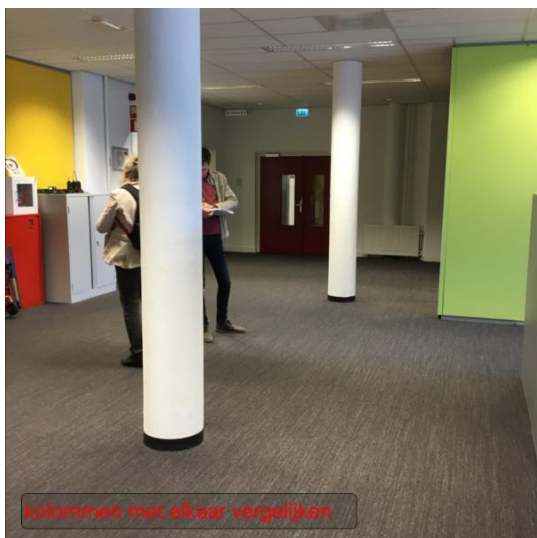
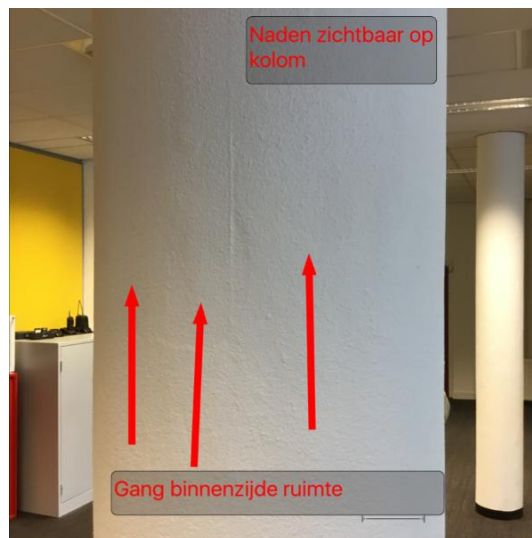
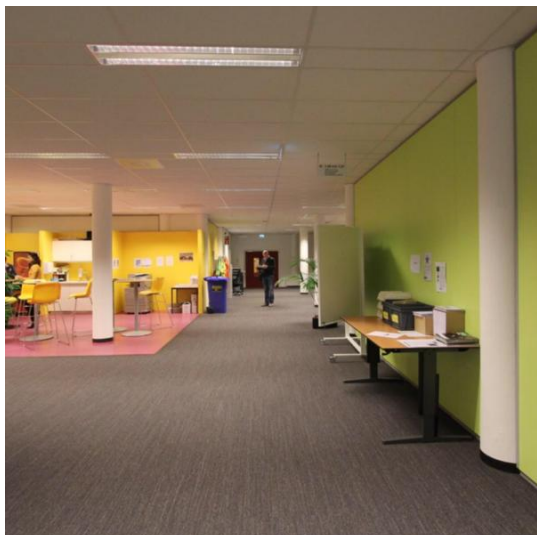
Component K 1.11 Kolommen  
Description Kolom lagenpakket overschildering. Naden zichtbaar in verlaag. Hoe was de eerste uitmonstering? kantoor versus gang

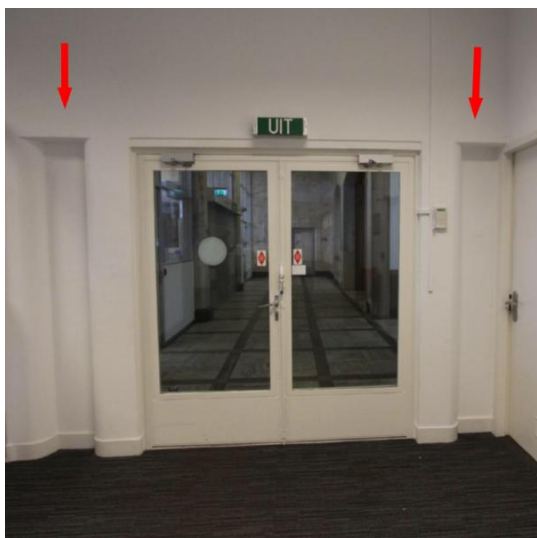
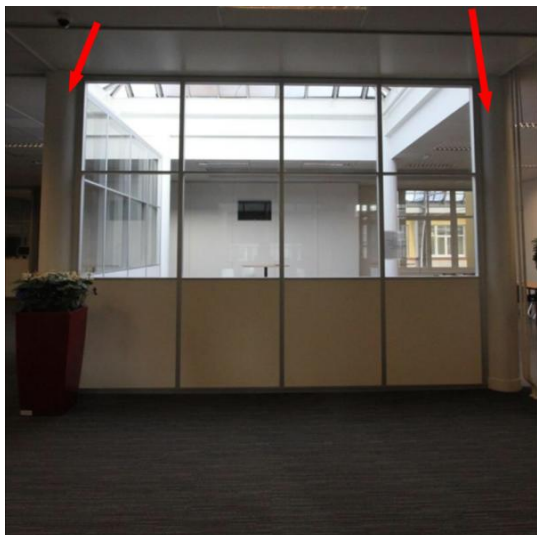
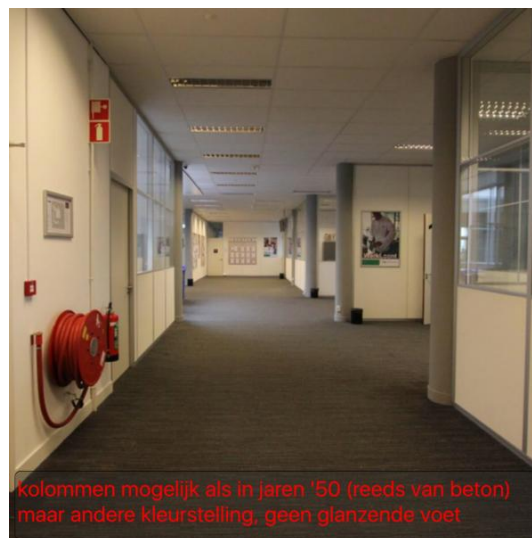
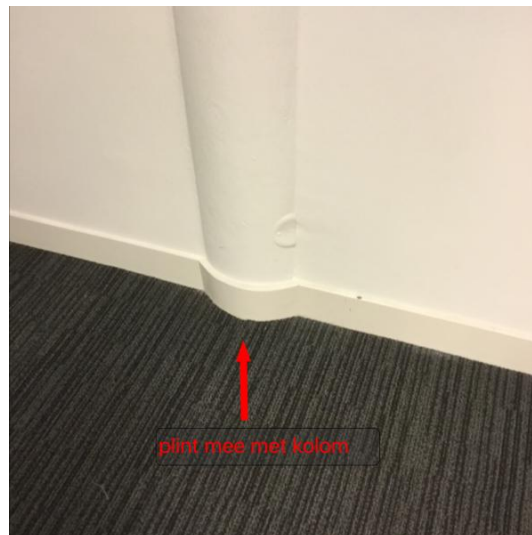
Component K 2.69 / 2.78 Kolommen gang  
Description Kleuronderzoek. Kolom in wand? Eerder vrij in de ruimte? Zie foto's steenhuismeurs '50. vorm, plint, kop. typologie

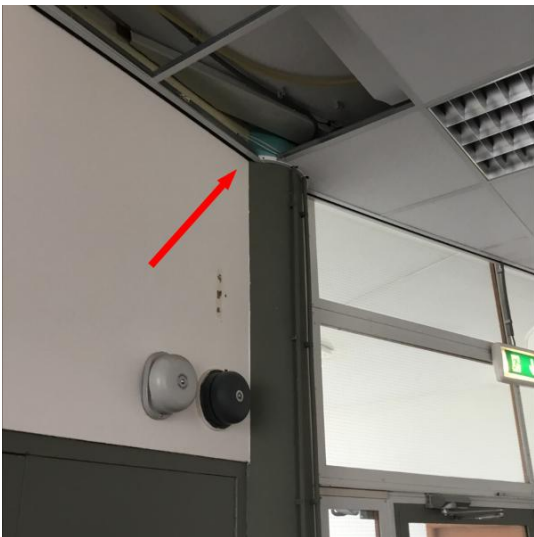
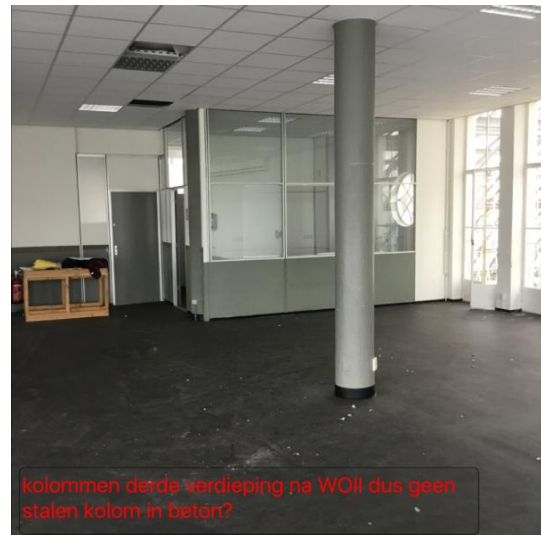
Component K 3.03 Kolommen kantine  
Description Zie ook dossier kantine.

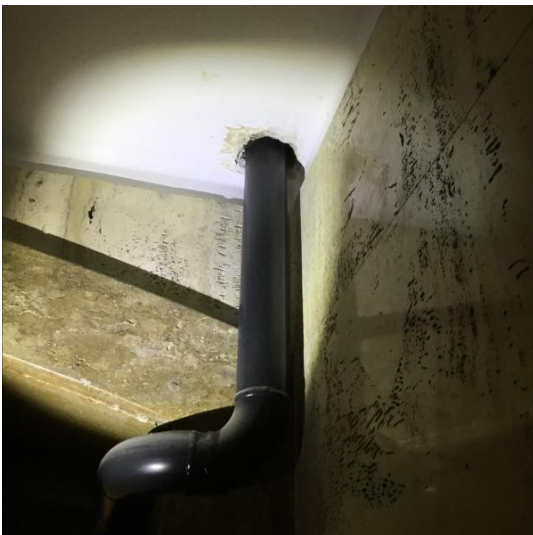
Component P 0.004 Plafond bij entreehal  
Description Entree politiedeel, kleurontwikkeling

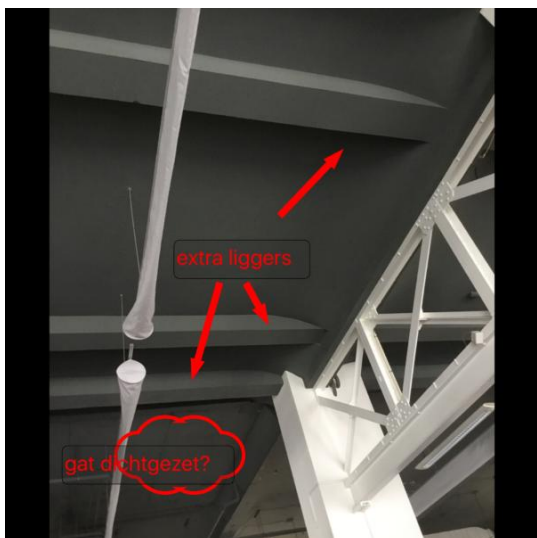
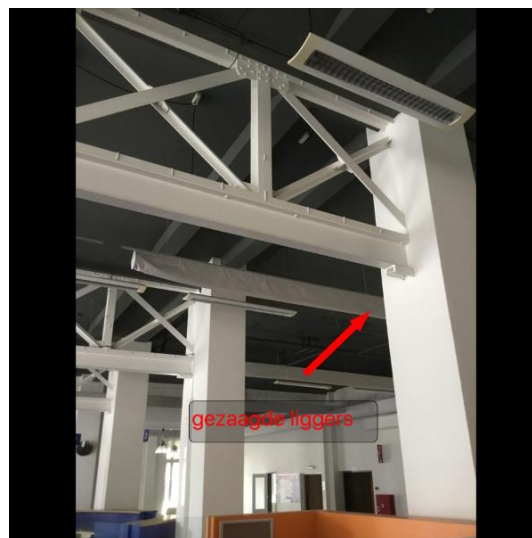
Component P 0.130 constr bij 0.36 & kolom 0.094  
Description Constructie al op tekening in 1910. Welke kleurontwikkeling heeft t gehad? Waarom toegepast? Extra liggers.

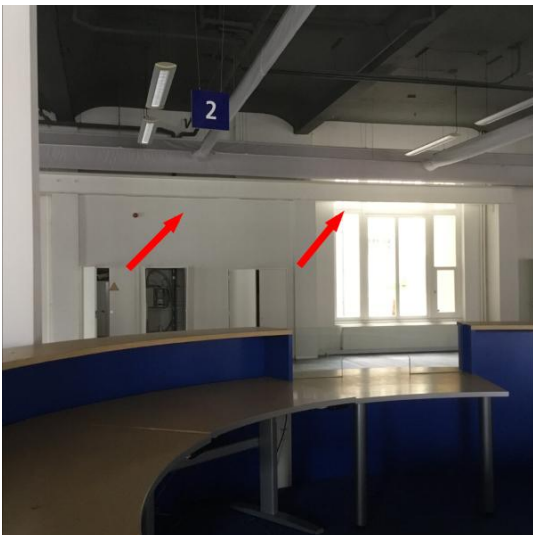
Component P 0.130 Ligger langs gevel  
Description waarom? kleurontwikkeling? verhaal ruimte.

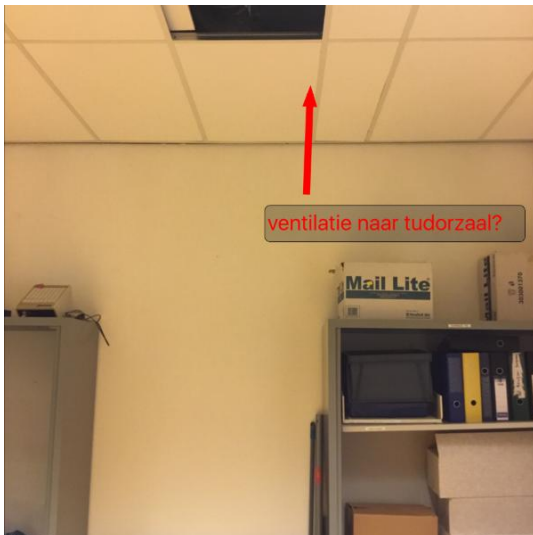
Component P 1.23 plafond buiten gotische zaal  
Description Stratigrafie plafondboog bovenaan wand

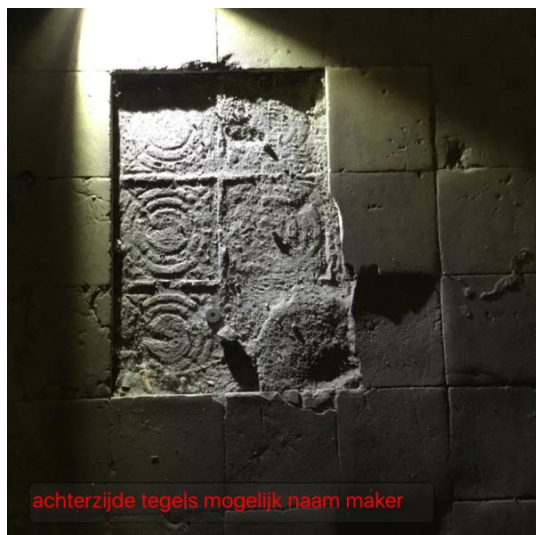
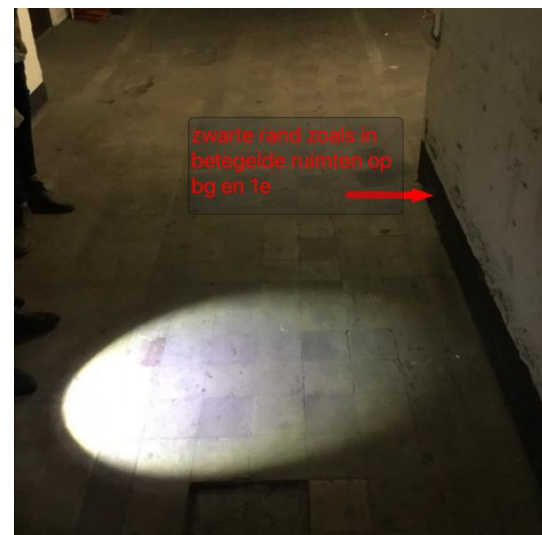
Component V -1.01 Tegels naast -1.27  
Description Rode en gele tegels uit mogelijk 51, bronnenonderzoek. Restauratieadvies.

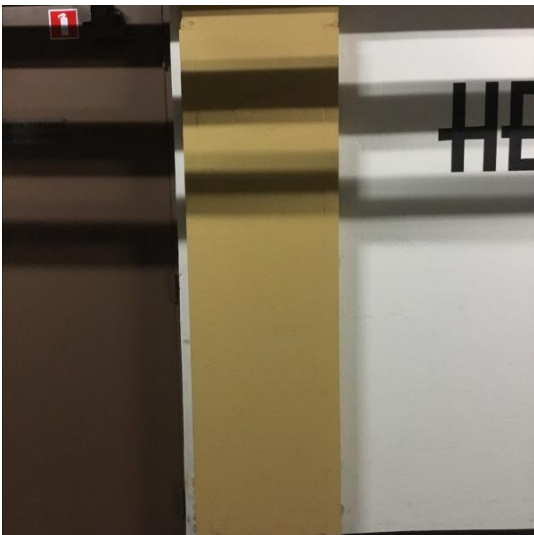
Component W -1.01 Gele kleur Oceaanhuis  
Description Monster en vergelijken met gele kleur liftkolom atrium. Dezelfde tijd?

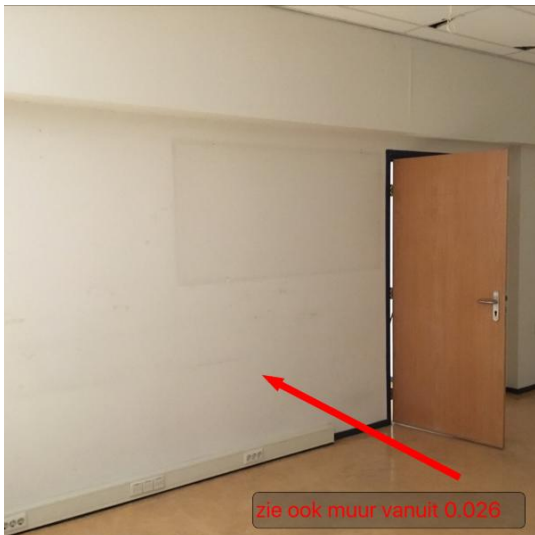
### Issue Information

Component W 0.025 Wand richting 0.026.  
Description Puncties. Oude muur met mogelijk doorgang eerder op een andere plek.

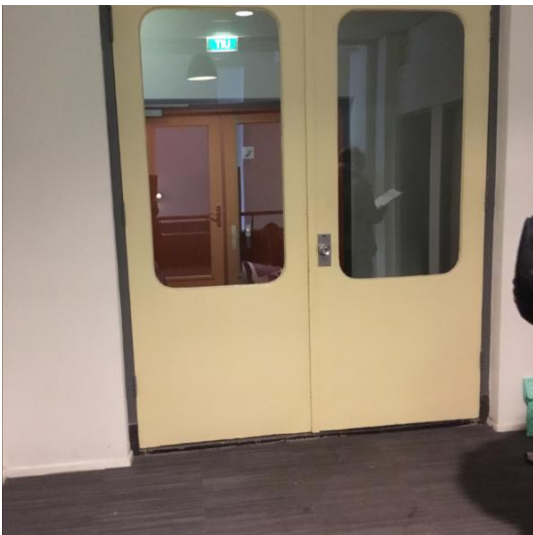
### Issue Information

Component W 0.094 Deur  
Description Gele deur nergens anders in het gebouw.  
datering

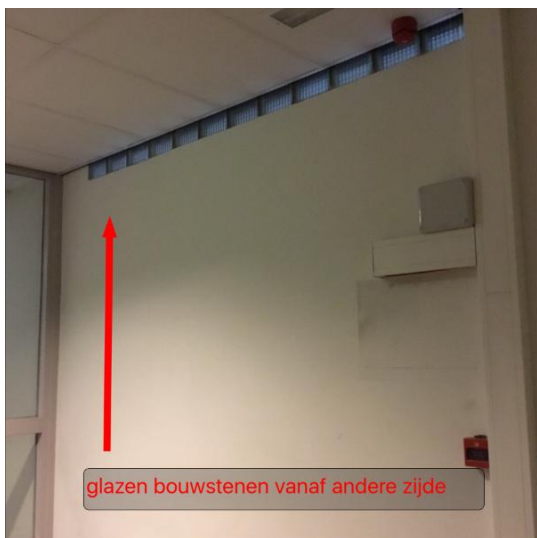
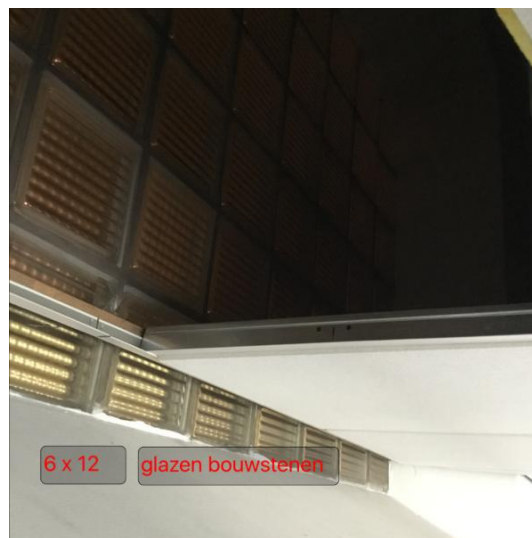
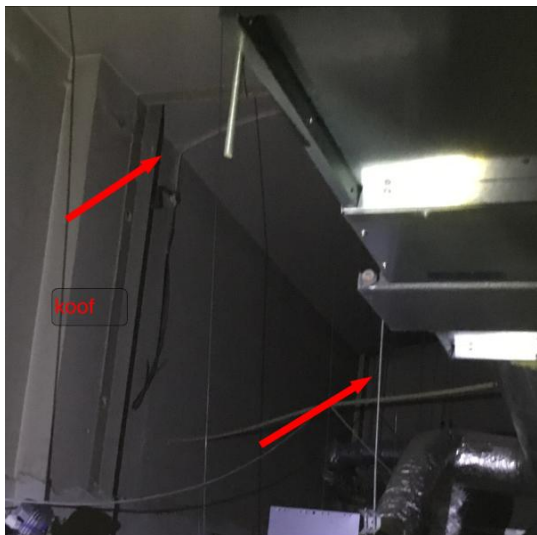
## Issue Information

Component W 0.096 Glazen bouwstenen bij 0.094  
Description Muur stond er wel voor jaren 50 maar met deuren. Mogelijk deels nog oud. GB mogelijk jaren 50. Vergelijk met idem 0.131.

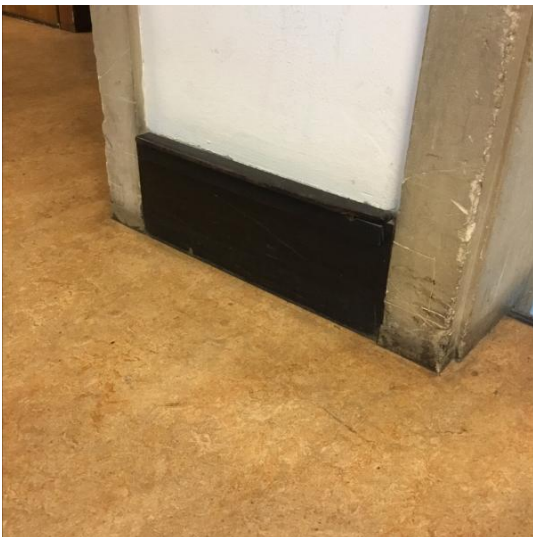
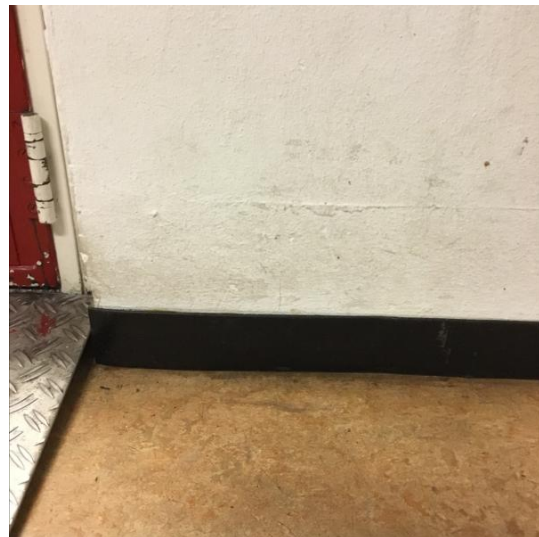
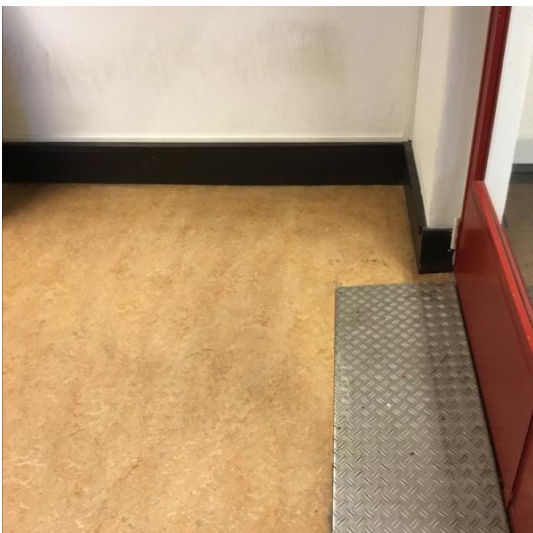
## Issue Information

Component W 1.02 plint  
Description Jaren 50 ?? dateren, restauratieadvies

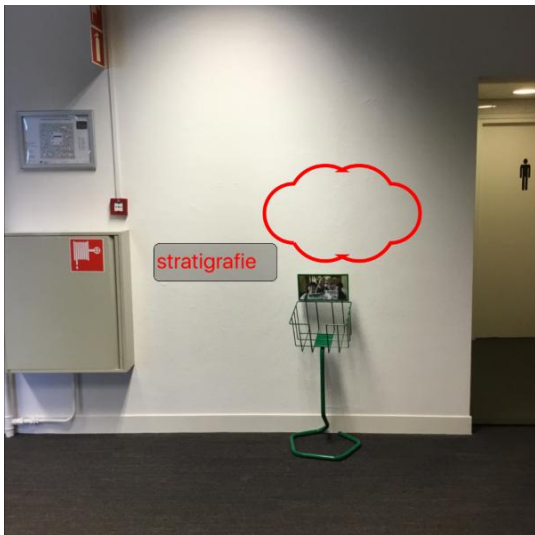
### Issue Information

Component W 1.11 Wand bij 1.05  
Description Wand stratigrafie, wand mogelijk deels dichtgezet.

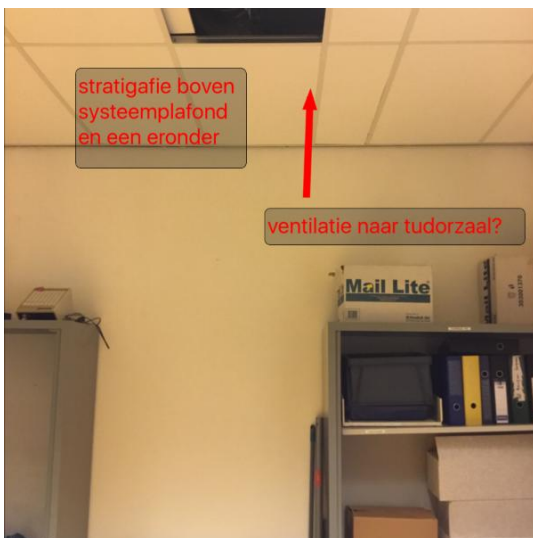
## Issue Information

Component W 1.23 Wand buiten gotische zaal  
Description Stratigrafie boven systeemplafond plafondboog

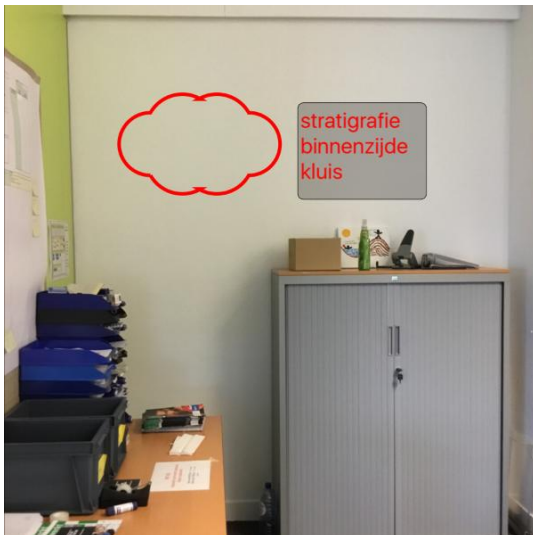
### Issue Information

Component W 1.46 Wand binnenkant kluis  
Description Binnenwand heeft misschien een andere afwerking dan andere kantoorwanden

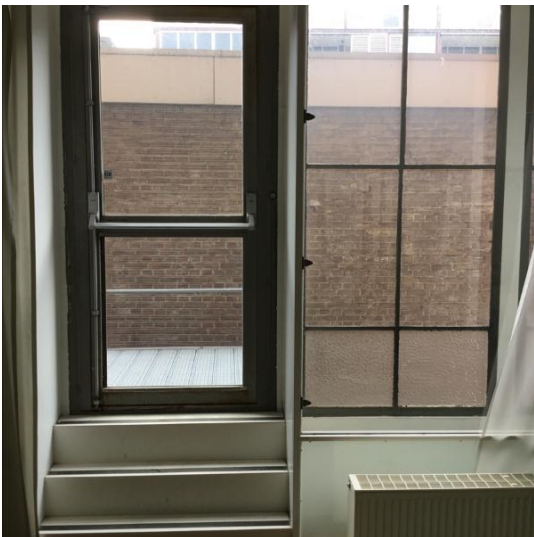
## Issue Information

Component 0.094 Deur  
Description Deur tussen 60 en 73 geplaatst. Sheds, toegang

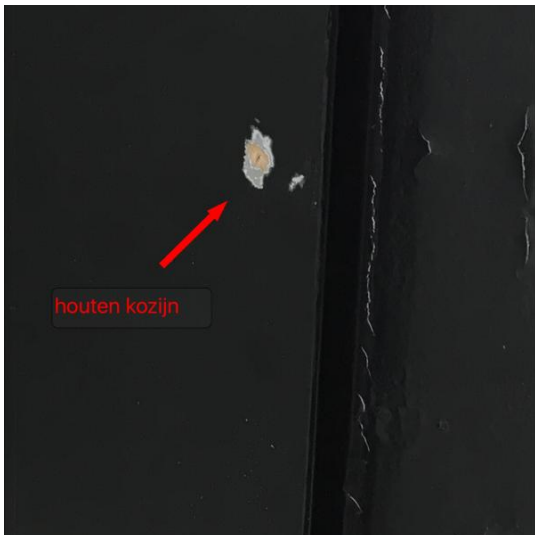
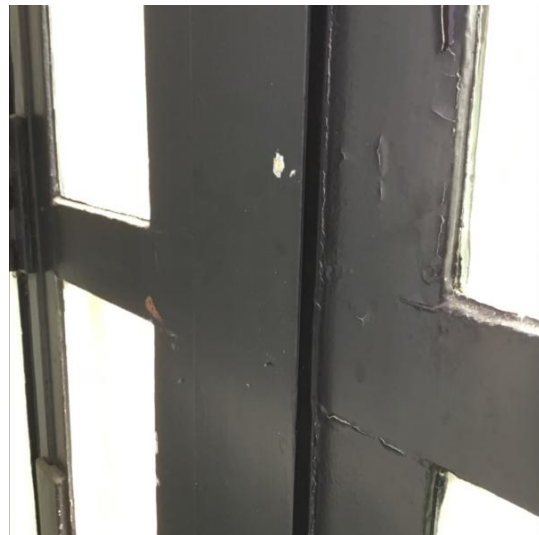
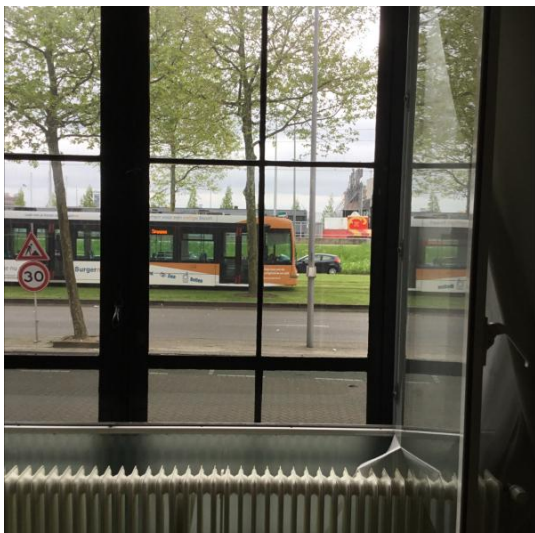
## Issue Information

Component 0.098 Houten kozijn  
Description Wanneer is dit kozijn erin gezet? Anders dan alle andere kozijnen. Kleuronderzoek voor datering.

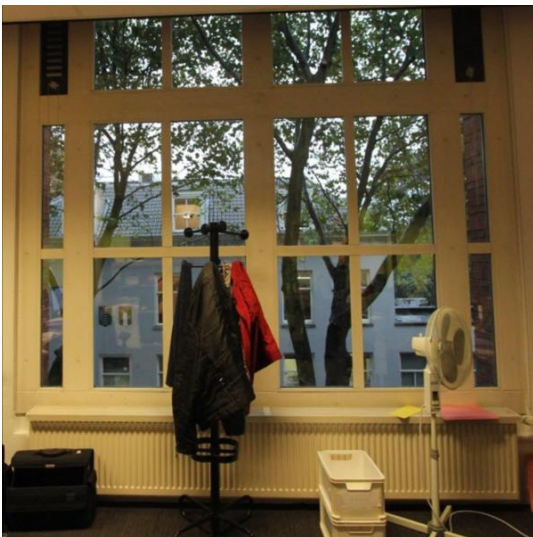
### Issue Information

Component 1.11 Kleuronderzoek binnenkant ramen  
Description

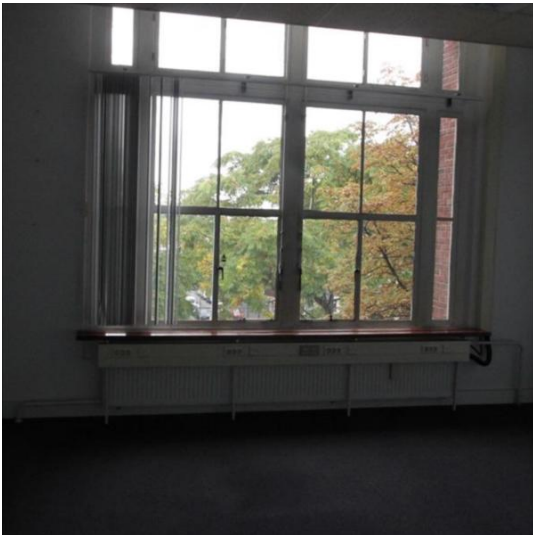
### Issue Information

Component 2.17 Ramen  
Description Kleuronderzoek binnenkant ramen

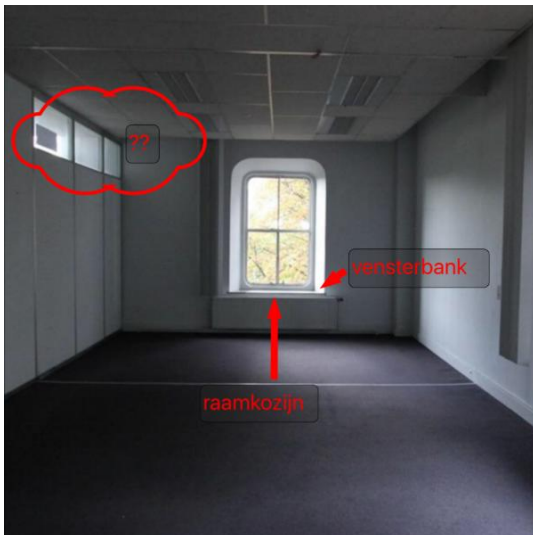
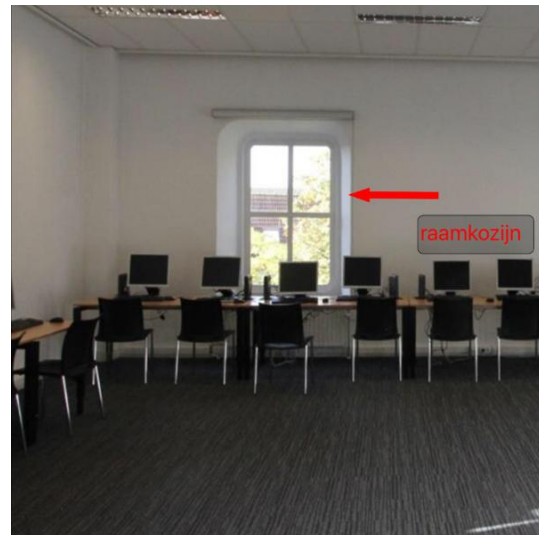
## Issue Information

Component 2.84 en 2.19 Raam  
Description Bijzondere ramen gevel 2e verdieping.

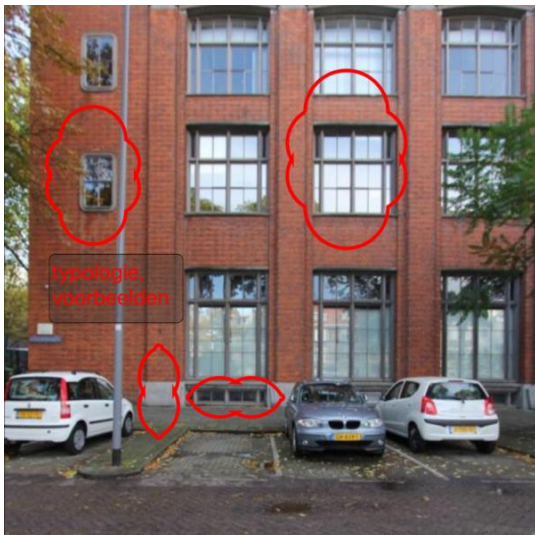
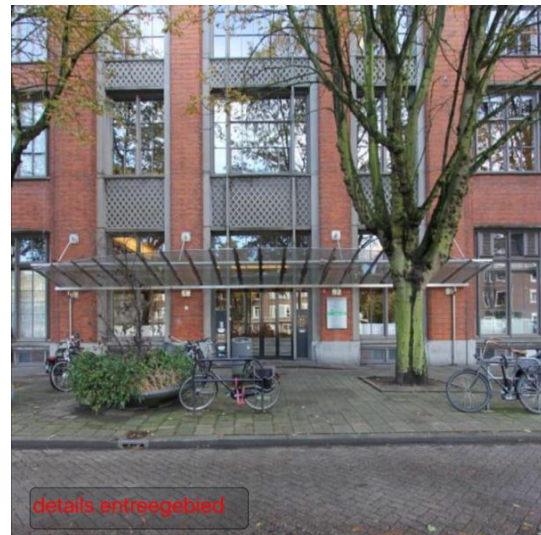
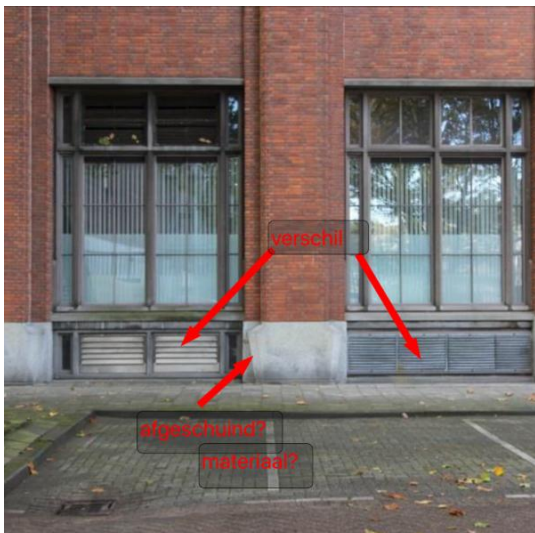
## Issue Information

Component Heiman Dullaertplein  
Description Details entreegebied, kleuronderzoek ramen en onderzoek detaillering gevel.

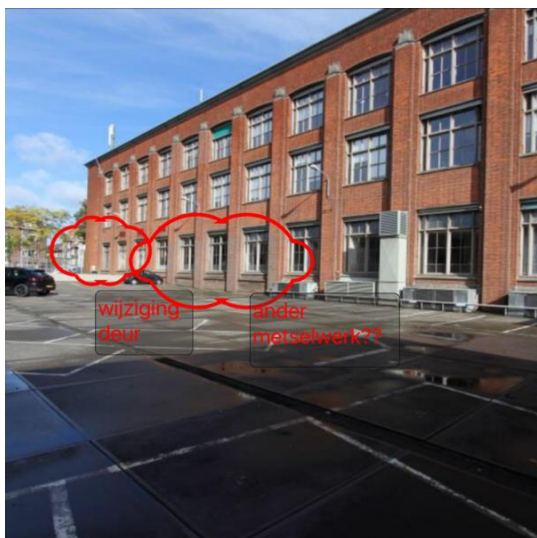
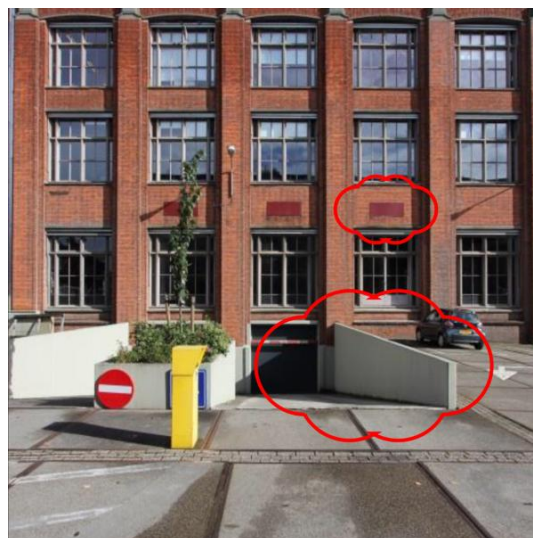
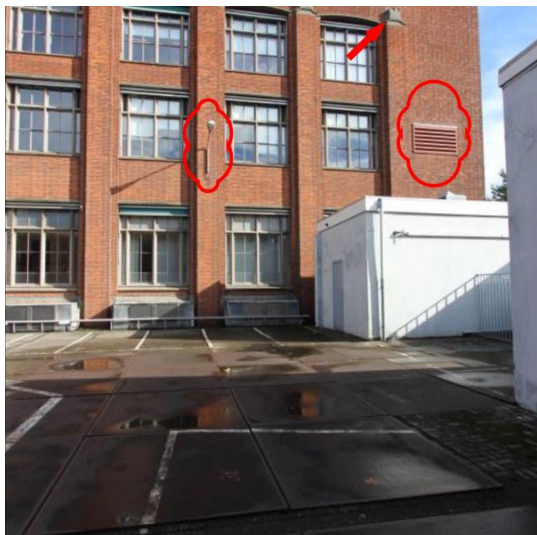
## Issue Information

Component Westwand  
Description Ontwikkeling ramen en details in wanden

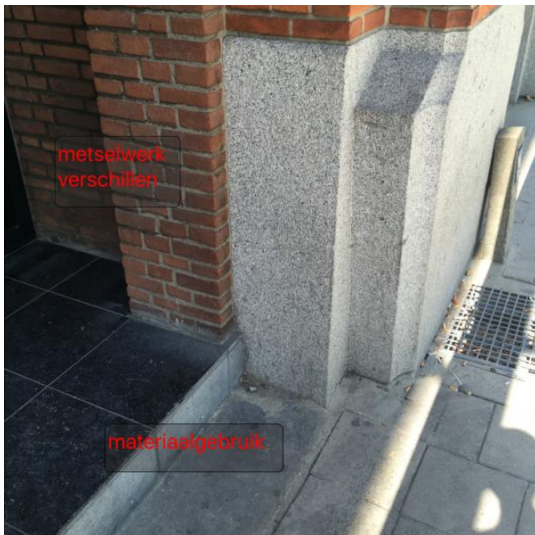
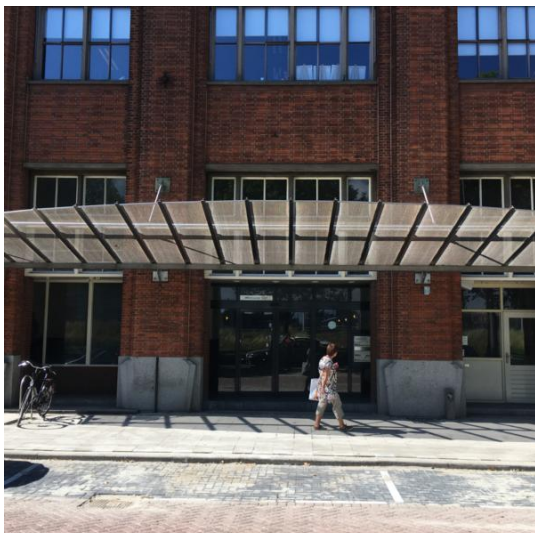
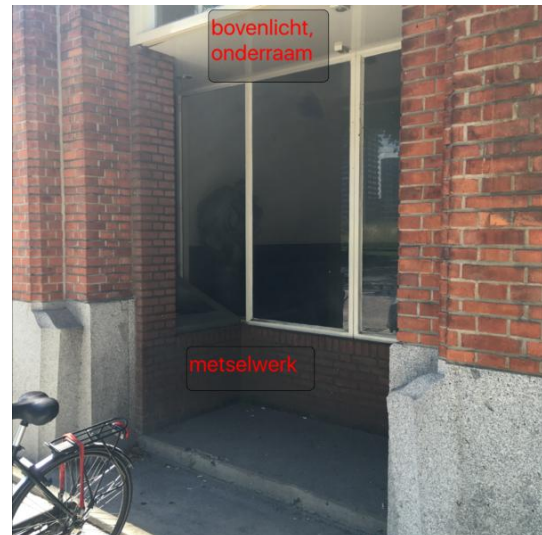
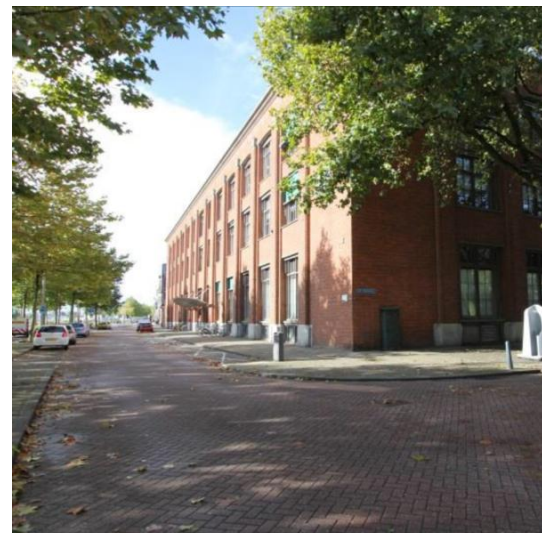
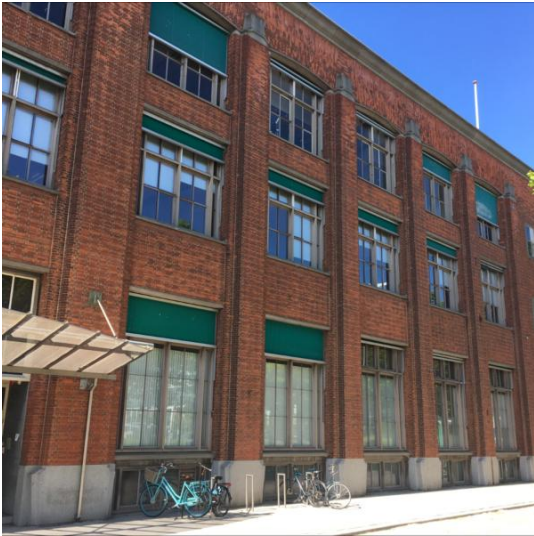
## Issue Information

Component Westzeedijk  
Description Entreegebied en ramen, ontwikkeling, kleuronderzoek. Zie ook dossier entreegebieden.

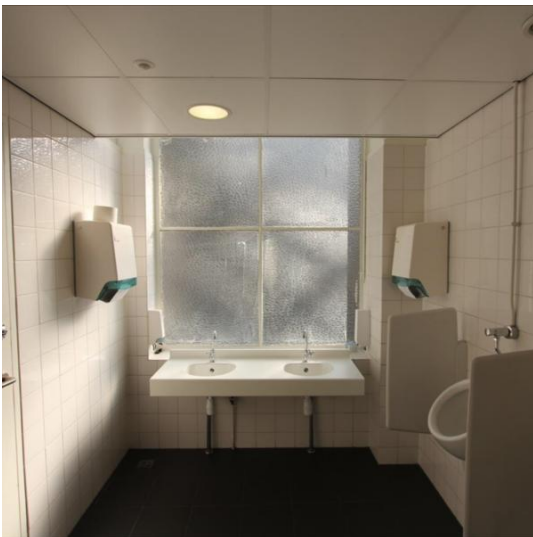
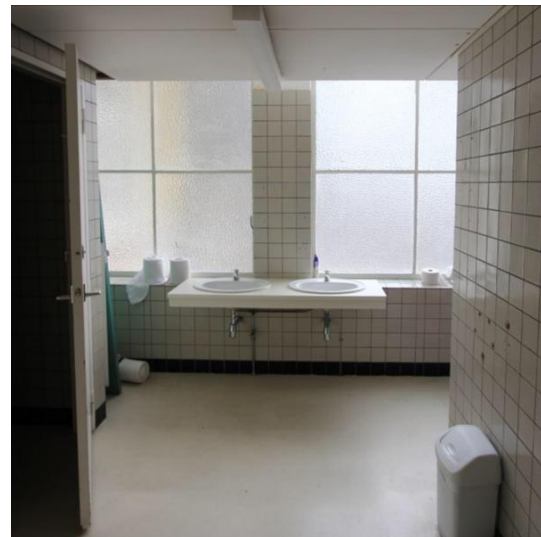
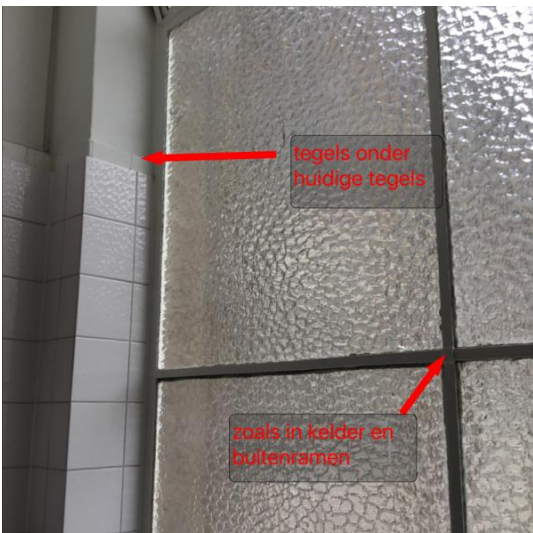
## Issue Information

Component 1.05 Toiletruimte  
Description Stratigrafie? Ramen checken, en scharnieren  
Zie ook buitengevel. Deurkozijnen eerder?  
Tegels onder tegellaag

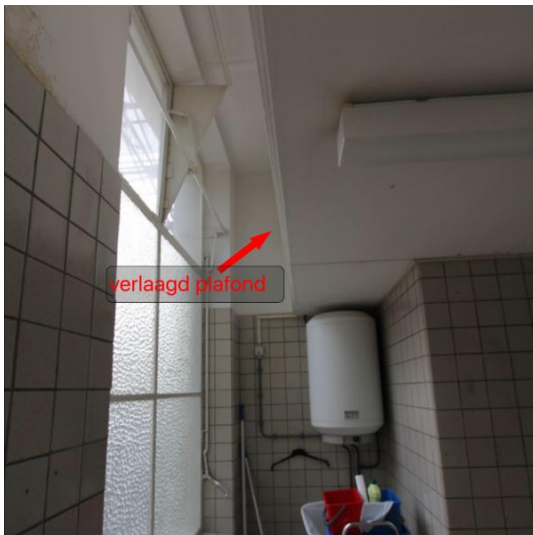
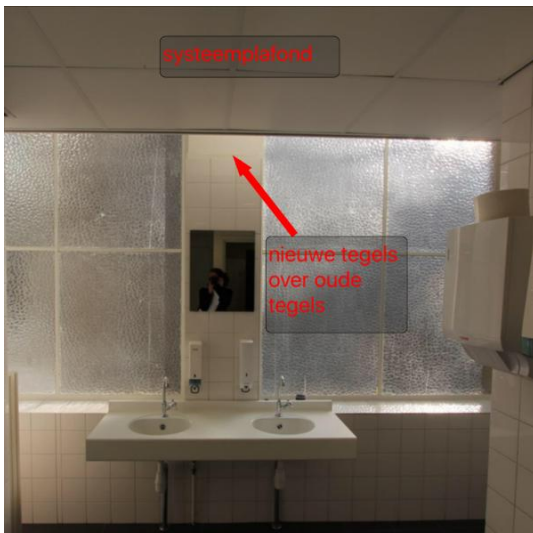
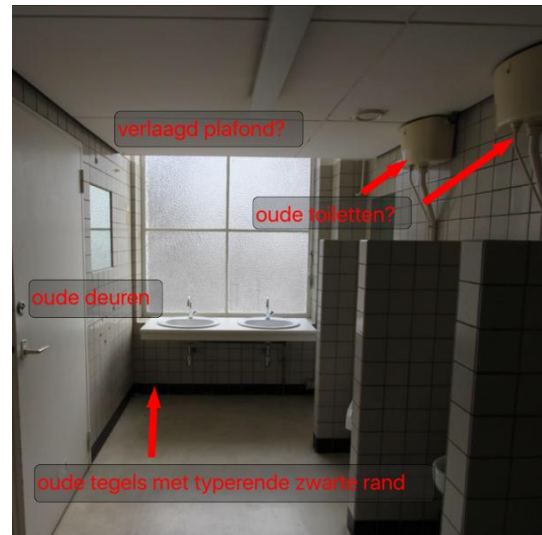
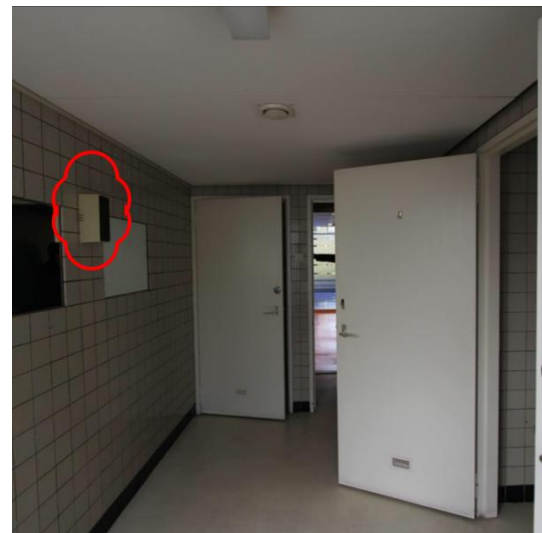
Component 2.05 Toiletruimte  
Description oude situatie toiletten.

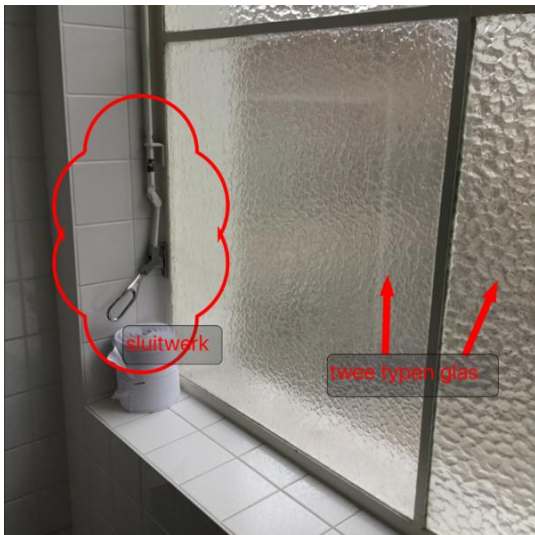
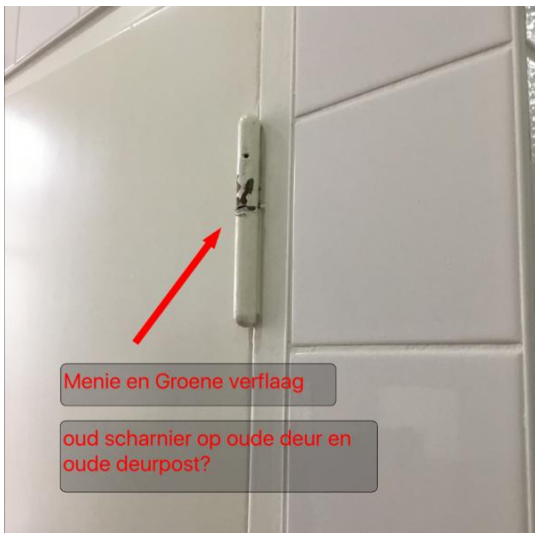
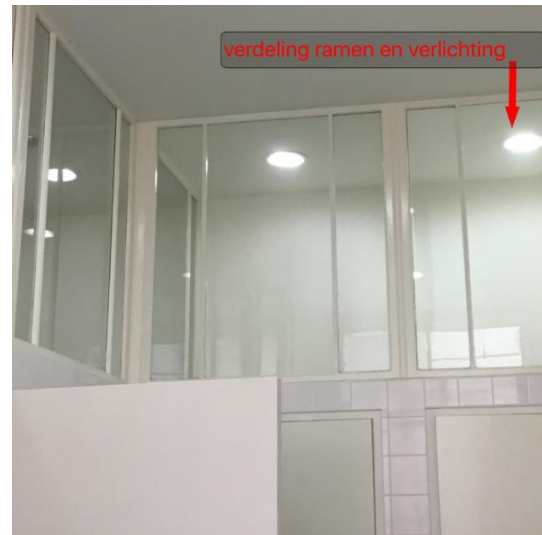
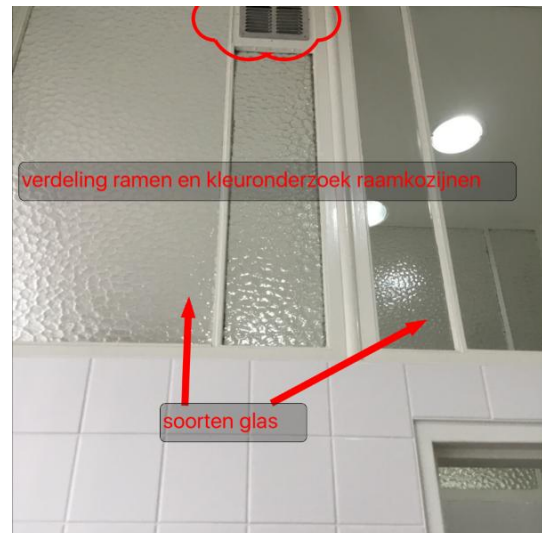
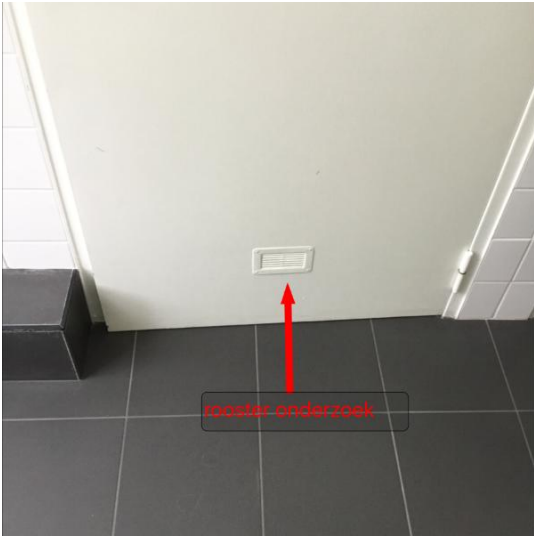
Component 2.92 Toiletruimte  
Description Verdeling raamkozijnen, puncties op kozijnen, deuren en roosters, sluitwerk, scharnieren en tegels. Restauratieadvies.

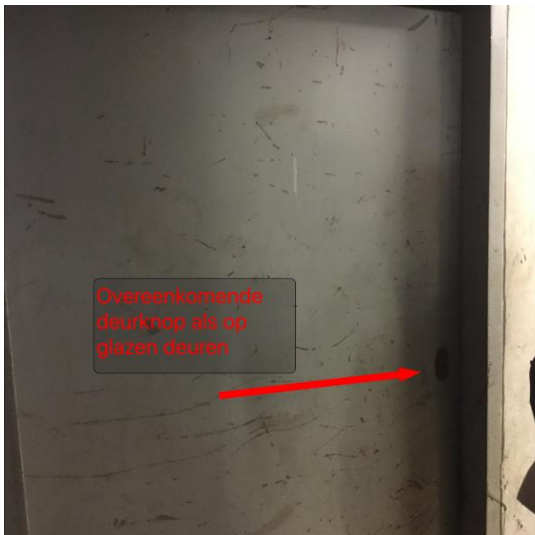
Component -1.06 Ketelhuis kelder, deuren  
Description Stratigrafie vergelijken met twee andere deuren.

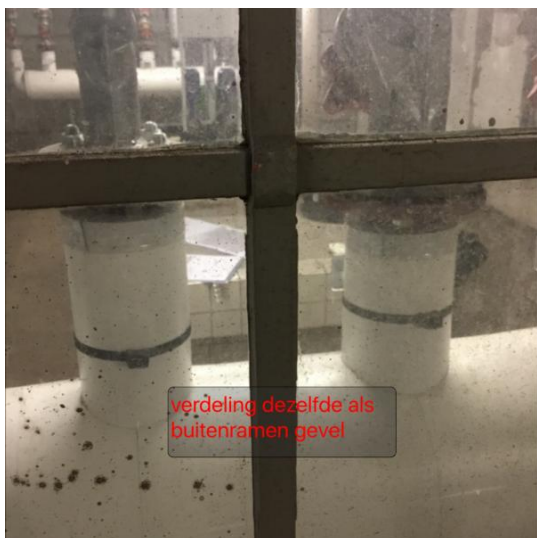
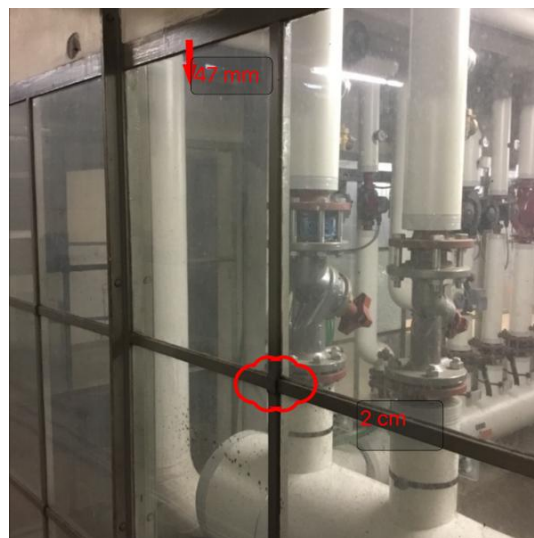
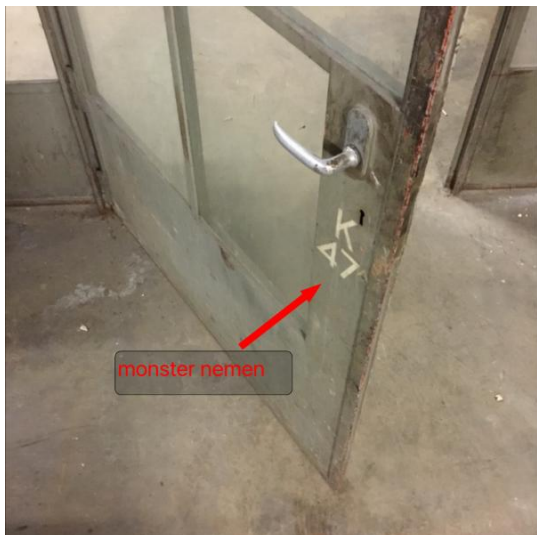
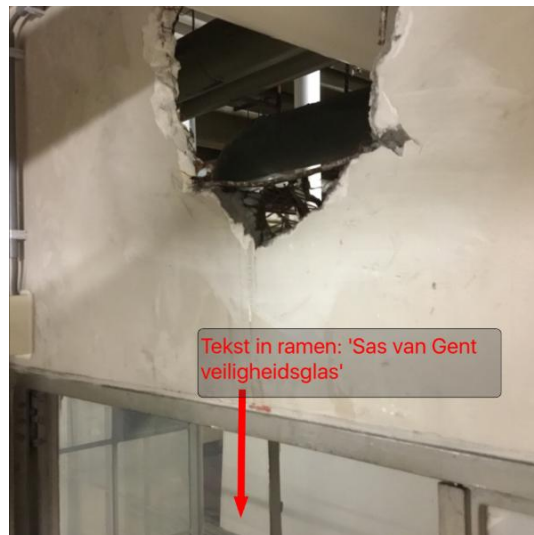
Component -1.06 Ketelhuis kelder, glazen wanden  
Description Glazen wanden puncties nemen, wanneer geplaatst? K47 punctie.

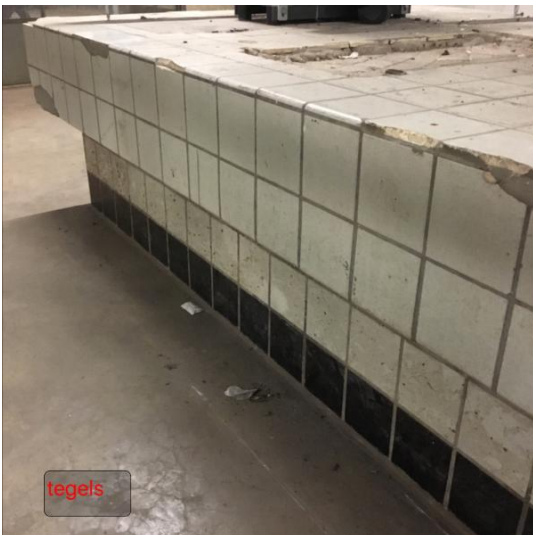
Component -1.06 Ketelhuis kelder, tegels podium  
Description Tegels bronnenonderzoek en vergelijk andere ruimten.

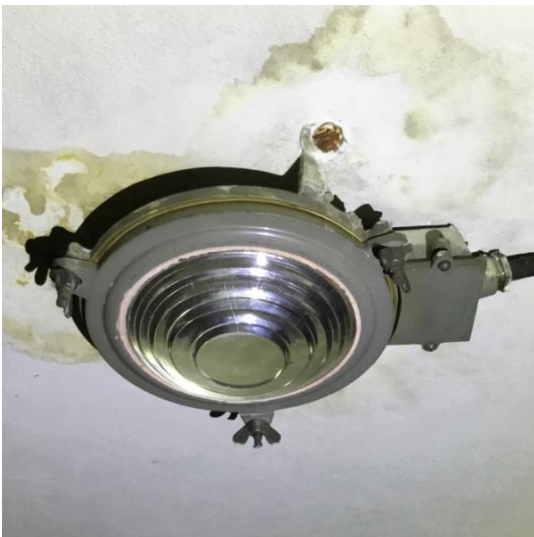
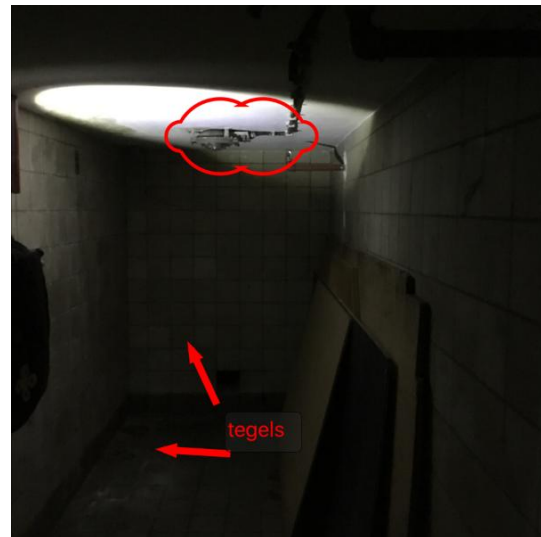
Component -1.08 Ruimte naast sprinkler  
Description Tegels en lamp bronnenonderzoek

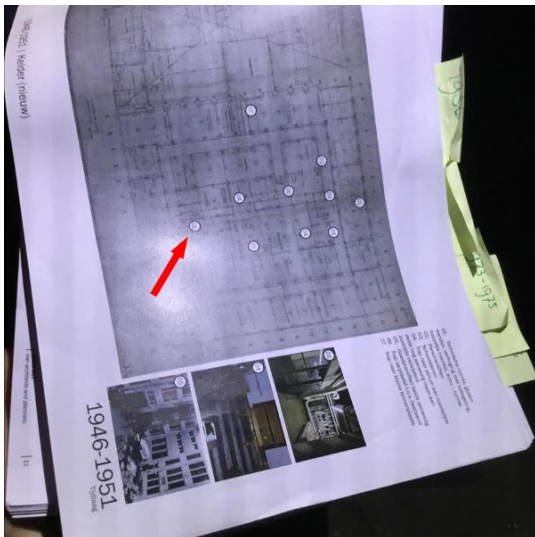
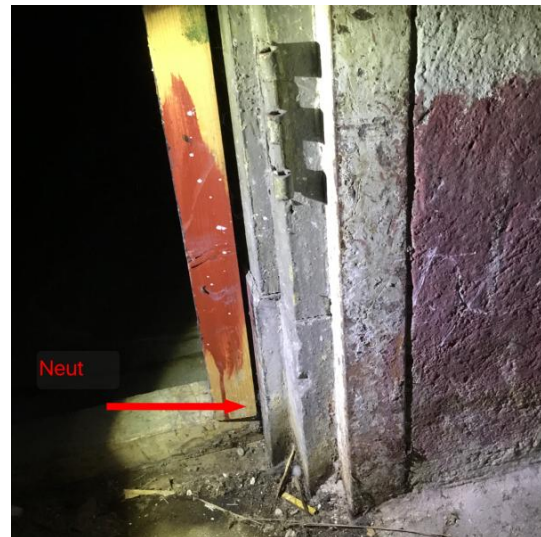
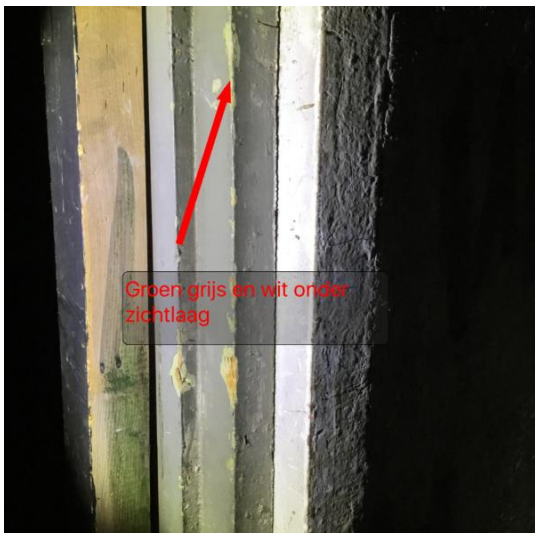
Component -1.13 Technische ruimte  
Description Kan helpen bij dateringen vd rest kelder.

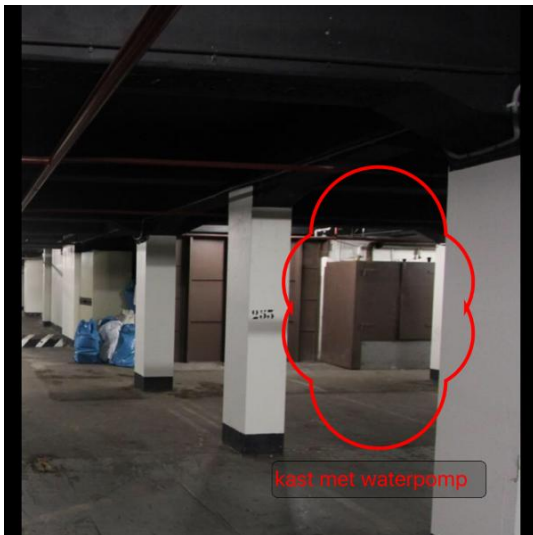
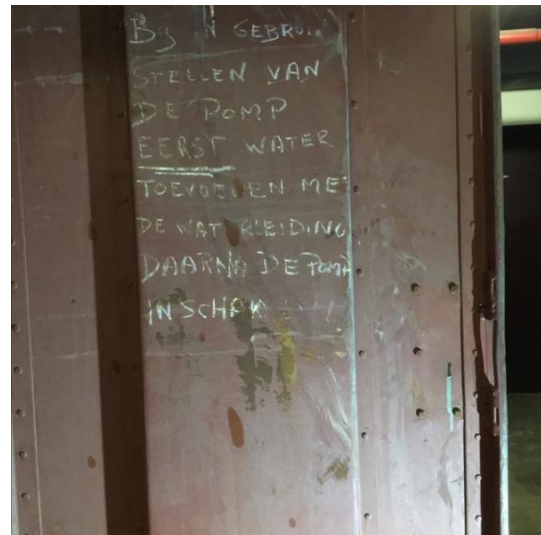
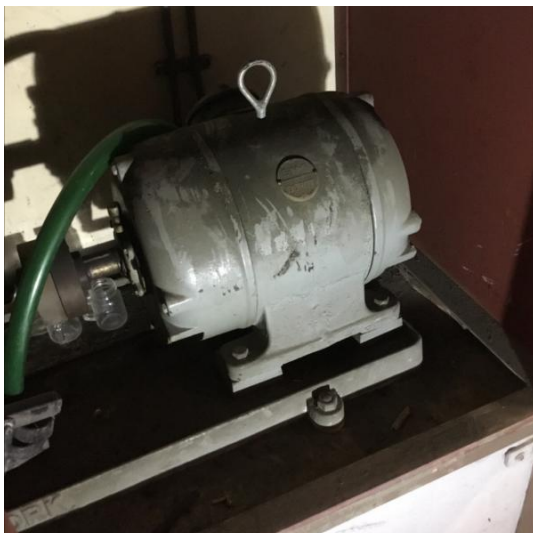
Component -1.25 Waterpomp naast goederenlift  
Description Pomp, kastombouw

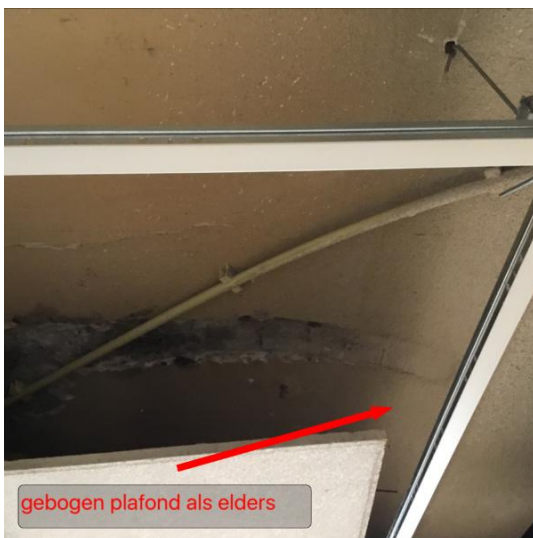
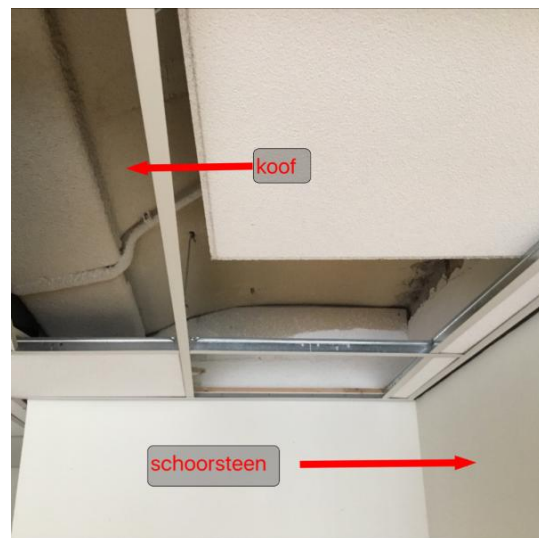
Component 0.026 Schoorsteen  
Description Schoorsteen: metselwerk lang in het zicht geweest?
