Aandachtspunten voor nader onderzoek per thema

West507 – transformatie Oceaanhuis

**Kleurhistorisch onderzoek en bouwhistorische verdieping**  
Plan van Onderzoek

14 juli 2017

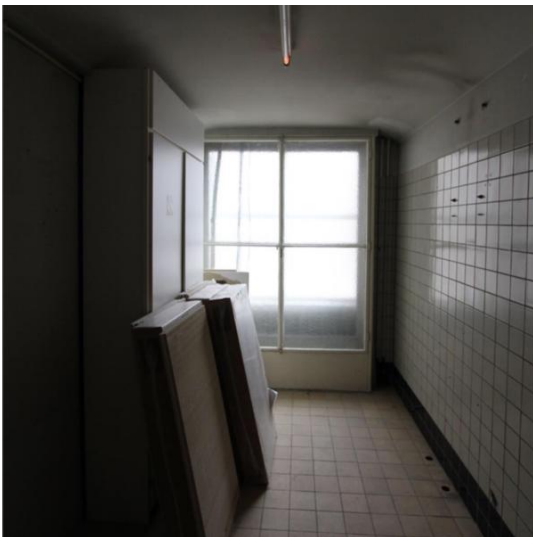
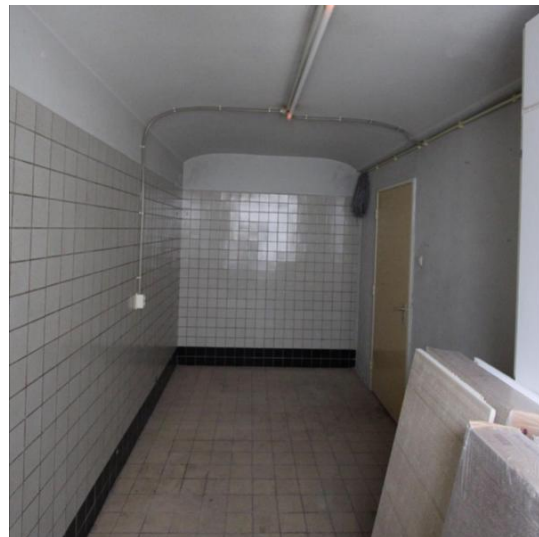
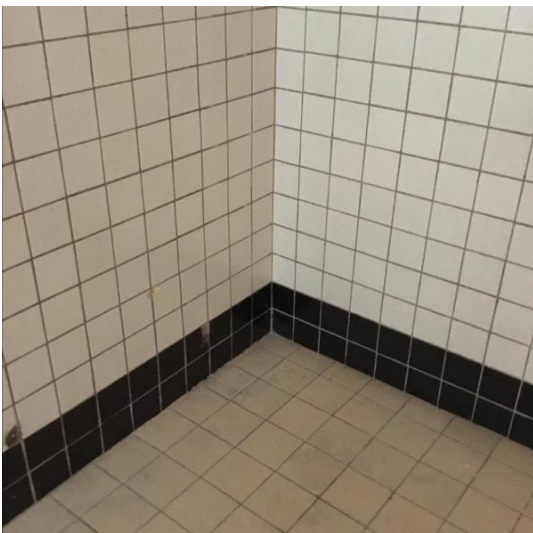
Component 0.027 Technische ruimte  
Description Tegels als in ketelruimte -1.06. Zwarte rand ook in toiletten maar dan enkele tegel.

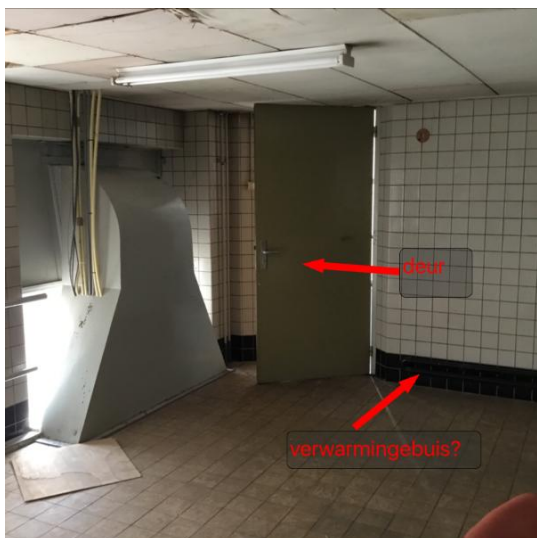
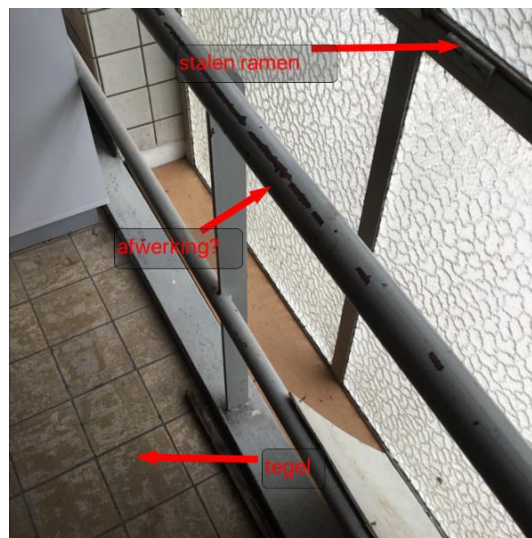
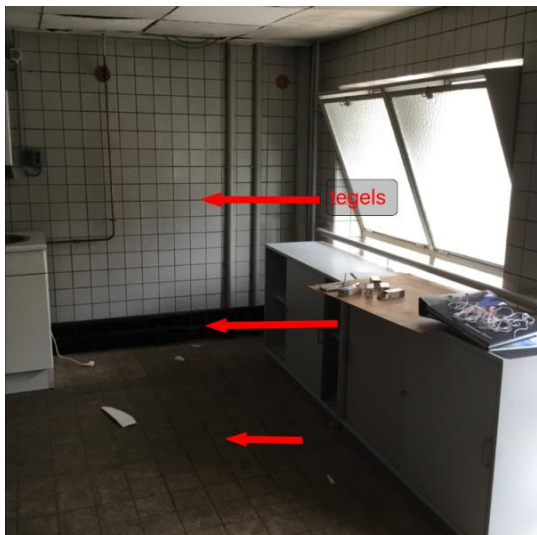
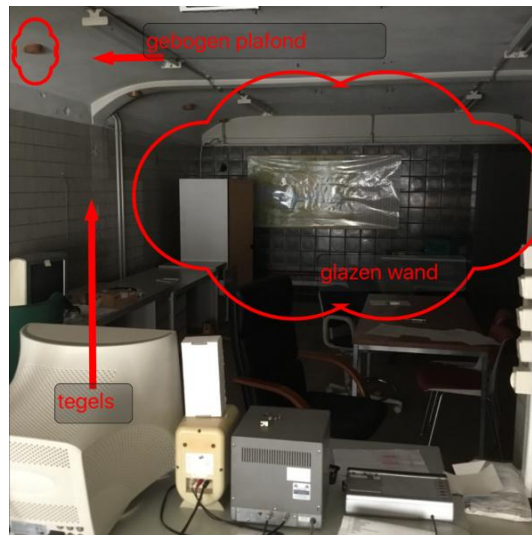
Component 0.131 Entresol conciierge ruimte  
Description Tegels vergelijken met 0.027. Glazen wand ook elders in het gebouw.

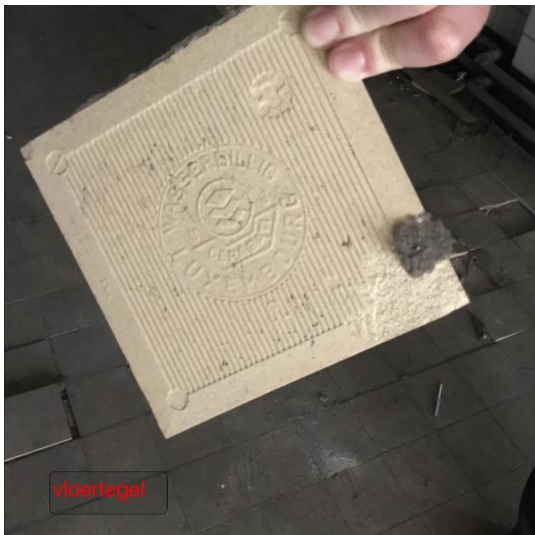
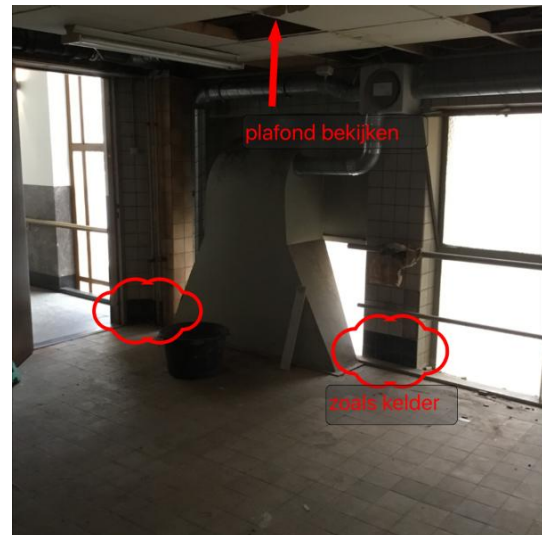
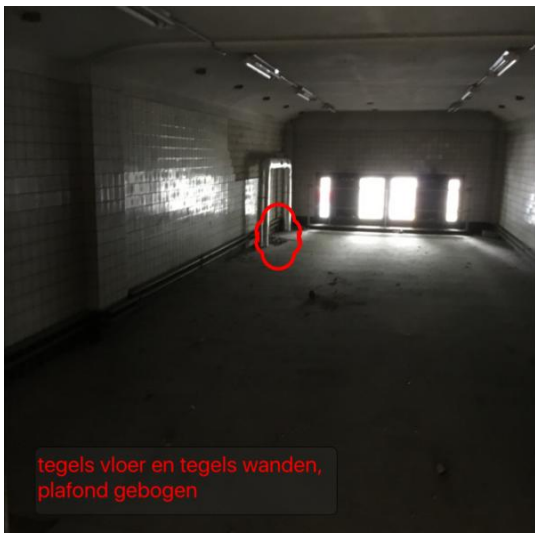
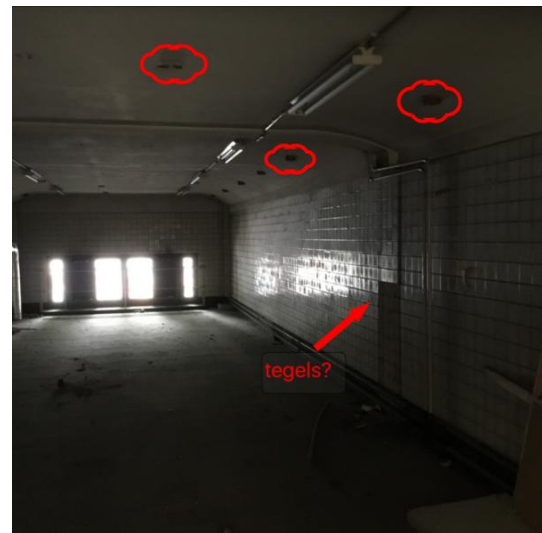
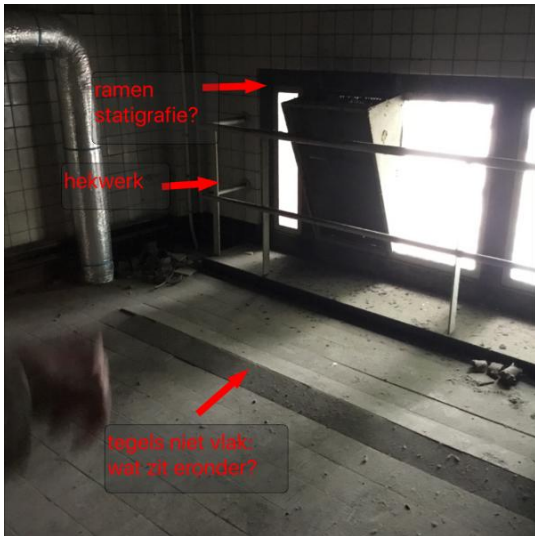
Component 0.137 Entresol open ruimte  
Description Functie van de ruimte? Vergelijk tegels andere ruimten.

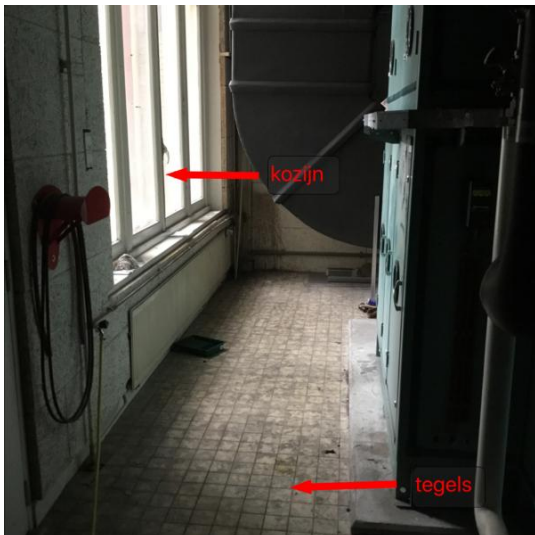
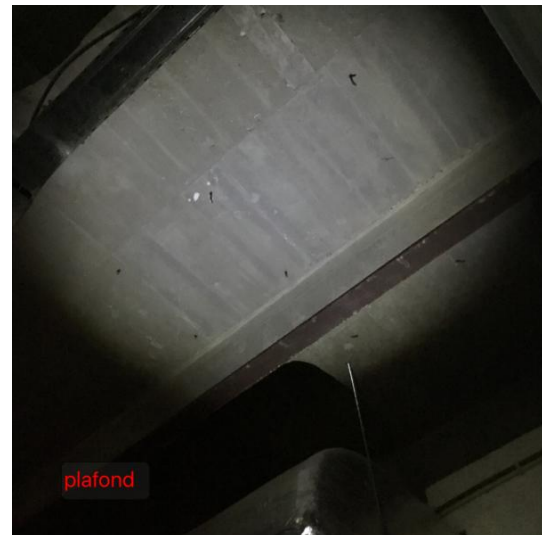
Component 1.69 Technische ruimte  
Description Plafond deels nooit afgewerkt geweest.  
Kleuronderzoek ramen. Tegels zijn anders dan elders.

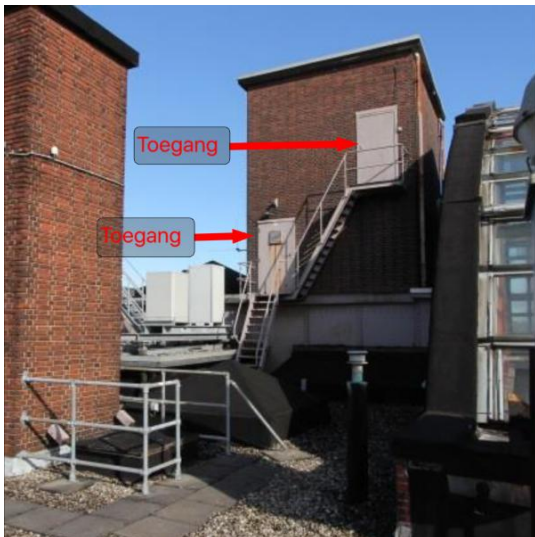
ID number 7.15  
Location  
Priority  None  
Date Time 2017-07-11 11:56:58  
Decision

Component 3.01 Lifthuis  
Description Twee deuren geven mogelijk de toegang tot twee ruimtes boven de lift HD

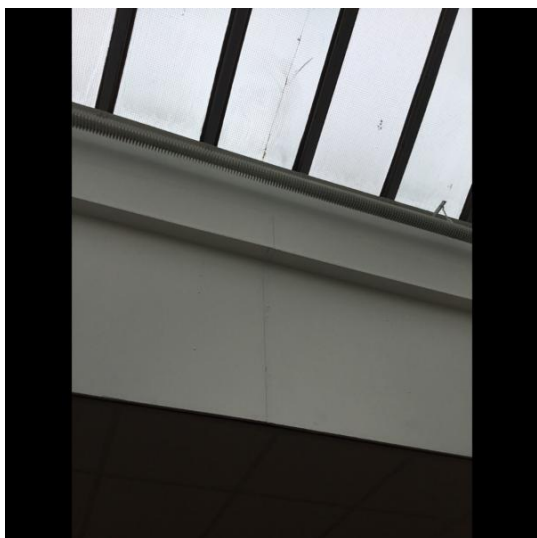
ID number 17.1  
Location  
Priority  None  
Date Time 2017-07-02 16:07:02  
Decision

Component 2.69 Lichthof binnenzijde muurdelen  
Description Lichthof onderzijde muurdelen kleuronderzoek

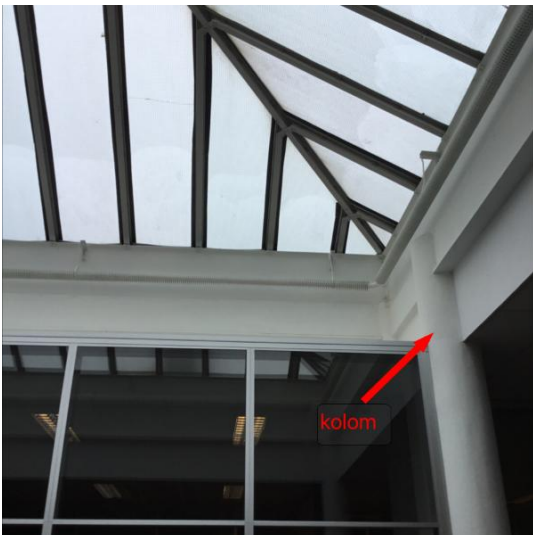
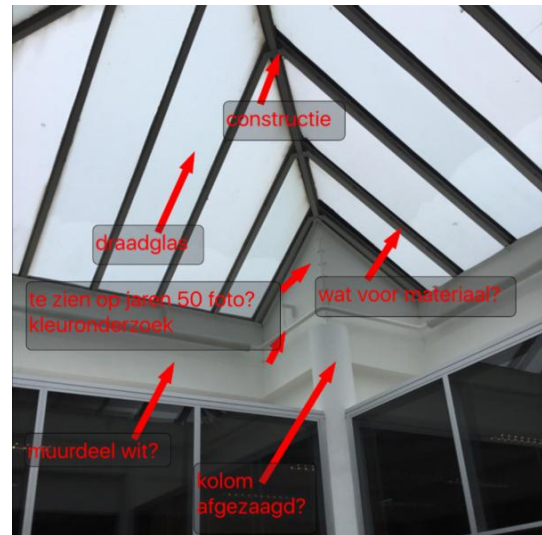
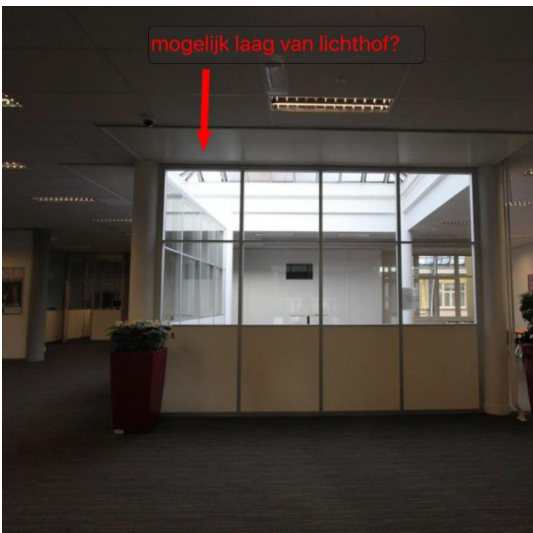
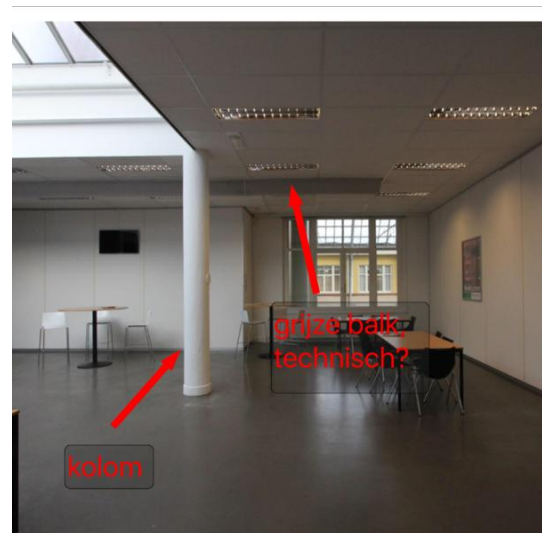
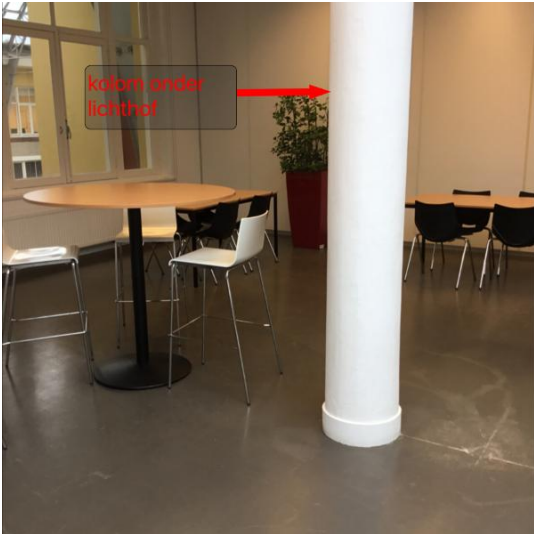
ID number 17.2  
Location  
Priority  None  
Date Time 2017-07-04 14:27:05  
Decision

Component Lichthof binnenzijde  
Description Lichthoven met elkaar vergelijken basis van oud fotomateriaal de ontwikkeling van materialiteit

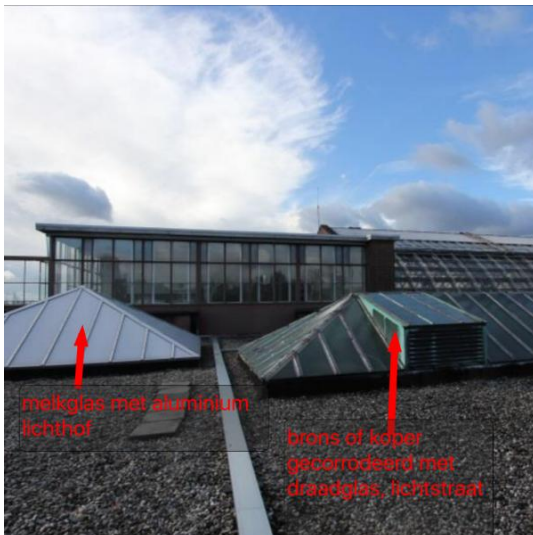
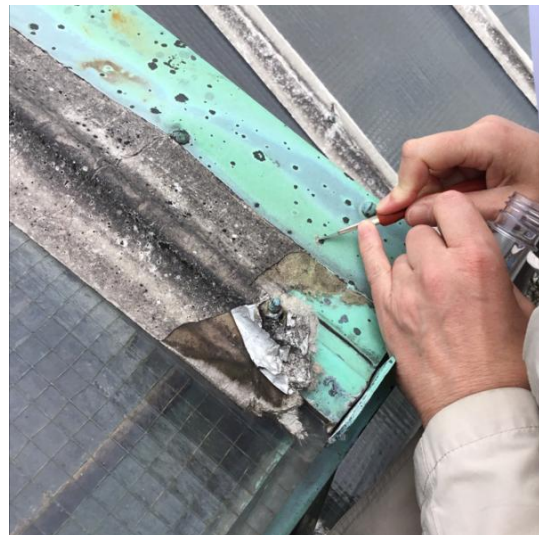
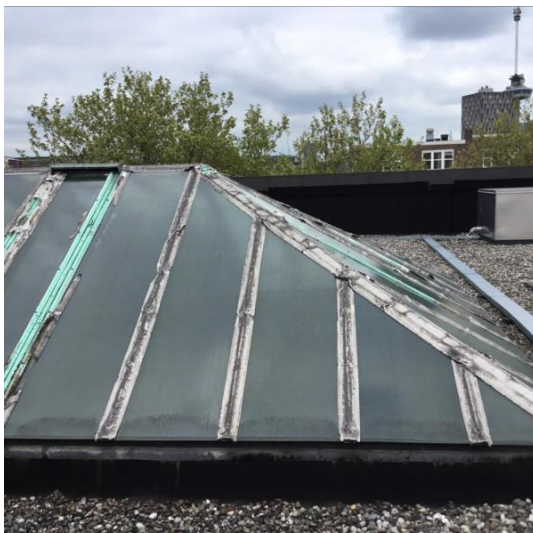
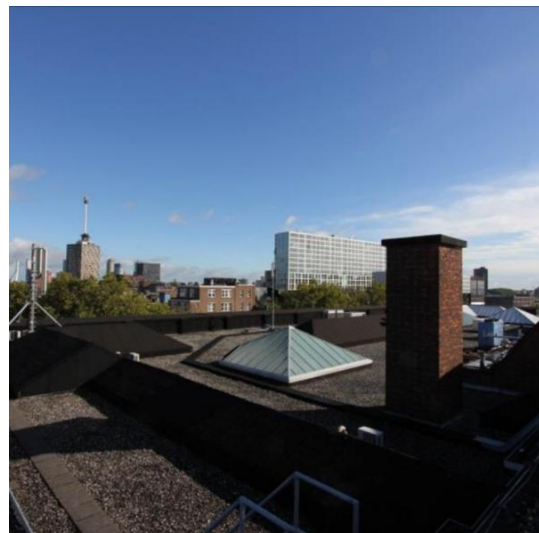
ID number 17.3  
Location  
Priority  None  
Date Time 2017-07-04 14:34:44  
Decision

Component Lichthof buitenzijde  
Description In kaart brengen welke lichthoven nog origineel zijn? Welke in aluminium met melkglas zijn uitgevoerd en wanneer?

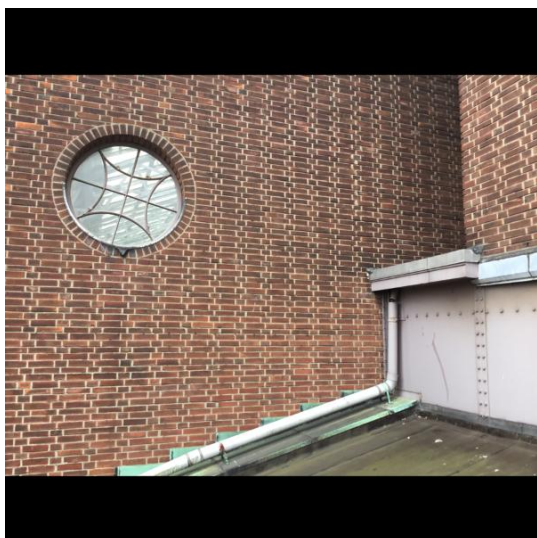
ID number 18.6  
Location  
Priority  None  
Date Time 2017-07-11 15:48:52  
Decision

Component 3.01 Dak  
Description Raampje bij kap atrium

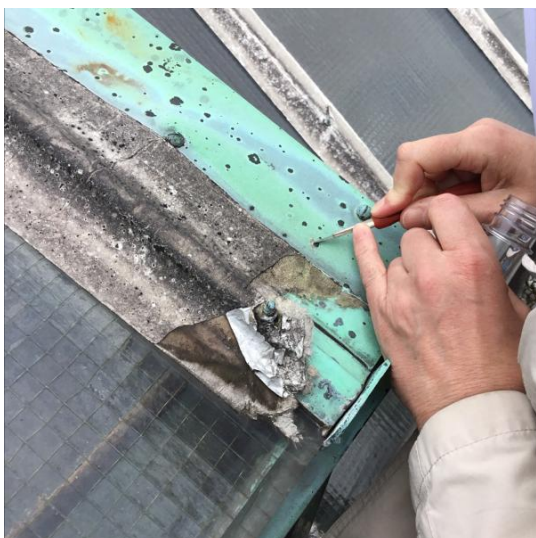
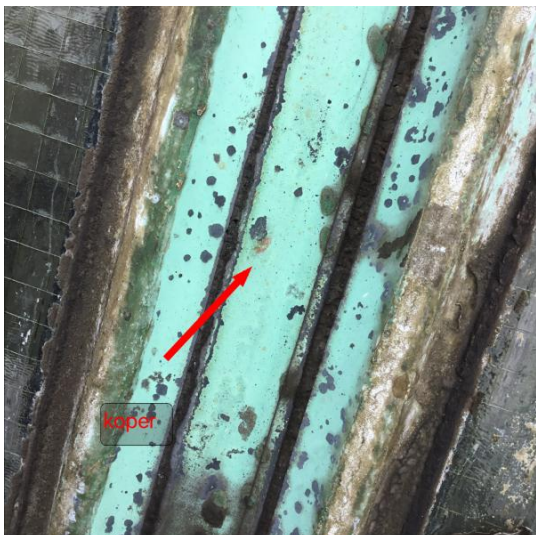
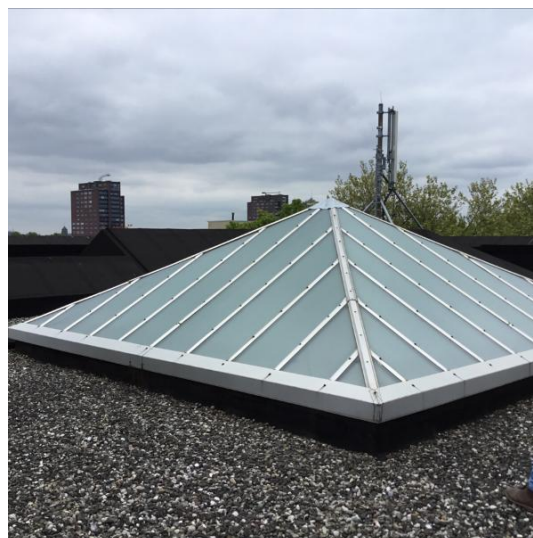
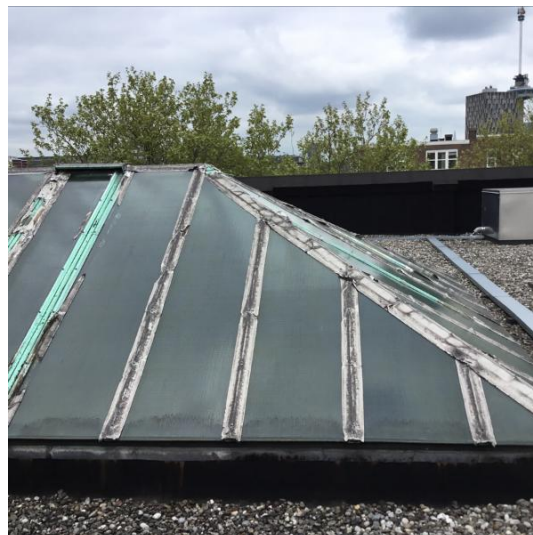
ID number 18.5  
Location  
Priority  None  
Date Time 2017-07-11 15:48:30  
Decision

Component 3.01 Dak  
Description Oude kappen in koper en draadglas, nieuwe in aluminium en melkglas. Kleuronderzoek voor dateringen.

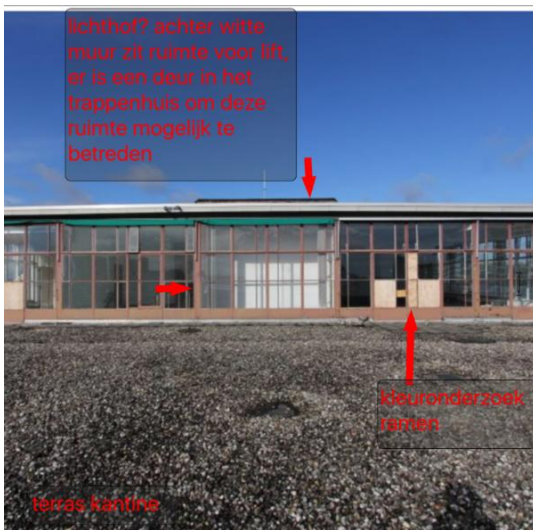
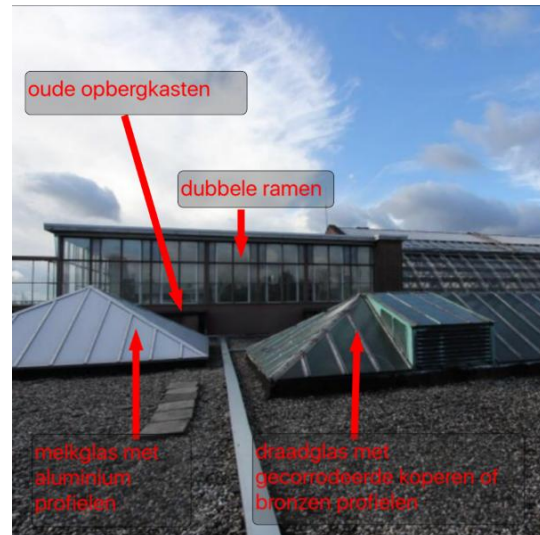
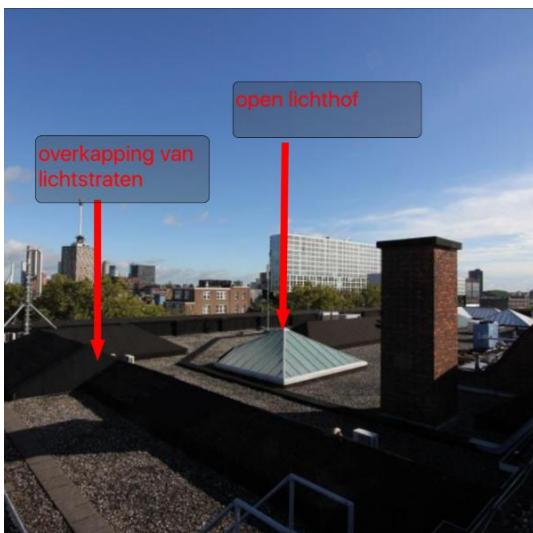
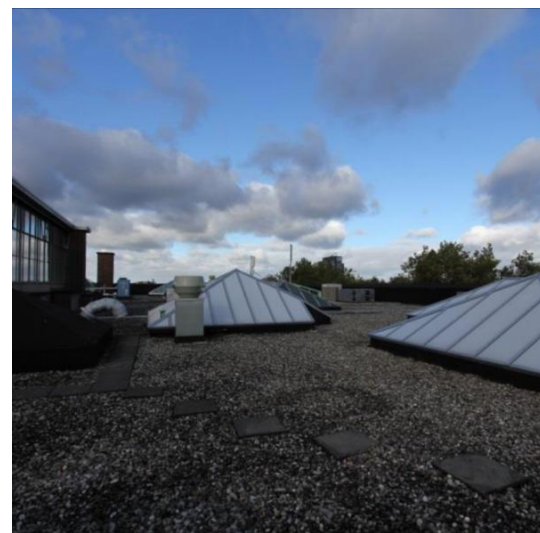
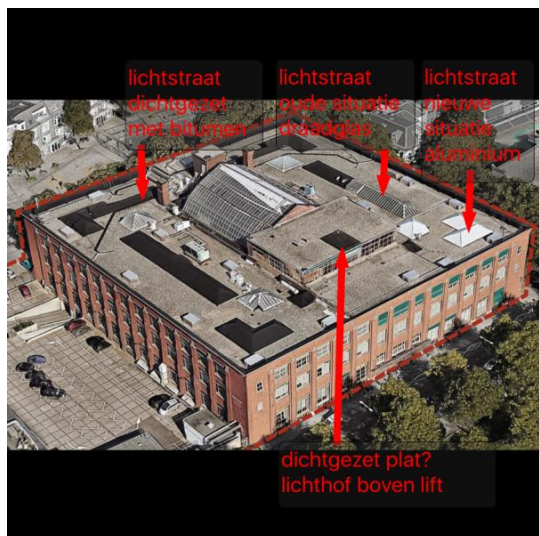
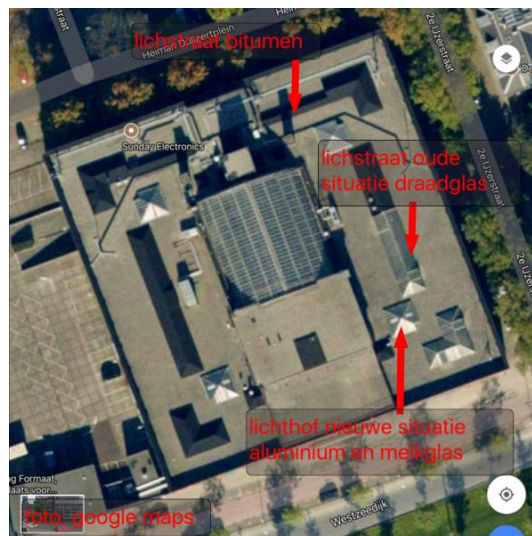
ID number 18.2  
Location  
Priority  None  
Date Time 2017-07-04 14:24:01  
Decision

Component 3.01 Daklandschap  
Description Lichtstraten en lighthoven deels origineel, deels vernieuwd, deels dichtgezet. Kantine kleuronderzoek.

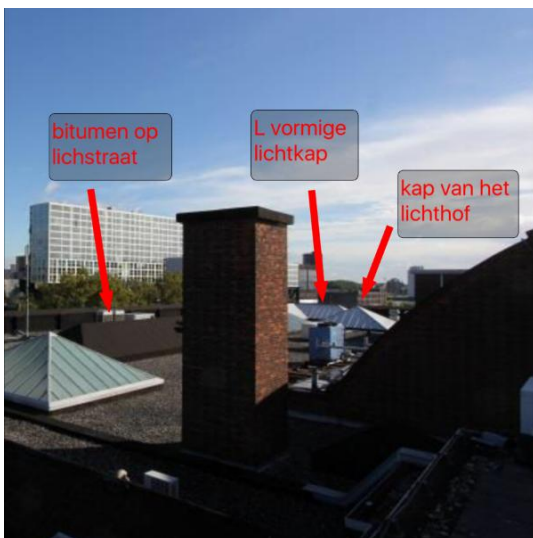
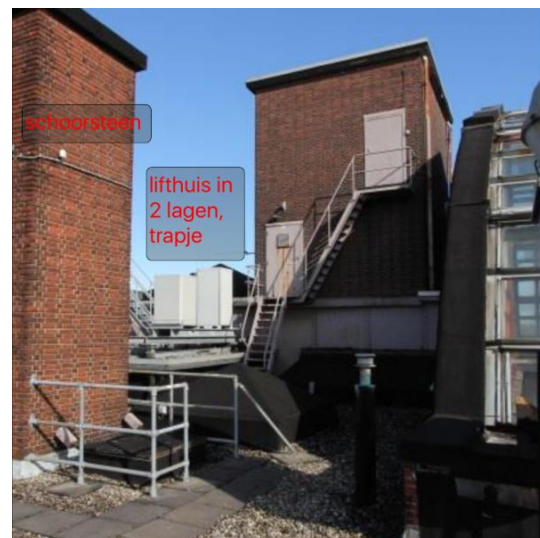
ID number 18.3  
Location  
Priority  None  
Date Time 2017-07-04 14:38:20  
Decision

Component 3.01 Daklandschap schoorstenen en lift  
Description Ombouw lift en schoorstenen

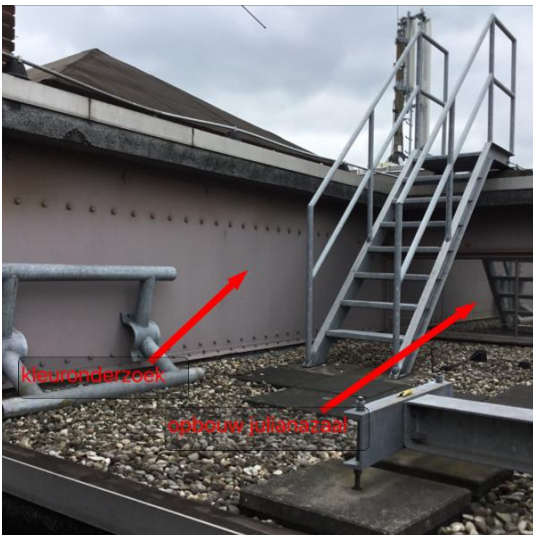
ID number 18.4  
Location  
Priority  None  
Date Time 2017-07-04 14:43:57  
Decision

Component 3.01 opbouw voor juliana zaal  
Description kleuronderzoek op roze metalen onderdelen
