# Remediation plan Ringdijk 390 in Ridderkerk

project number 465250-02  
final revision 01  
February 2, 2021

Panattoni Dutch Development Coöperatie U.A.  
Saturnusstraat 40  
2132 HB Hoofddorp

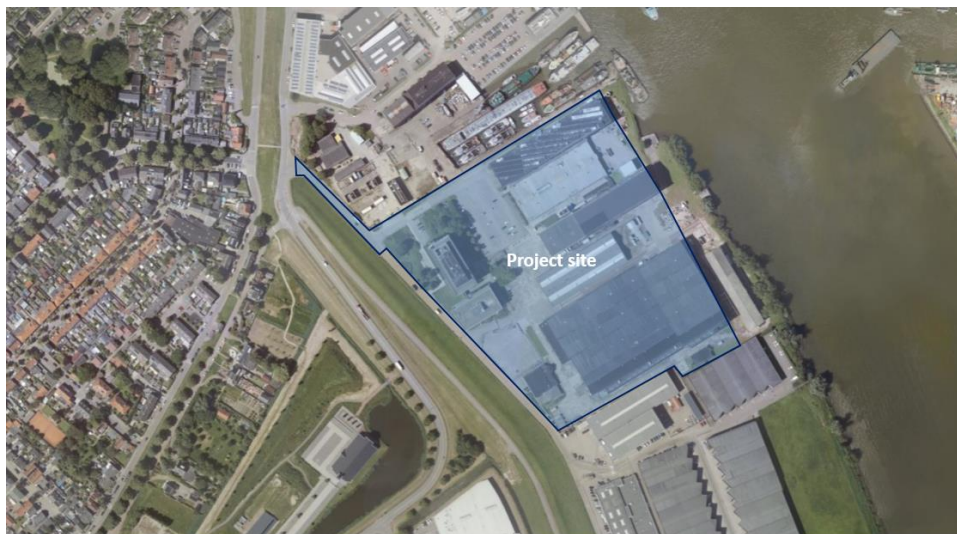
Figure 1: Aerial photo of the site (source: Cyclomedia, 2019)

Figure 1 is an aerial photo showing the location of the survey site. The cadastral map of the site is shown in figure 2.
